Victoria Square Boulevard Class
Environmental Assessment

Environmental Study Report

HERITAGE IMPACT ASSESSMENT

Victoria Square Boulevard Class Environmental Assessment, Between North & South Connections to Woodbine By-Pass City of Markham, Ontario

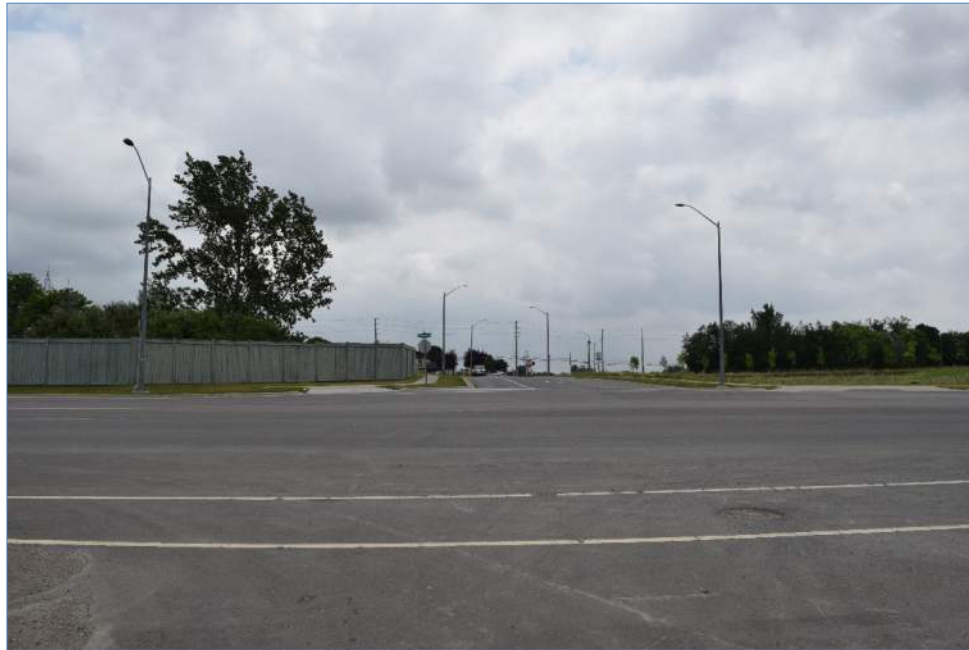
Figure 9: View facing east of the north connection of Woodbine Bypass and Victoria Square Boulevard.

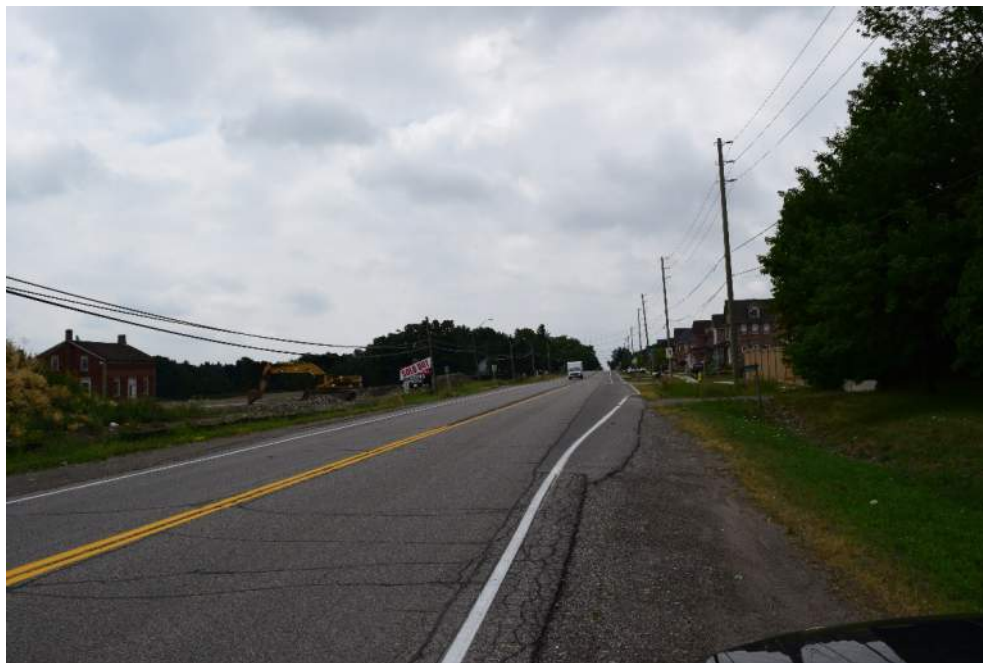
Figure 10: View facing south of the residential development (right) and relict agricultural lands (left) between Woodbine Avenue Bypass (north connection) and Edward Roberts Drive.

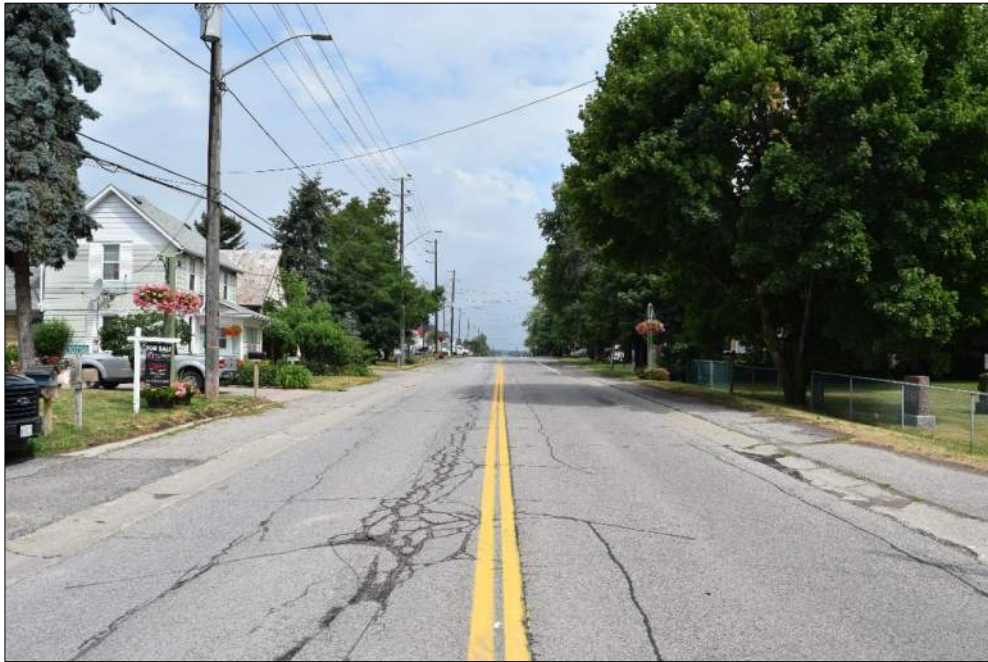
Figure 11: View facing north of the streetscape north of the crossroads at Victoria Square.

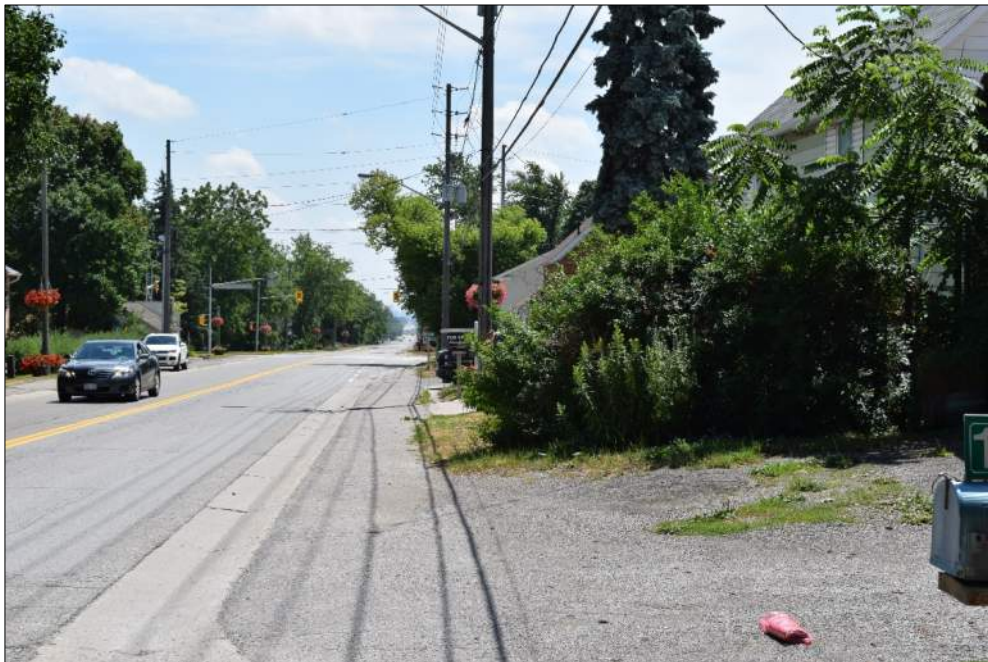
Figure 12: View facing south of the crossroads at Victoria Square, within the boundaries of the proposed HCD

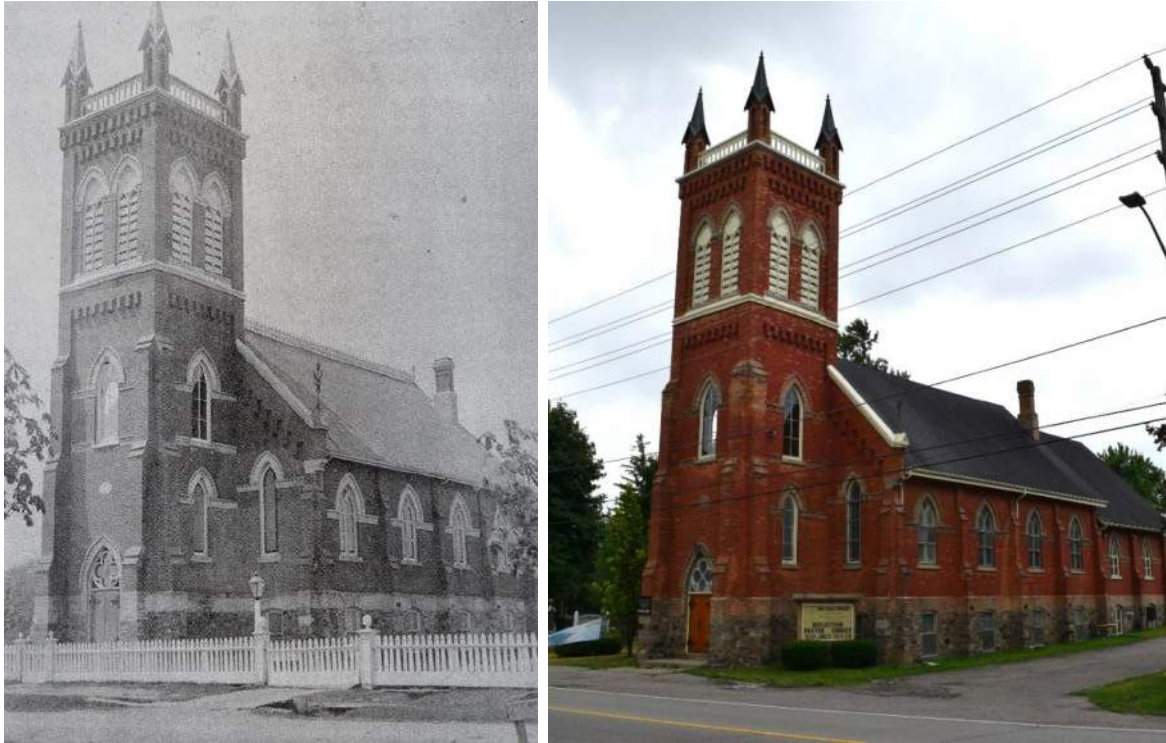
Figure 13: Late 19th century and contemporary views of the 1880 United Church at 10720 Victoria Square Boulevard. The ditches as seen in the historic photo have been filled and the road was marginally widened.

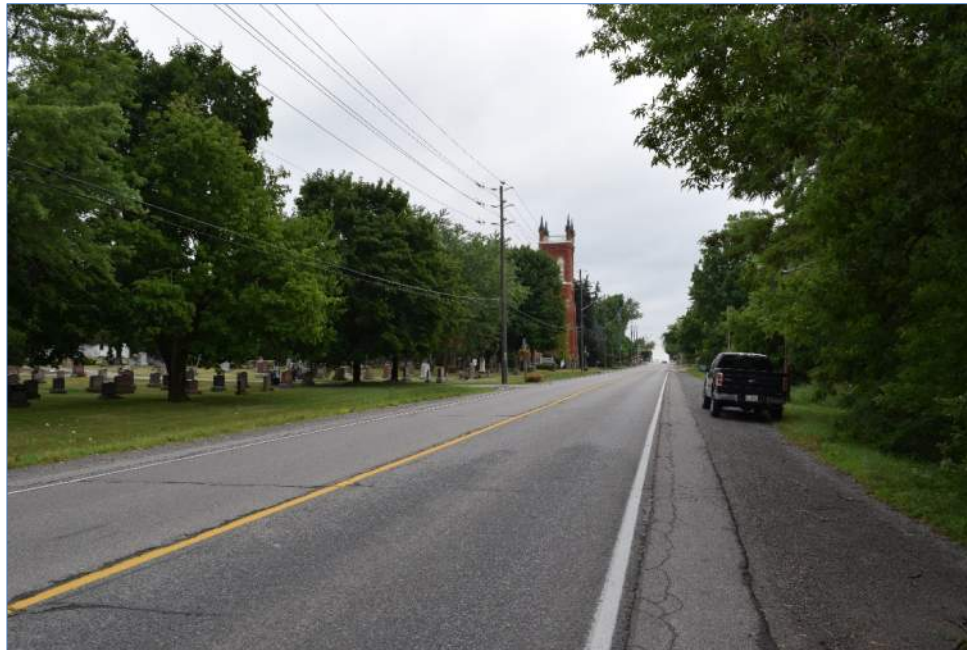
Figure 14: View facing north of the south approaches to Victoria Square, within the boundaries of the proposed HCD.

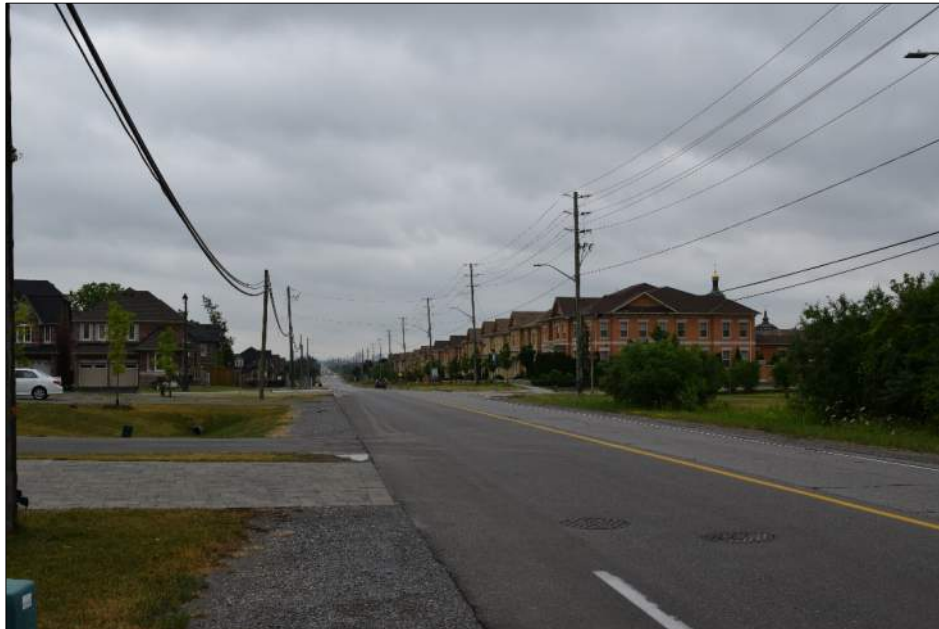
Figure 15: View facing south of the residential area between Reflection Road/ Rinas Avenue and Woodbine Avenue Bypass (south connection).

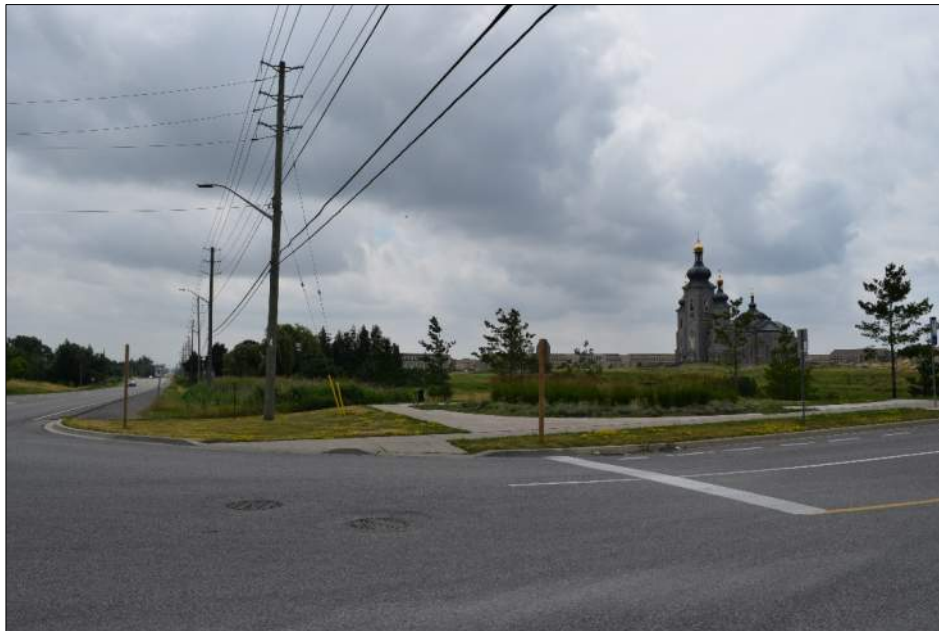
Figure 16: View facing south from Betty Roman Boulevard of the Cathedral of the Transfiguration and surrounding residential development.

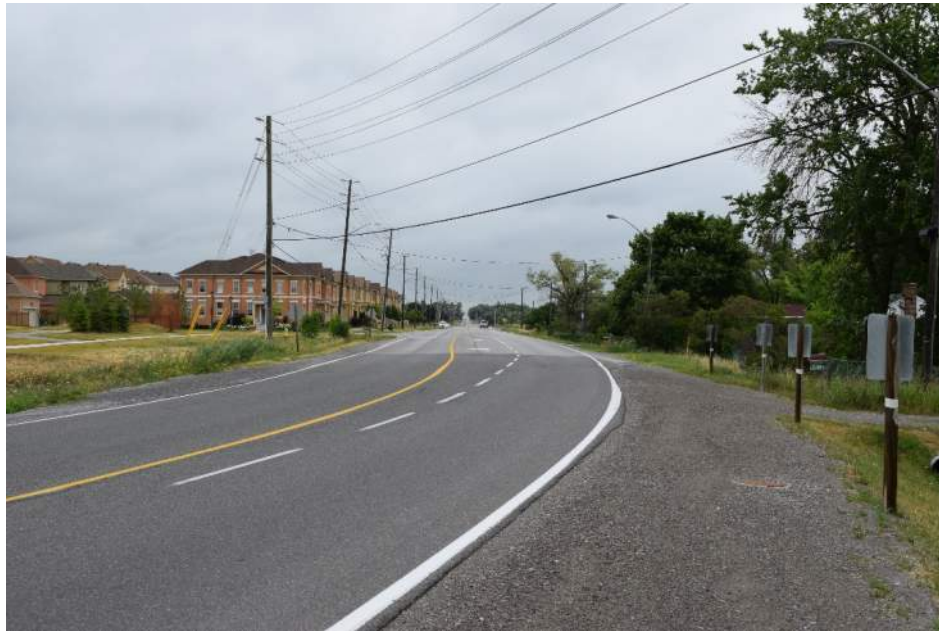
Figure 17: View facing north of the area between Woodbine Avenue Bypass (south connection) and Reflection Road/ Rinas Avenue.

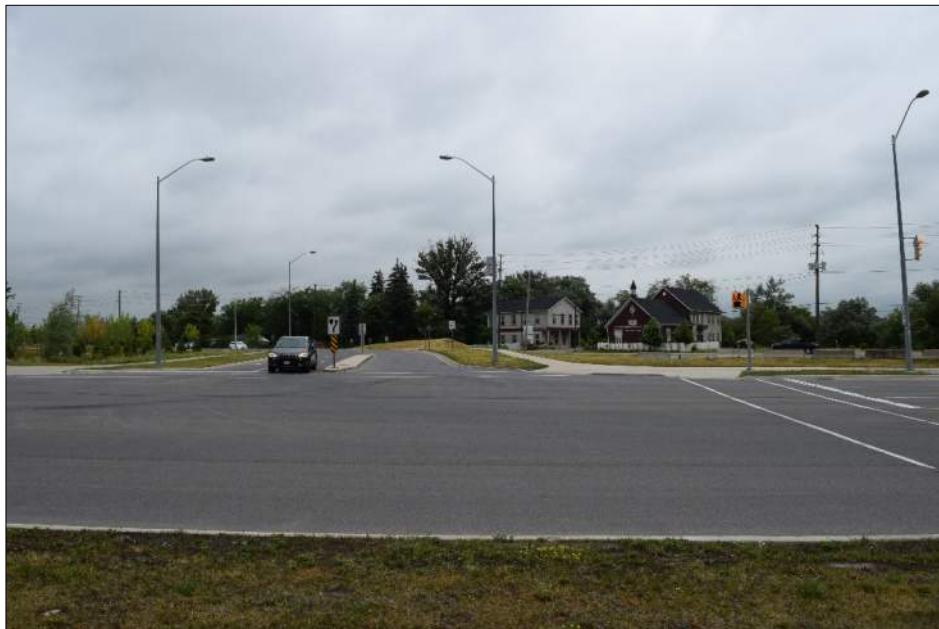
Figure 18: View facing northeast of the south connection of Woodbine Bypass and Victoria Square Boulevard.

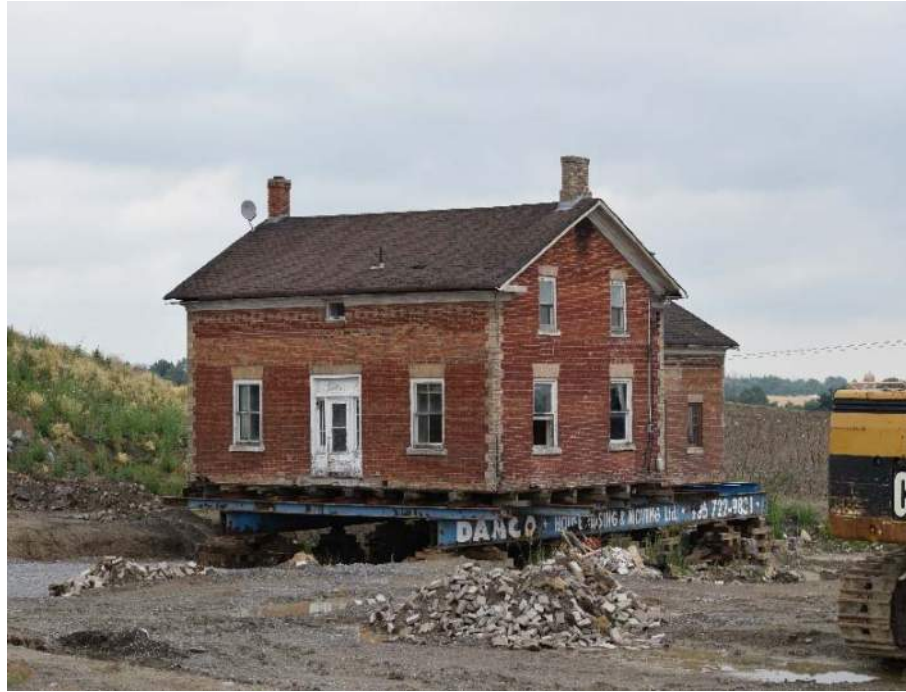
10975 Victoria Square Boulevard (George Peach House, c. 1860)

View facing northeast

10975 Victoria Square Blvd. George Peach House, c. 1860	2	Low to no risk for direct impact to heritage attributes that is irreversible, short term, infrequent, and widespread. Rationale: The heritage attributes of the property are setback from the ROW and the building was relocated to a newly constructed foundation. There is no risk of indirect impact to heritage attributes since the Project does not represent a substantial change to the setting from those of existing conditions.	Low to no risk for direct or indirect impact to heritage attributes that is irreversible, short term, infrequent, and widespread.	No conservation or mitigation measures required.
Victoria Square Victoria Square Historic Hamlet Cultural Landscape	3	Medium to high risk for direct and indirect impact to heritage attributes that is irreversible, short term, infrequent, and widespread. Rationale: Victoria Square is recognized for its mature vegetation and open spaces, as well as the building stock lining its streets. The Project could potentially impact these values by reducing mature trees and introducing signage and road marking that obscures or disrupts significant views and vistas. Risk of impact to Victoria Square Boulevard and Elgin Mills Road as cultural heritage resources is considered low since their profiles have been altered from the historic configuration (see Figure 13), and the road will remain two-lanes wide.	Medium to high risk for direct and indirect impact to heritage attributes that is irreversible, short term, infrequent, and widespread.	MEASURES REQUIRED DURING CONSTRUCTION & OPERATION: Signage & Road Marking: Design for directional signage and road marking should respect the heritage character of the hamlet. Placement and size of signage should not obstruct streetscape views or those of properties of CHVI, nor should signage and road marking contribute to visual clutter. Tree retention: Existing mature trees should be retained and maintained as much as possible.

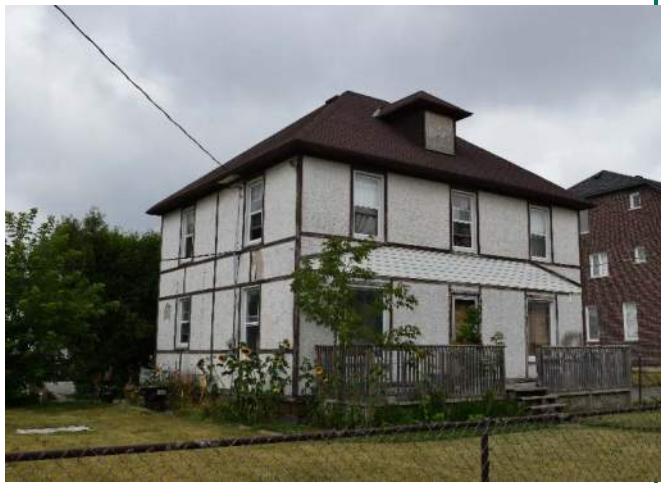
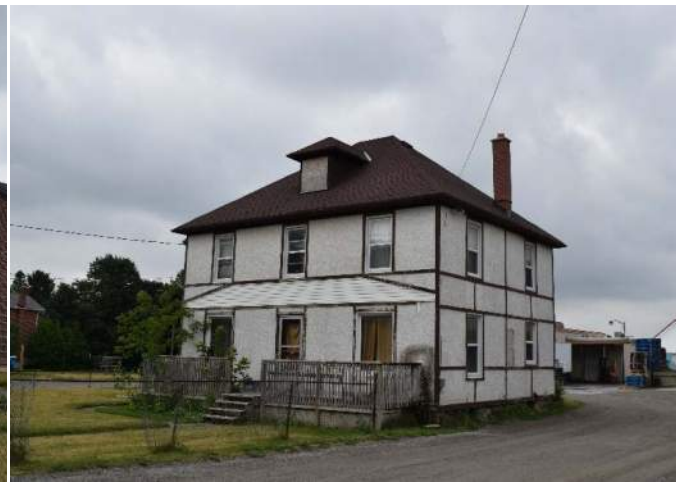
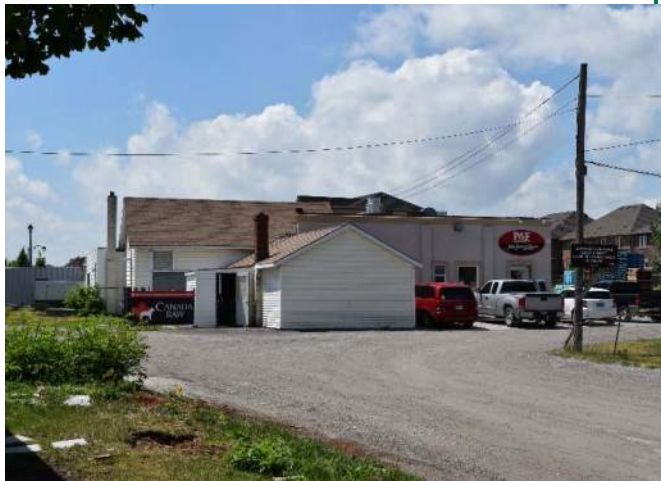
10768 Victoria Square Boulevard (Herman Boynton House, c.1912)

View of Herman Boynton House facing northwest

View of Herman Boynton House facing west

View of shop southwest of Herman Boynton House

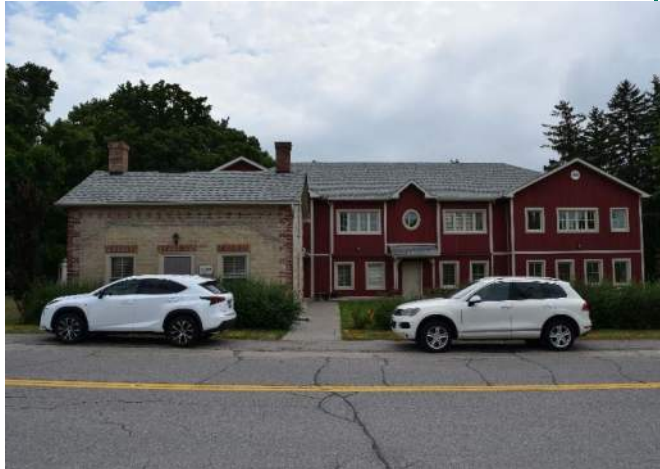
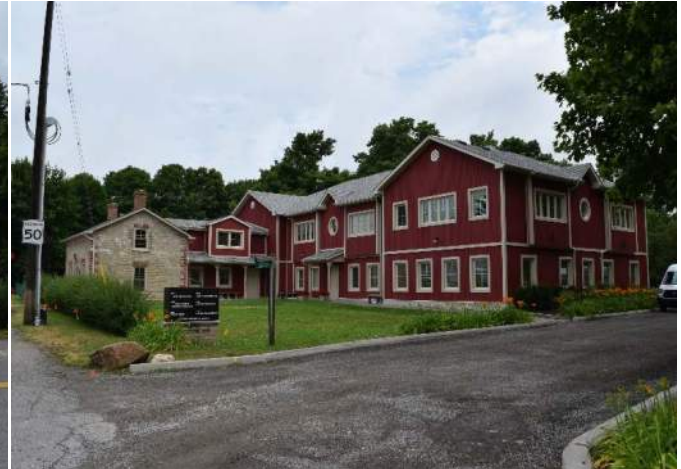
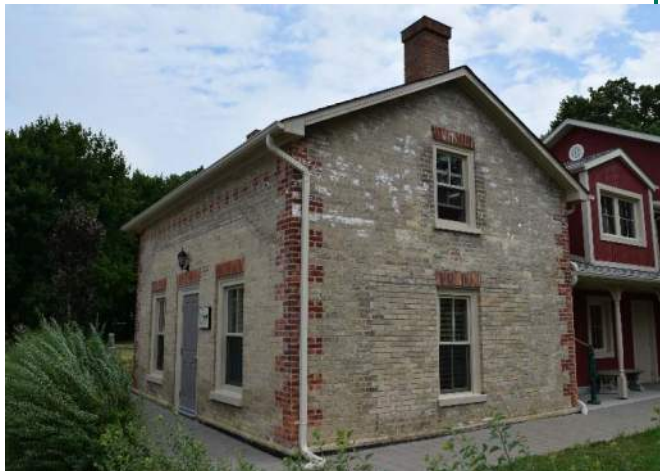
10761 Victoria Square Boulevard (Hatton-Baker House, c.1850)

View facing east

View facing northeast

View of original portion facing east

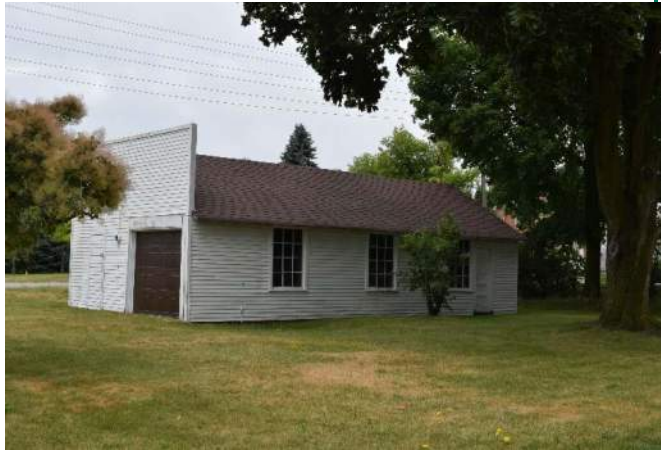
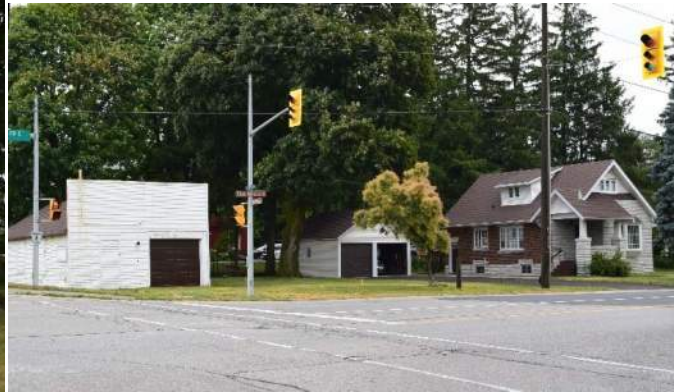
3026 Elgin Mills Road (Louis G. Stoutenburgh Garage [1927] & House [1926-27])

View of garage facing northwest

Garage, secondary structure and house at 3026 Elgin Mills Road

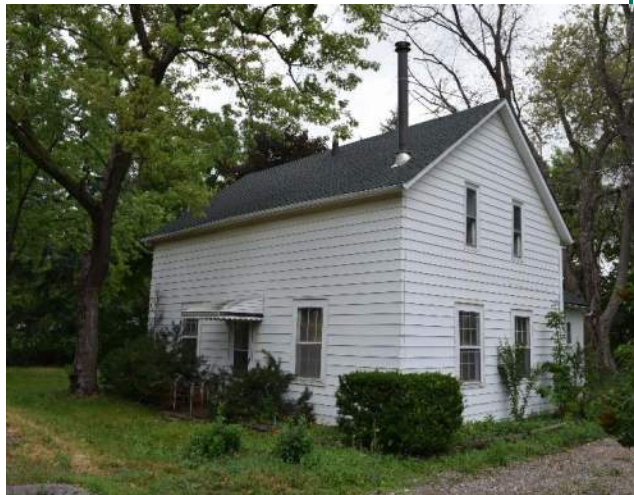
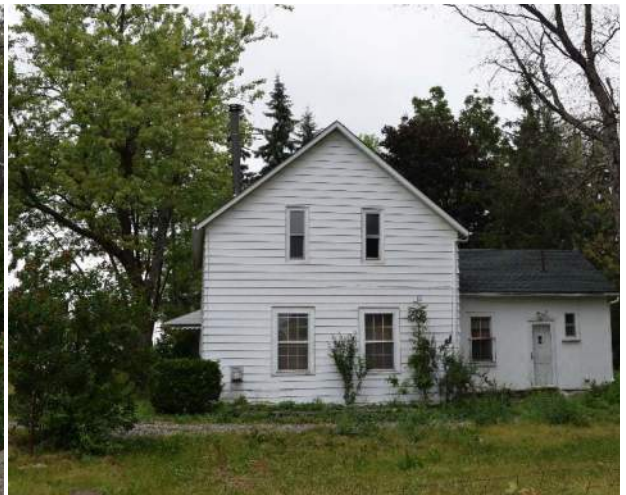
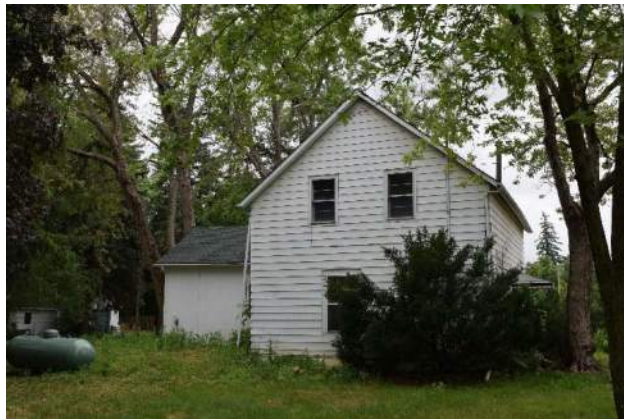
10737 Victoria Square Boulevard (Savage-Schell House, c.1872) (formerly 10747 Woodbine Avenue)

View facing southeast

View facing north

View facing south. The secondary structure can be seen at left

Property of Known or Potential CHVI	Area	Risk of Adverse Impact to Heritage Property or Attributes during Construction	Risk of Adverse Impact or Residual Effect during Operation	Conservation or Mitigation Measures Recommended
10737 Victoria Square Blvd. Savage-Schell House, c.1872	3	High risk for direct impact to heritage attributes that is irreversible, short term, infrequent, and widespread. Rationale: The heritage attributes of the property are within 10 m of the ROW.	High risk for direct impact to heritage attributes that is irreversible, short term, infrequent, and widespread.	MEASURES REQUIRED DURING CONSTRUCTION & OPERATION: Site plan control & communication: The property and specifically the footprint of the house should be clearly marked on project mapping and communicated to all project personnel for avoidance during construction and subsequent operation. Create a physical buffer: Temporary fencing should be erected at a 10 m distance from the house to ensure that all excavation, installation and associated vehicle traffic during construction or subsequent operational work will not impact the heritage attributes of the property. Monitor for vibration impact: Continuous ground vibration monitoring should be carried out near the foundations of the house using a digital seismograph capable of measuring and recording ground vibration intensities in digital format in each of three (3) orthogonal directions. The instrument should also be equipped with a wireless cellular modem for remote access and transmission of data. The installed instrument should be programmed to record continuously, providing peak ground vibration levels at a specified time interval (e.g. 5 minutes) as well as waveform signatures of any ground vibrations exceeding a threshold level that would be determined during monitoring. The instrument should also be programmed to provide a warning should the peak ground vibration level exceed the guideline limits specified. In the event of either a threshold trigger or exceedance warning, data would be retrieved remotely and forwarded to designated recipients.

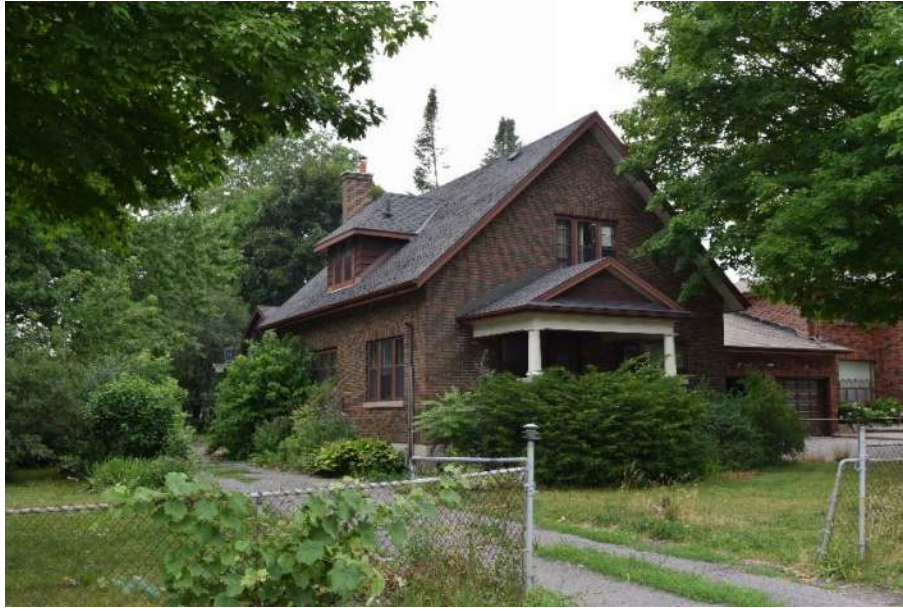
10732 Victoria Square Boulevard (Rolph Boynton House, 1937)

View facing west

Rolph Boynton House is a single-detached, single-storey and 2-bay, Craftsman-style house with an irregular-shaped plan and medium gable roof with hipped dormer. Construction is in mottled brick over a stone or concrete foundation. The principal façade has symmetrical fenestration of combined tall, 3-pane windows and the centre door is covered by an off-centre open porch with pediment and columns. Other elements of the structure are the prominent stone or concrete lugsills and rear wings. A secondary structure is located west of the house but could not be seen from public rights of way.

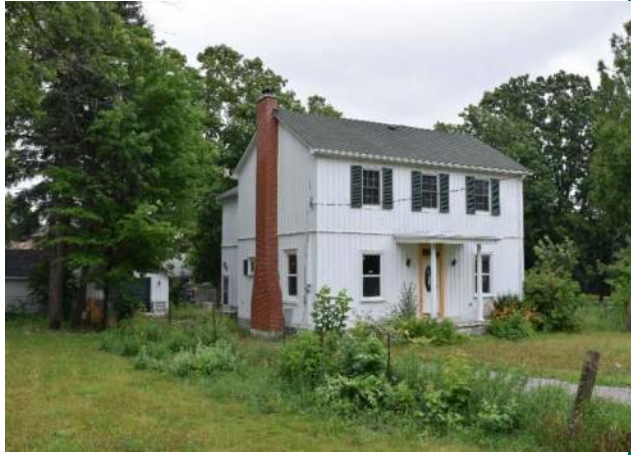
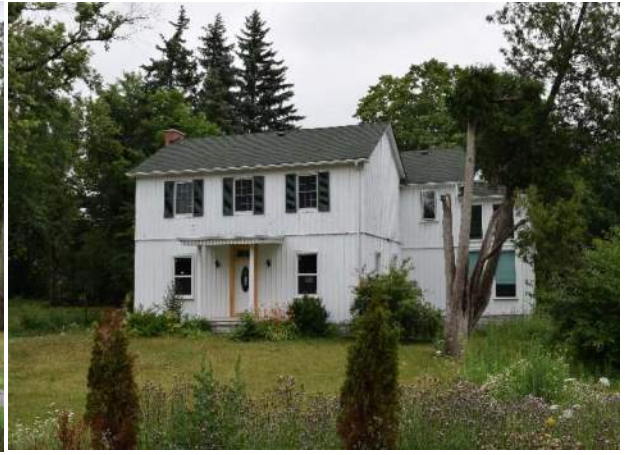
10729 Victoria Square Boulevard (Macey-Perkins House, c.1861)

View facing southeast. The secondary structure can be seen at left.

View facing northeast.

Property of Known or Potential CHVI	Area	Risk of Adverse Impact to Heritage Property or Attributes during Construction	Risk of Adverse Impact or Residual Effect during Operation	Conservation or Mitigation Measures Recommended
<p>10729 Victoria Square Blvd. Macey-Perkins House, c.1861</p>	<p>3</p>	<p>Medium risk for direct impact to heritage attributes that is irreversible, short term, infrequent, and widespread. Rationale: The house is over 10 m from ROW but within a 60-m potential vibration impact zone (see Carman <i>et al.</i> 2012:31).</p>	<p>Medium risk for direct impact to heritage attributes that is irreversible, short term, infrequent, and widespread.</p>	<p>MEASURES REQUIRED DURING CONSTRUCTION & OPERATION: Site plan control & communication: The property and specifically the footprint of the house should be clearly marked on project mapping and communicated to all project personnel for avoidance during construction and subsequent operation. Create a physical buffer: Temporary fencing should be erected at the property line to ensure that all excavation, installation and associated vehicle traffic during construction or subsequent operational work will not impact the heritage attributes of the property. Monitor for vibration impact: Continuous ground vibration monitoring should be carried out near the foundations of the house using a digital seismograph capable of measuring and recording ground vibration intensities in digital format in each of three (3) orthogonal directions. The instrument should also be equipped with a wireless cellular modem for remote access and transmission of data. The installed instrument should be programmed to record continuously, providing peak ground vibration levels at a specified time interval (e.g. 5 minutes) as well as waveform signatures of any ground vibrations exceeding a threshold level that would be determined during monitoring. The instrument should also be programmed to provide a warning should the peak ground vibration level exceed the guideline limits specified. In the event of either a threshold trigger or exceedance warning, data would be retrieved remotely and forwarded to designated recipients.</p>

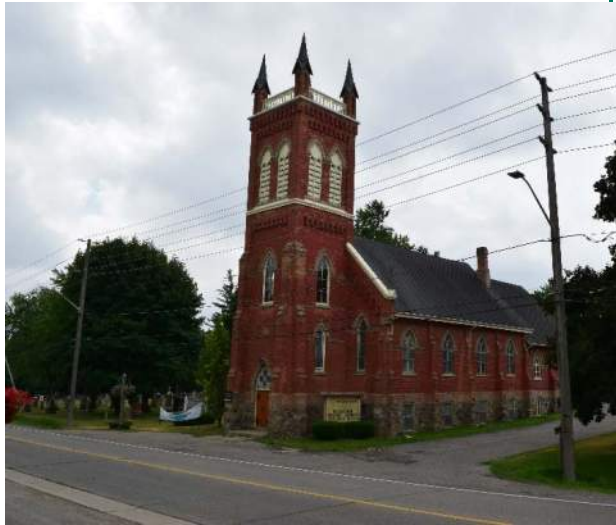
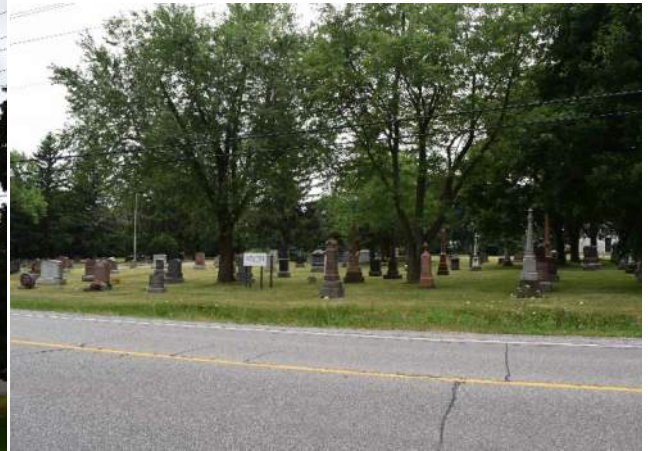
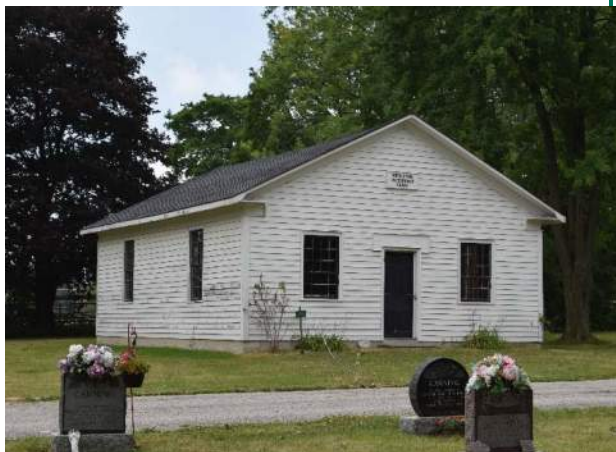
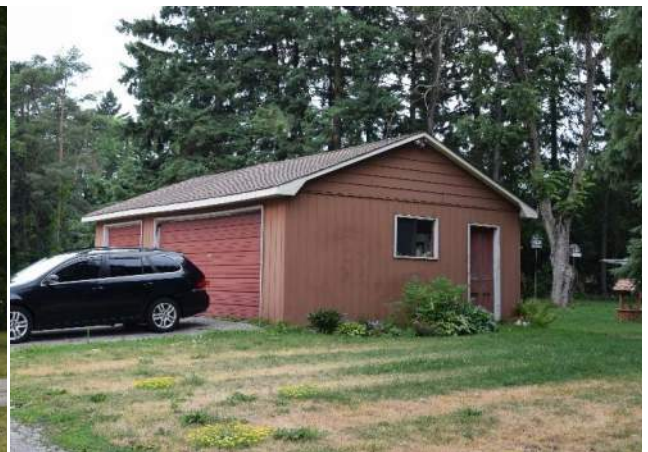
10720 Victoria Square Boulevard (United Church, 1880, Wesleyan Chapel, 1845, & Cemetery)

View of the United Church facing southwest

View of the cemetery, facing west

View of the Wesleyan Chapel, facing west

View of the shed, facing west

Property of Known or Potential CHVI	Area	Risk of Adverse Impact to Heritage Property or Attributes during Construction	Risk of Adverse Impact or Residual Effect during Operation	Conservation or Mitigation Measures Recommended
10720 Victoria Square Blvd. United Church, 1880, Wesleyan Chapel, 1845, & Cemetery	3	High risk for direct impact to heritage attributes that is irreversible, short term, infrequent, and widespread. Rationale: The heritage attributes of the church and graveyard are within 10 m of the ROW.	High risk for direct impact to heritage attributes that is irreversible, short term, infrequent, and widespread.	DURING CONSTRUCTION & OPERATION: Site plan control & communication: The property and specifically the footprint of the United Church should be clearly marked on project mapping and communicated to all project personnel for avoidance during construction and subsequent operation. Create a physical buffer: Temporary fencing should be erected at a 10 m distance from the Church and on the property line near the graveyard to ensure that all excavation, installation and associated vehicle traffic during construction or subsequent operational work will not impact the heritage attributes of the property. Monitor for vibration impact: Continuous ground vibration monitoring should be carried out near the foundations of the house using a digital seismograph capable of measuring and recording ground vibration intensities in digital format in each of three (3) orthogonal directions. The instrument should also be equipped with a wireless cellular modem for remote access and transmission of data. The installed instrument should be programmed to record continuously, providing peak ground vibration levels at a specified time interval (e.g. 5 minutes) as well as waveform signatures of any ground vibrations exceeding a threshold level that would be determined during monitoring. The instrument should also be programmed to provide a warning should the peak ground vibration level exceed the guideline limits specified. In the event of either a threshold trigger or exceedance warning, data would be retrieved remotely and forwarded to designated recipients.

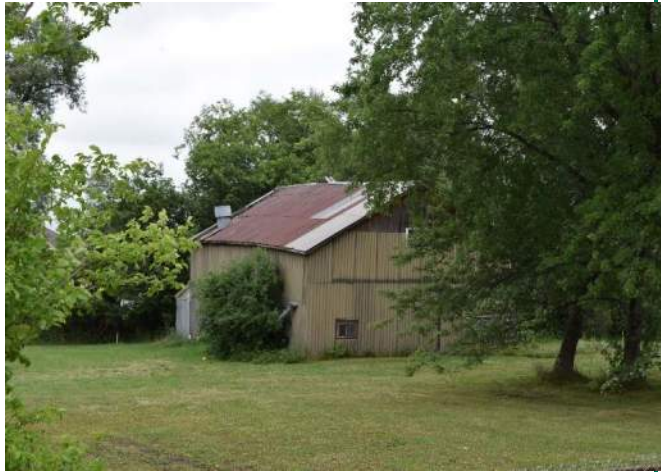
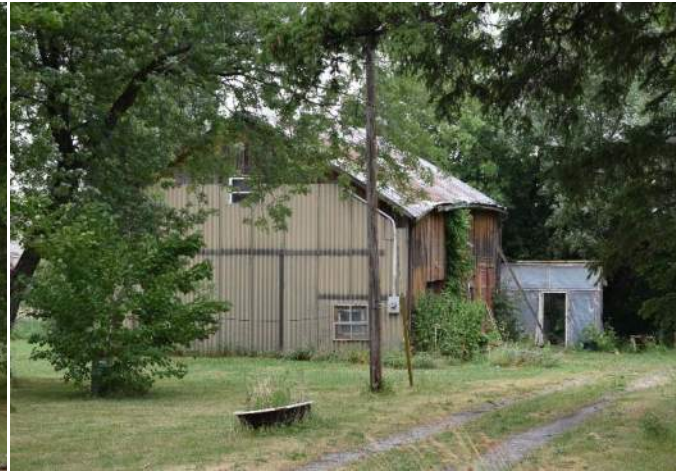
10165 Victoria Square Boulevard (Barn)

View facing east

View facing northeast

10165 Victoria Square Blvd. Barn	6	No risk for direct or indirect impact to heritage attributes that is irreversible, short term, infrequent, and widespread. Rationale: The heritage attributes of the property are situated approximately 40 m from the ROW. There is no risk of indirect impact to heritage attributes since the Project does not represent a substantial change to the setting from those of existing conditions.	No risk for direct or indirect impact to heritage attributes that is irreversible, short term, infrequent, and widespread.	No conservation or mitigation measures required.
10137 Victoria Square Blvd. Victoria Square Schoolhouse S.S. #6, 1877	6	No risk for direct or indirect impact to heritage attributes that is irreversible, short term, infrequent, and widespread. Rationale: Only minor development is proposed for the area fronting the property. There is no risk of indirect impact to heritage attributes since the Project does not represent a substantial change to the setting from those of existing conditions.	No risk for direct or indirect impact to heritage attributes that is irreversible, short term, infrequent, and widespread.	No conservation or mitigation measures required.

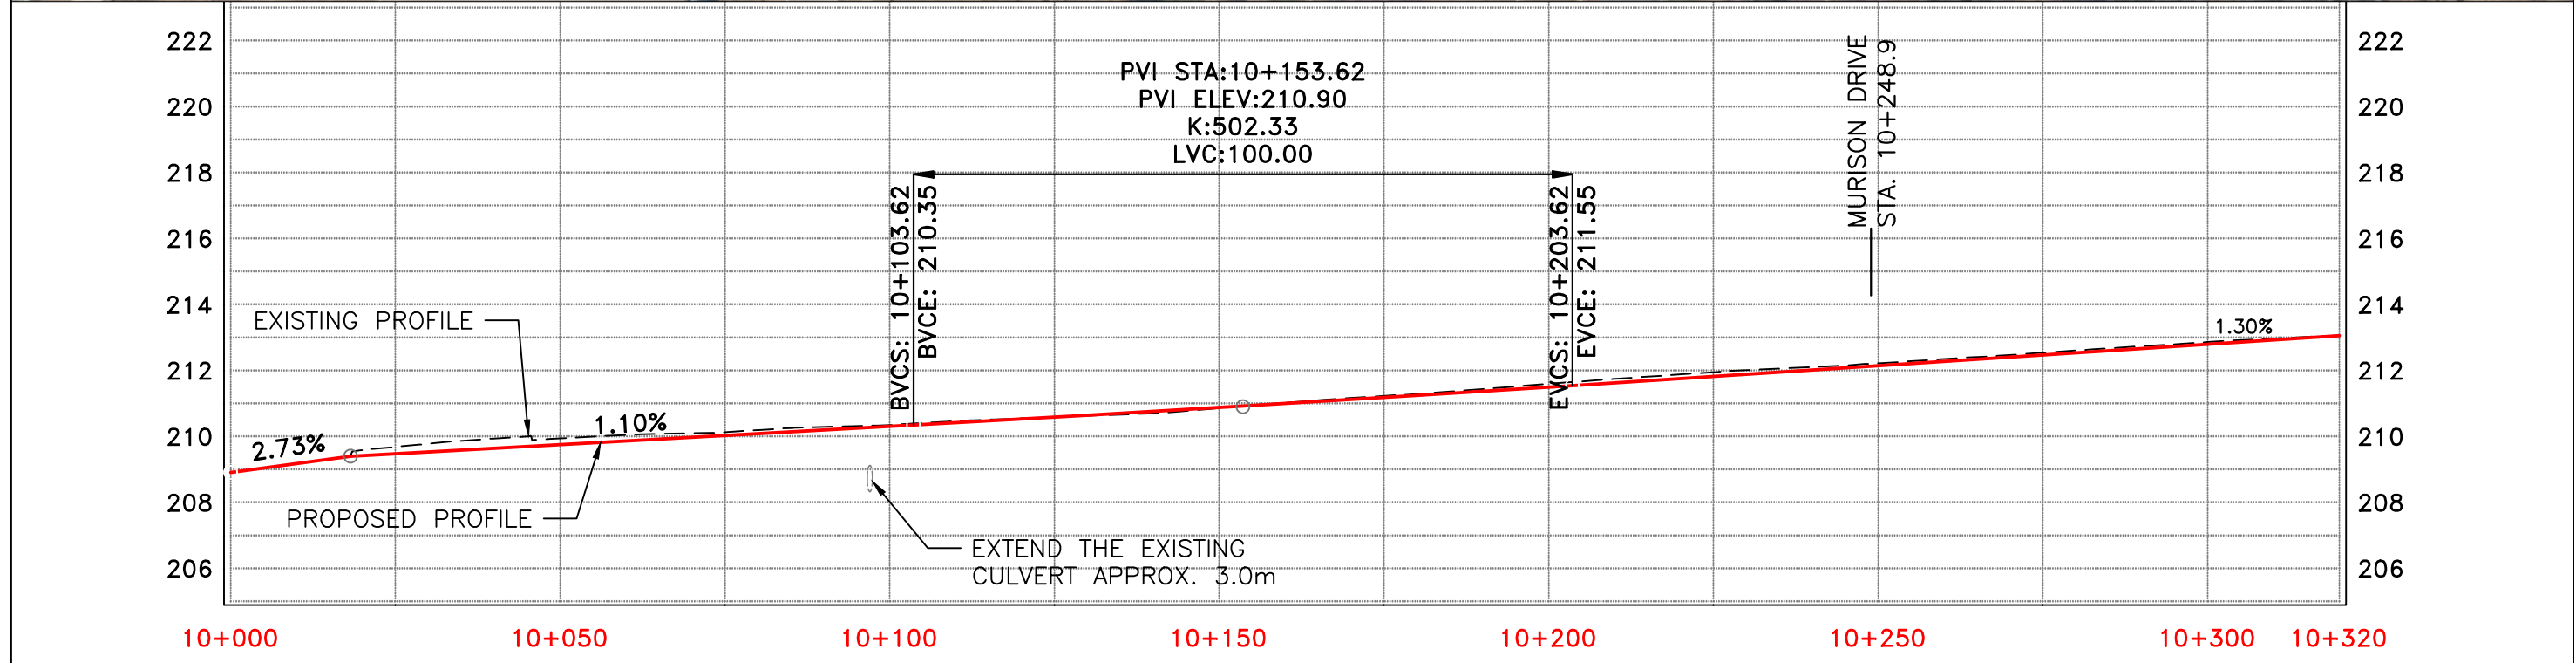
SHEET.NO	01
DATE	DEC. 2017

LEGEND (PLAN)	
	PROPOSED MULTI-USE PATH
	EXISTING R.O.W
	LOT LINES
	EXISTING CL ALIGNMENT
	PROPOSED CL ALIGNMENT
	PROPOSED CURB
	PROPOSED PAVEMENT MARKING
	EXISTING UTILITY POLES
	EXISTING CULVERT
	PROPOSED CULVERT
	EXISTING CHAIN LINK FENCE

LEGEND (PROFILE)	
	EXISTING PROFILE
	PROPOSED PROFILE
	EXISTING CULVERT
	PROPOSED CULVERT

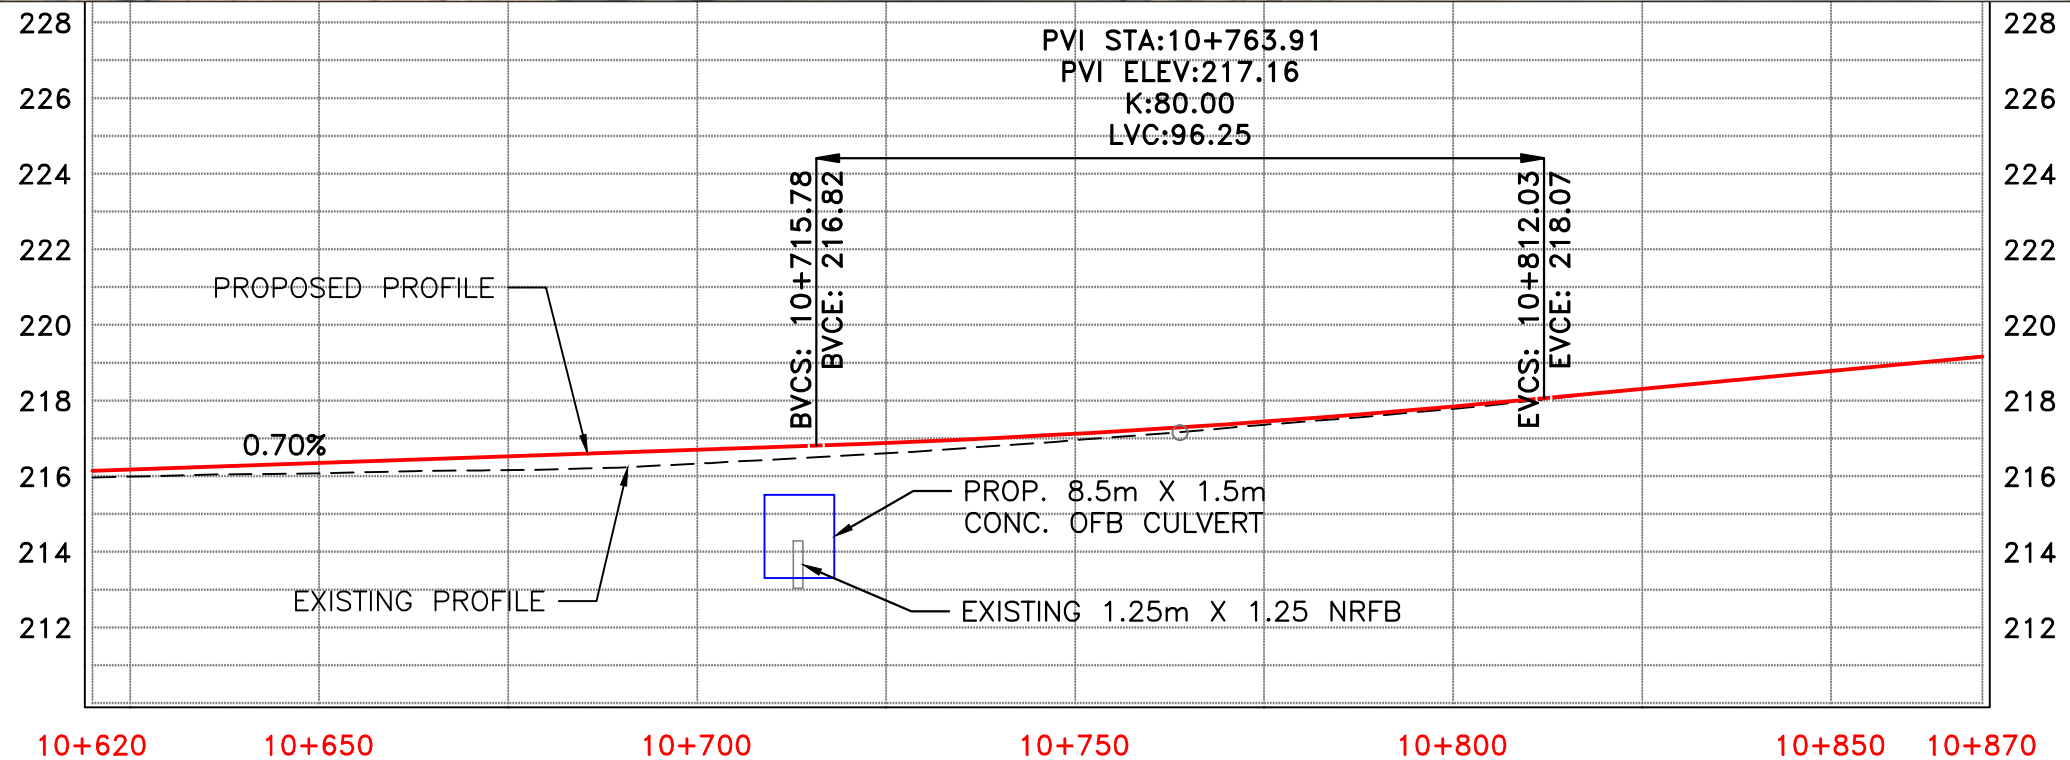
SHEET.NO
03
DATE
DEC. 2017

VICTORIA SQUARE BOULEVARD
CLASS ENVIRONMENTAL ASSESSMENT
PLAN AND PROFILE
STA. 10+620 TO STA. 10+870

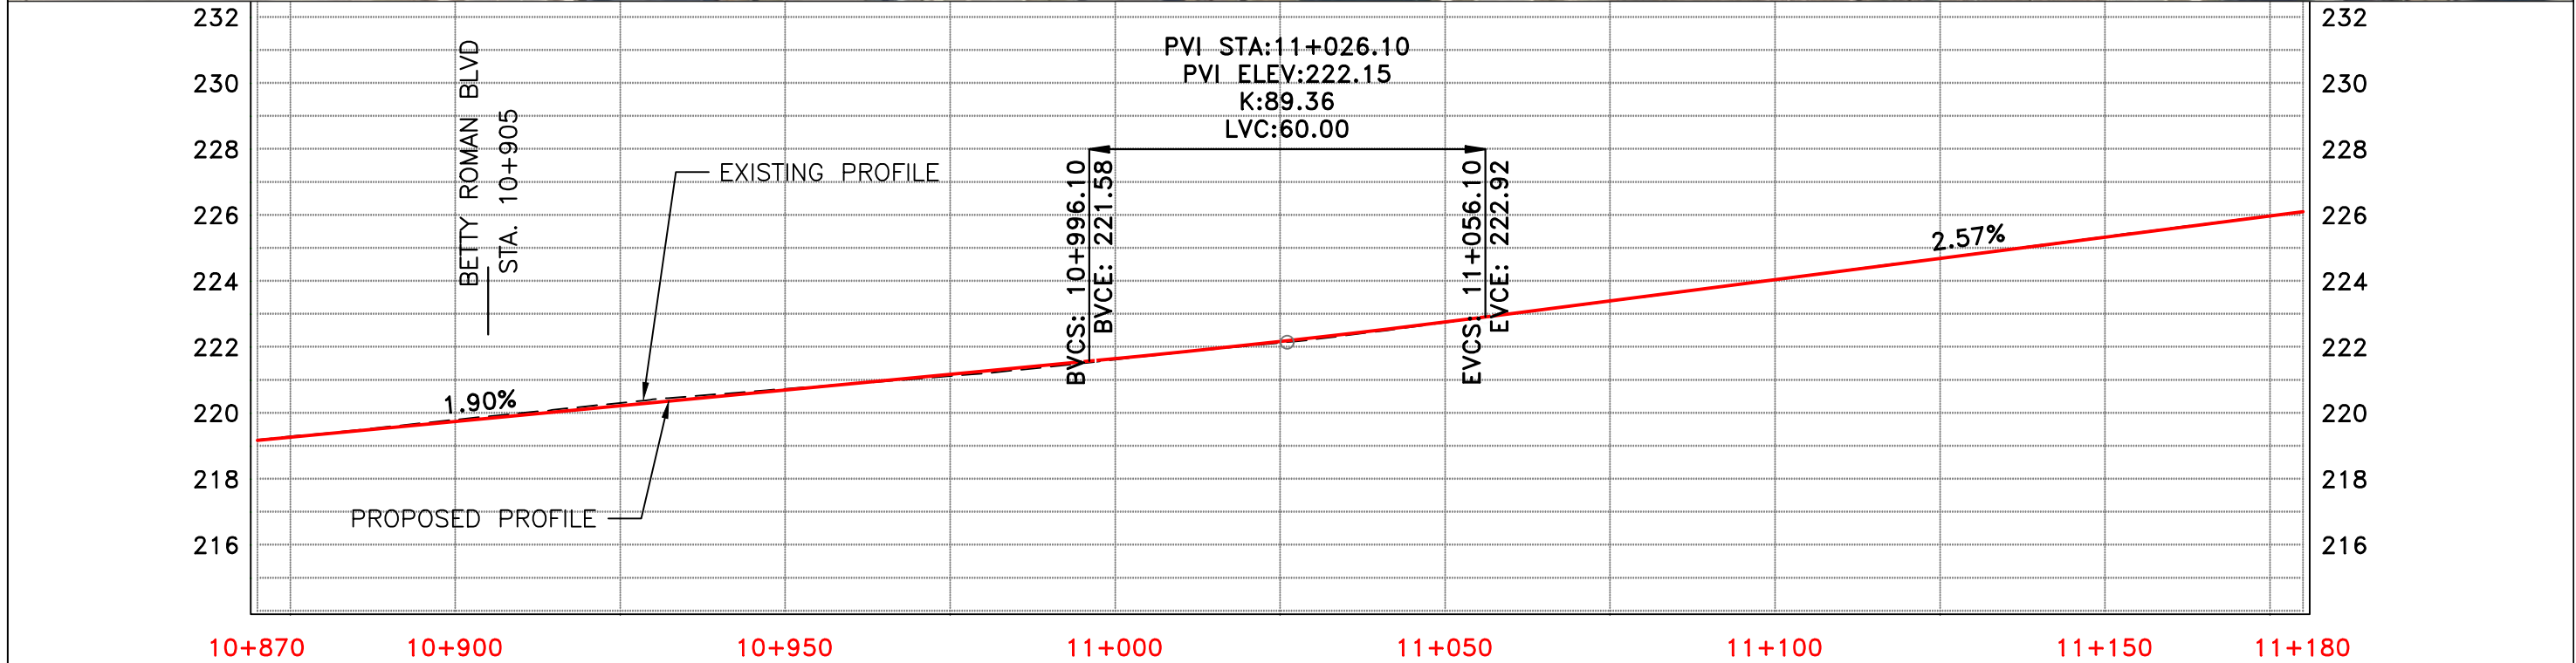
LEGEND (PLAN) 		LEGEND (PROFILE) 		SCALES 		VICTORIA SQUARE BOULEVARD CLASS ENVIRONMENTAL ASSESSMENT PLAN AND PROFILE STA. 10+870 TO STA. 11+180	SHEET NO 04 DATE DEC. 2017
--------------------------	--	-----------------------------	--	-------------------	--	--	-------------------------------------
