Victoria Square Boulevard Class
Environmental Assessment

Environmental Study Report

HERITAGE IMPACT ASSESSMENT

Victoria Square Boulevard Class Environmental Assessment, Between North & South Connections to Woodbine By-Pass City of Markham, Ontario

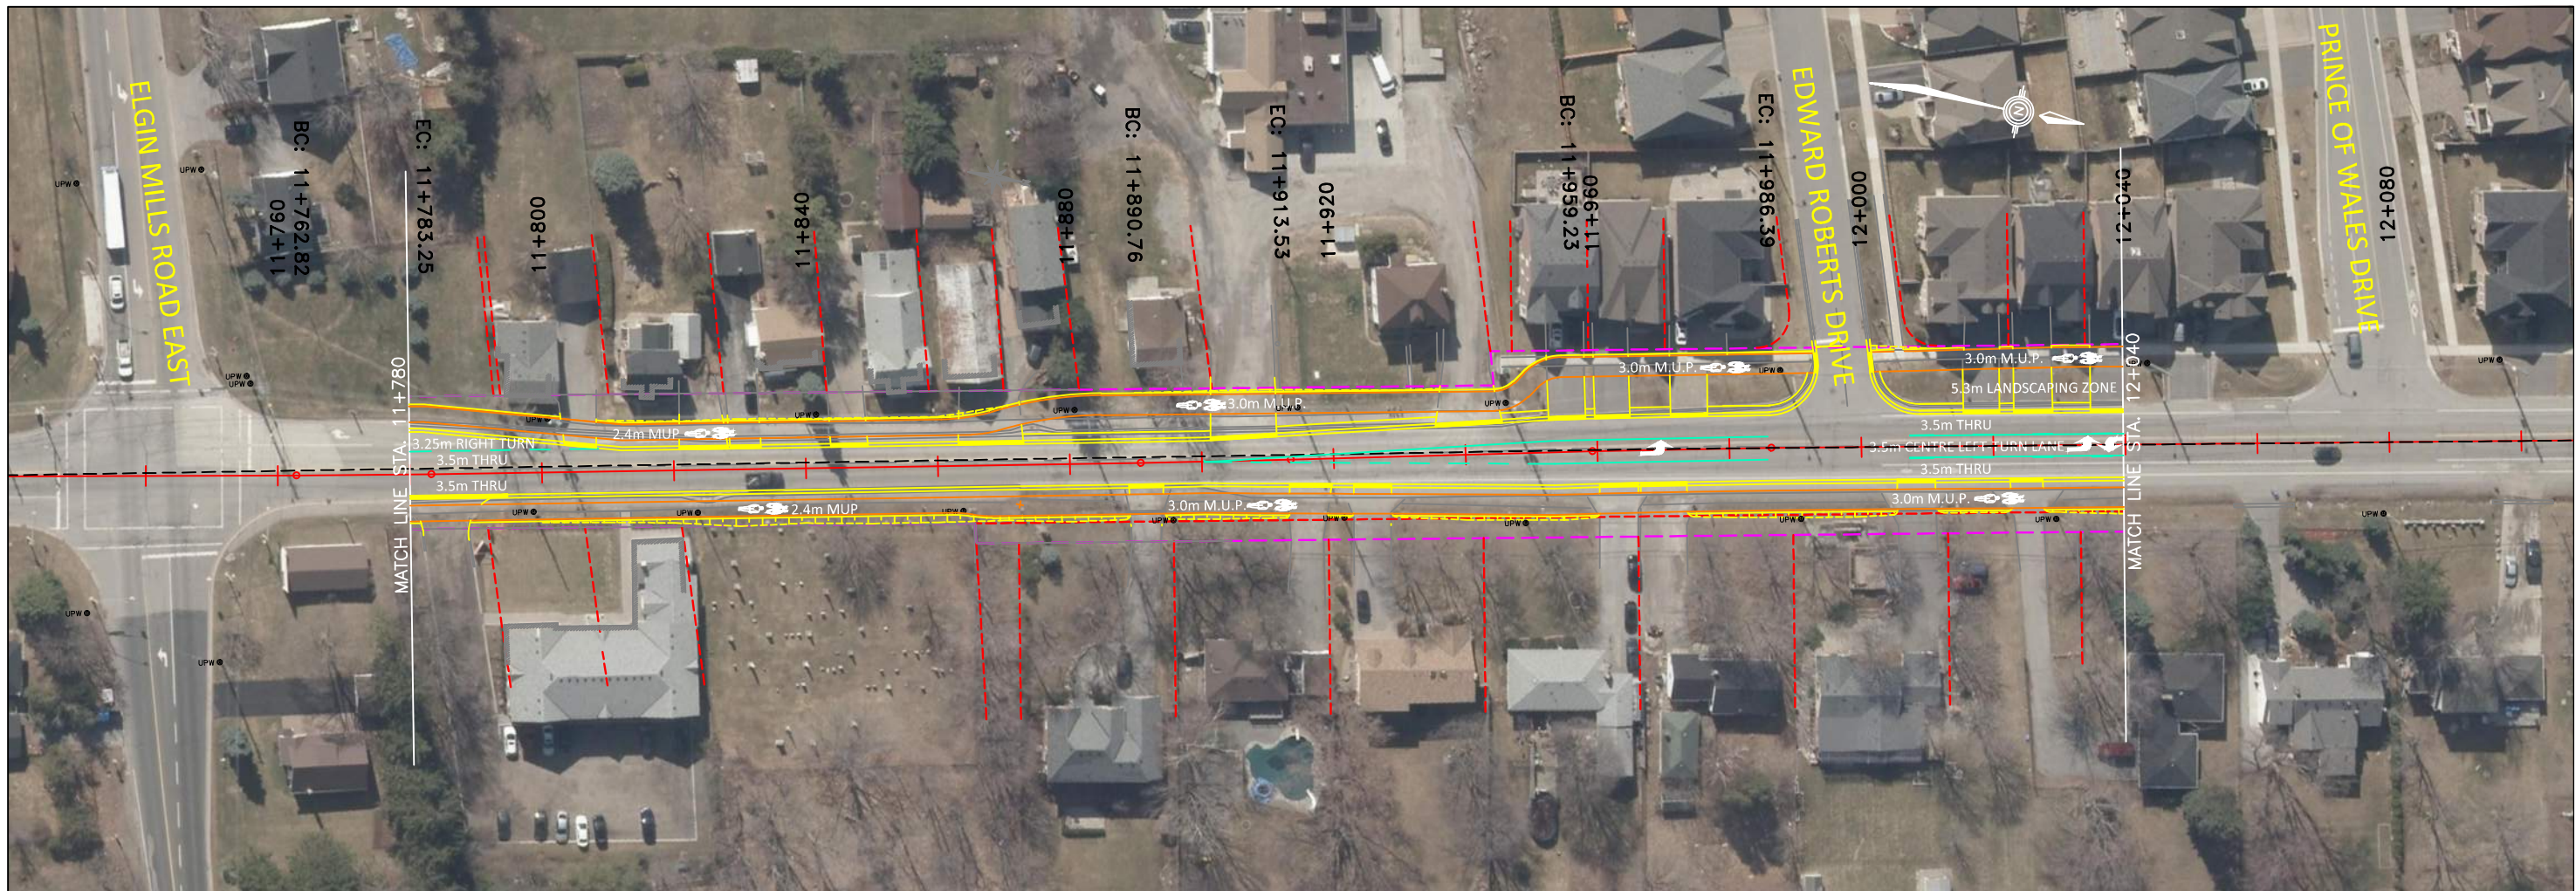
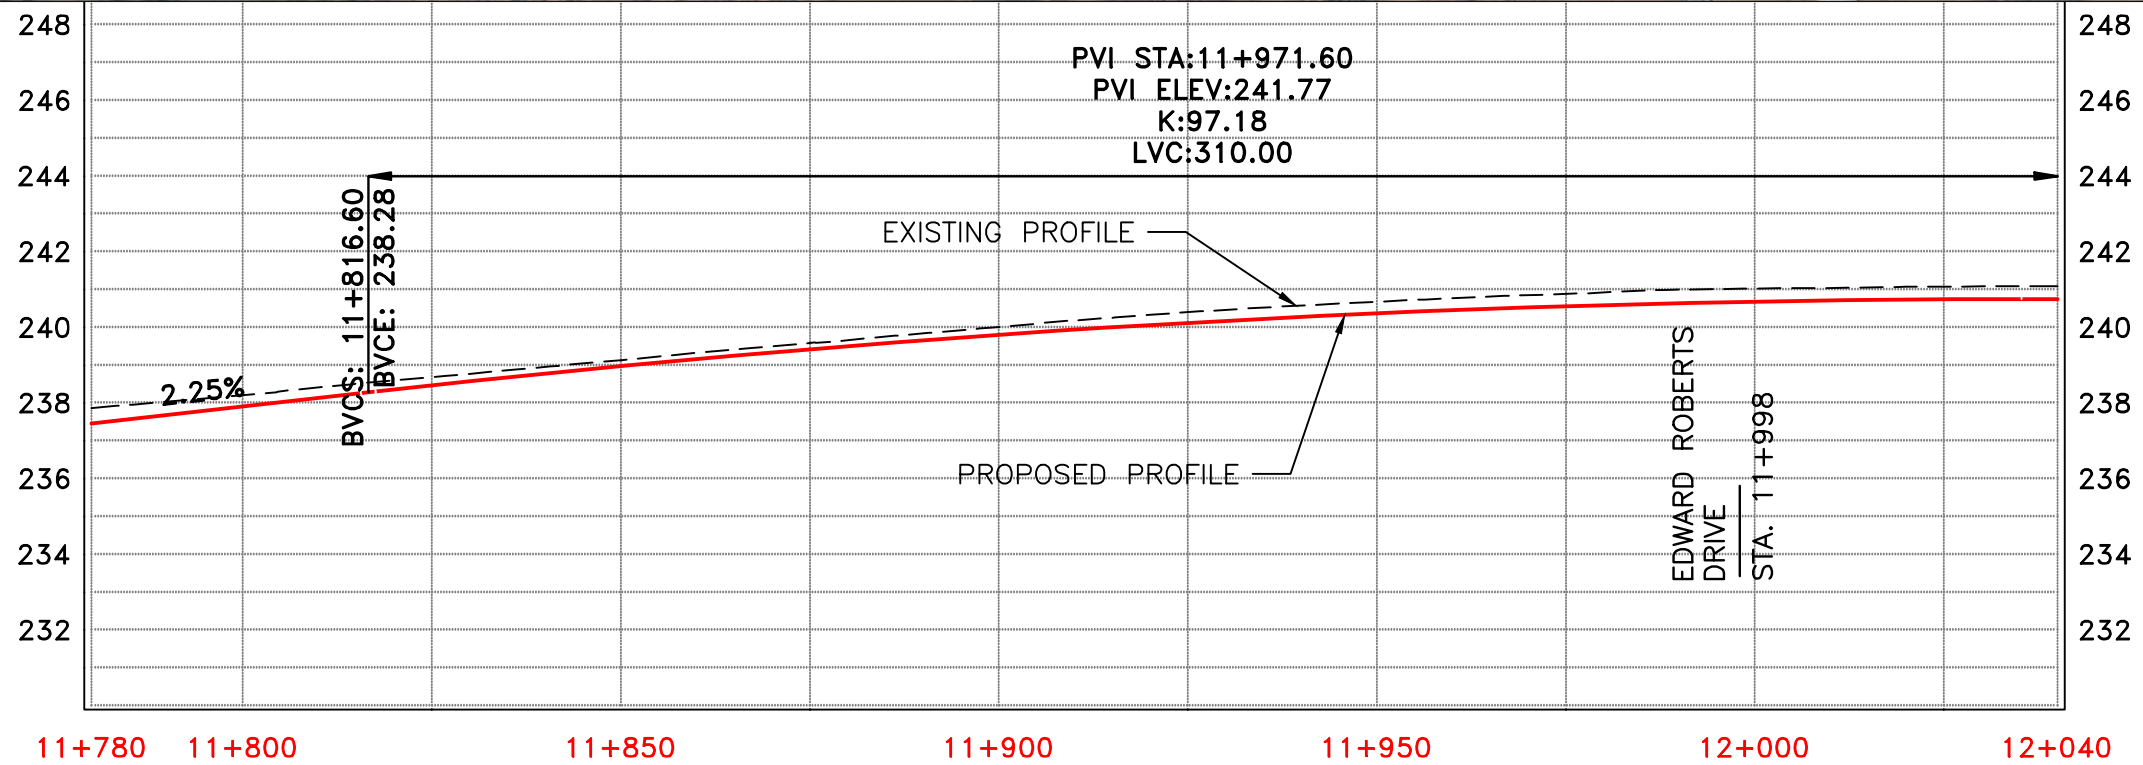
SHEET.NO
07
DATE.
DEC. 2017

VICTORIA SQUARE BOULEVARD
CLASS ENVIRONMENTAL ASSESSMENT
PLAN AND PROFILE
STA. 11+780 TO STA. 12+040

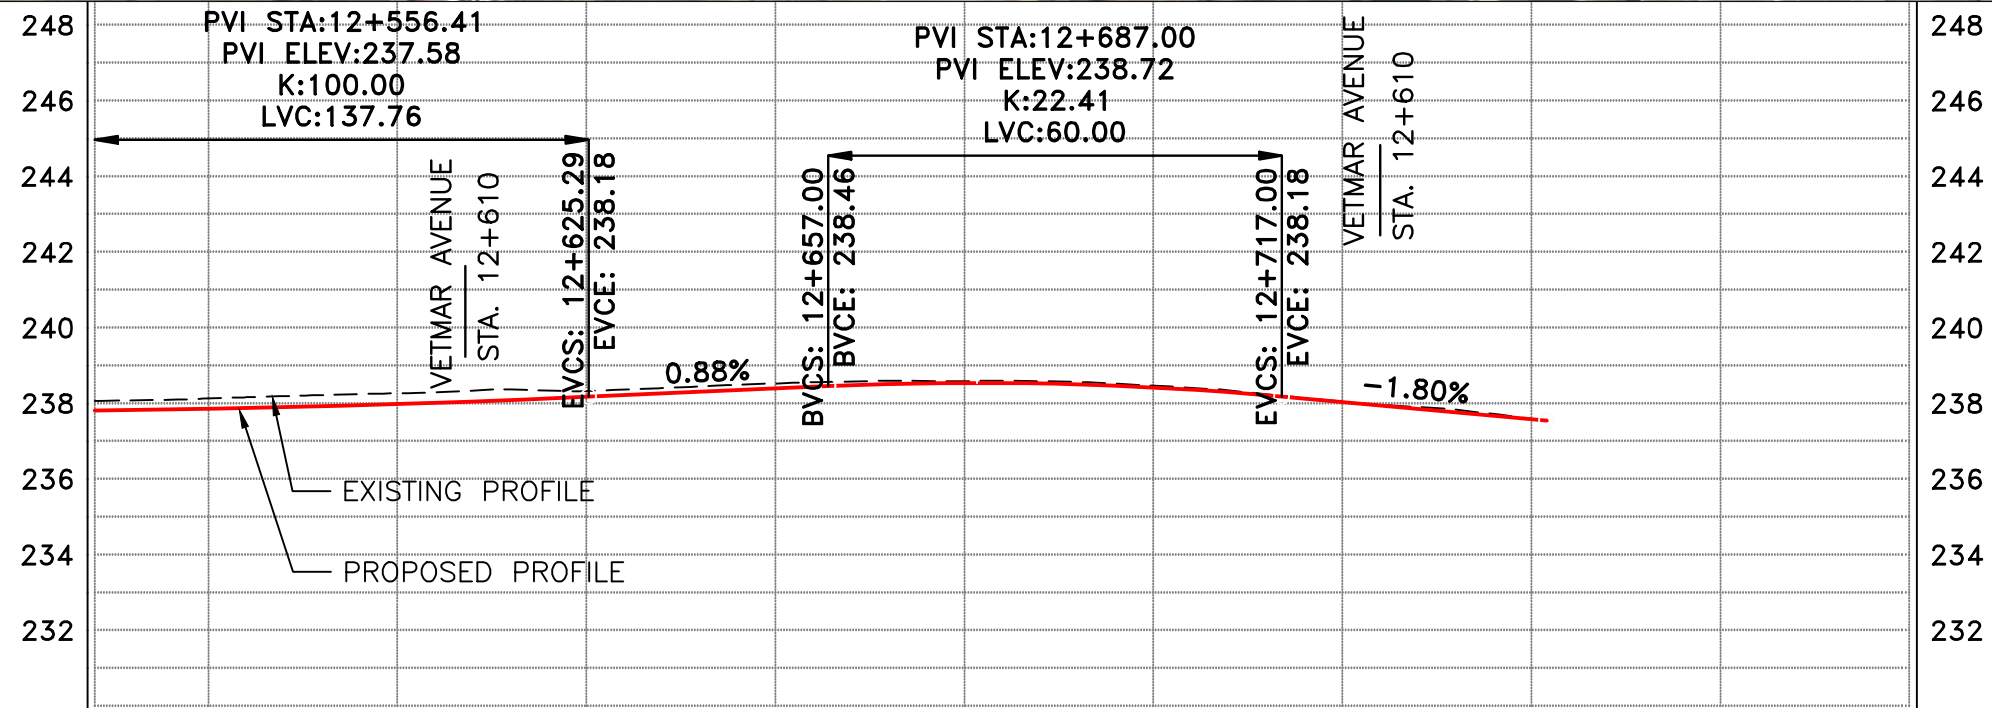
LEGEND (PLAN) 		LEGEND (PROFILE) 		SCALES 		VICTORIA SQUARE BOULEVARD CLASS ENVIRONMENTAL ASSESSMENT PLAN AND PROFILE STA. 12+560 TO STA. 12+800	SHEET.NO 10 DATE. DEC. 2017
--------------------------	--	-----------------------------	--	-------------------	--	--	--------------------------------------
