CLASS EA DOCUMENTATION

GLYNNWOOD TRIBUTARY AREA STORM SEWER SYSTEM CLASS ENVIRONMENTAL ASSESSMENT

Glynnwood Tributary Sewer Surcharge Environmental Assessment Project Progress Meeting #4

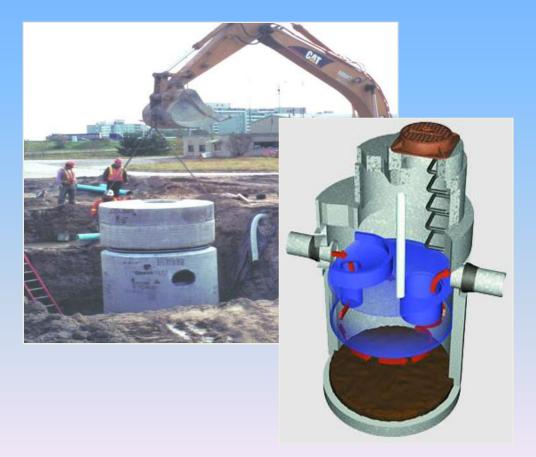
Oil/Grit Separator

An oil / grit separator is an underground structure connected to the storm sewer to improve stormwater quality by removing contaminants from the stormwater such as grease, oil, mud, sand and trash.

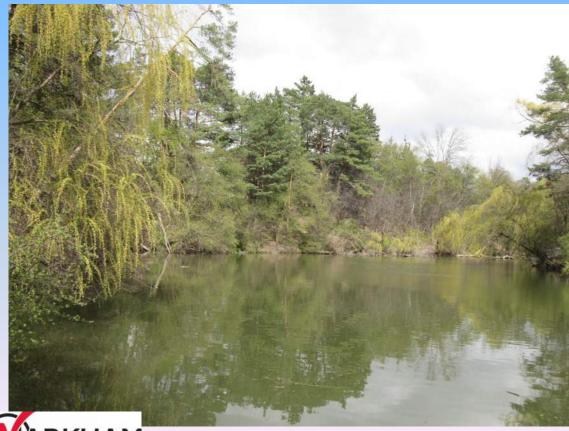
Modify Existing Wet Pond Outlet to provide Extended Detention Control

Wet ponds are basins that have a permanent pool of water throughout the year to store runoff during and after storm events. They treat and filter stormwater runoff through settling and through nutrient uptake by plants and other aquatic organisms.

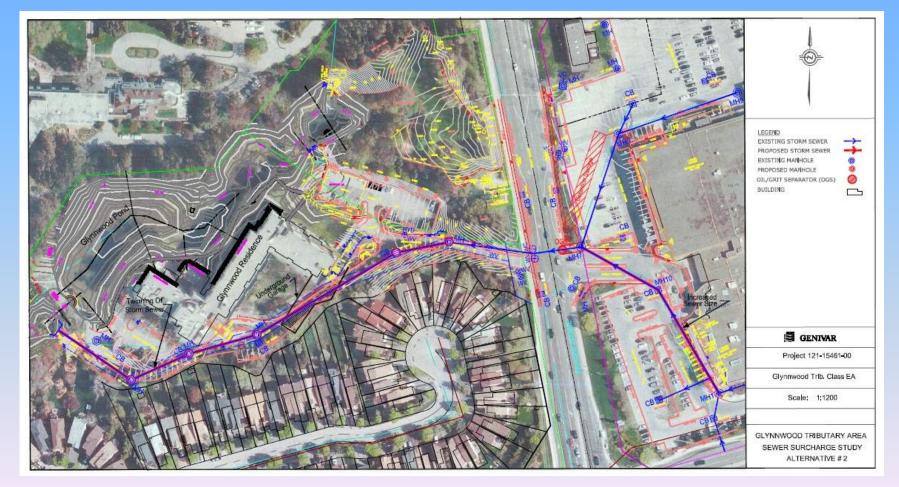
- 1. Install underground storage tank in Parking Lot between MH 8 and MH7;
- 2. Install Oil/Grit Separator at outlet from Thornhill Square (MH7);
- 3. Increase size of storm sewer from MH1 to MH7 in Thornhill Square , adjacent to Community Centre;
- 4. Twin storm sewer through easement in Glynnwood Retirement Residence Access Road.

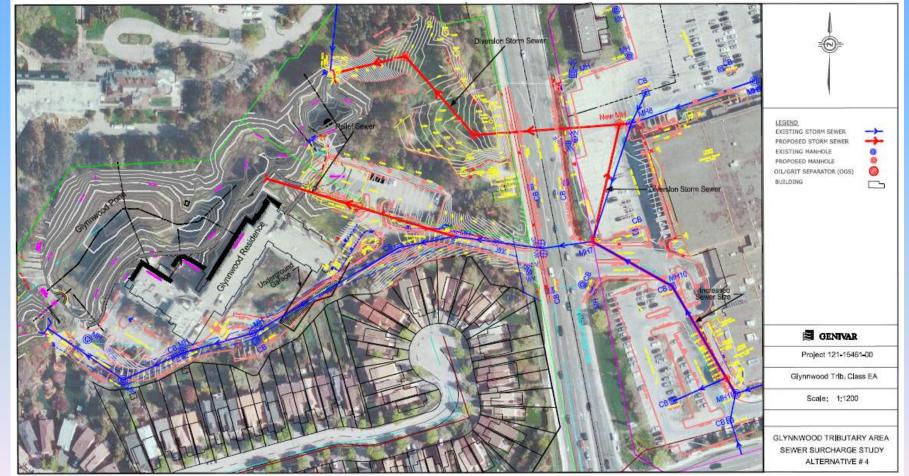
Alternative 4 (Recommended)

- 1. New sewer to divert low flows from MH7 to New MH downstream of MH8;
- 2. Construct diversion sewer across Bayview Avenue to existing inlet to Glynnwood Upper Pond
- 3. Increase size of storm sewer from MH1 to MH7 in Thornhill Square, adjacent to Community Centre;
- 4. Construct bypass sewer through easement in Glynnwood Retirement Residence upper parking lot to main Glynnwood Pond.

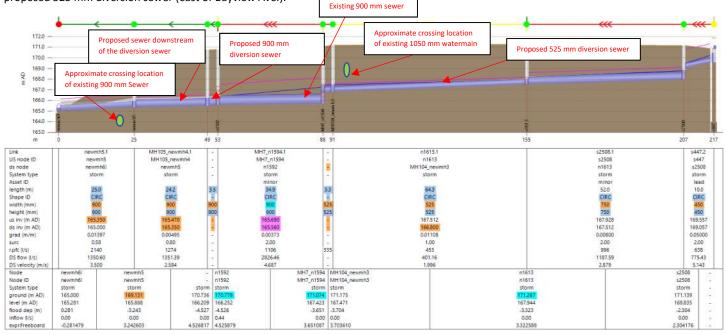
The vertical distance (including pipe size and thickness) is estimated to be **0.34 m** at the crossing location where the proposed 900 mm sewer is above the existing 900 mm sewer, and **0.50 m** at the crossing location where the existing 1050 mm City of Markham watermain is above the proposed 525 mm diversion sewer (east of Bayview Ave.).

Proposed Sewers Profile with 100-yr design storm event simulation results from s448 to overland system at newmh6! (Depth of HGL is greater than 1.8 m at all minor system locations. No pipes surcharge in the 5-year design storm event)

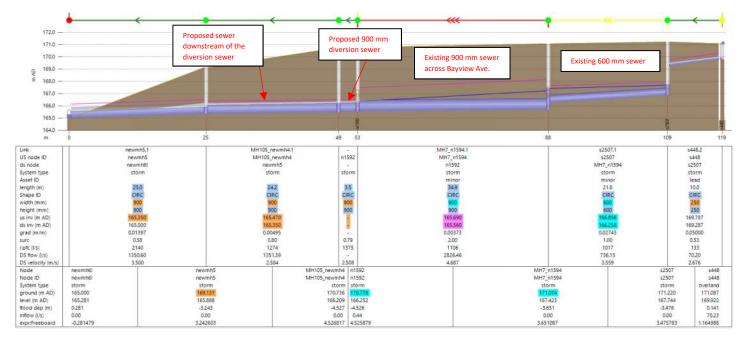
Proposed Sewers Profile with 100-yr design storm event simulation results from s468 to overland system at newmh6! (Depth of HGL is greater than 1.8 m at all minor system locations. No pipes surcharge in the 5-year design storm event)

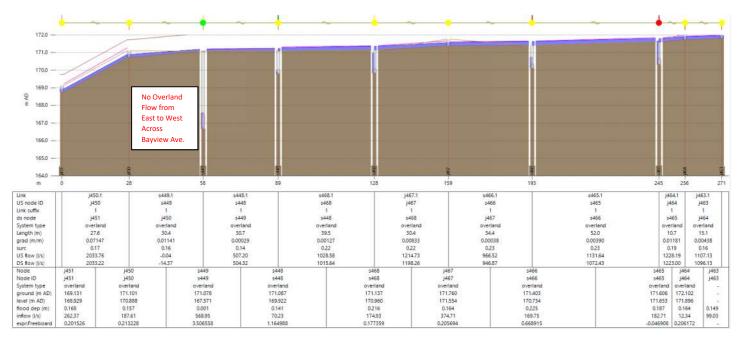
Existing overland system profile with 100-yr design storm event simulation results from Bayview Avenue North to SWM Pond

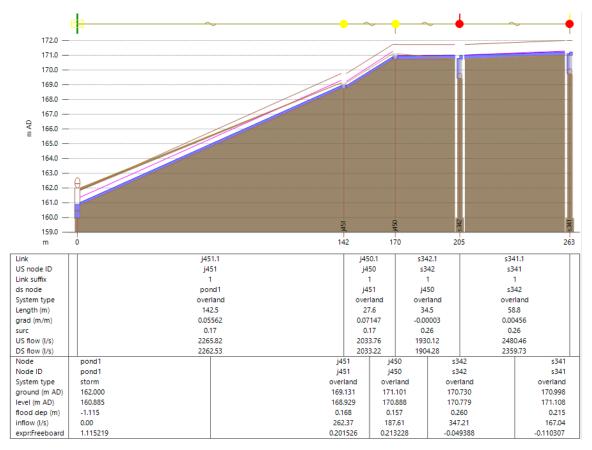
Glynnwood Scenario 2 under the 100-yr Design Storm Event Simulation Results

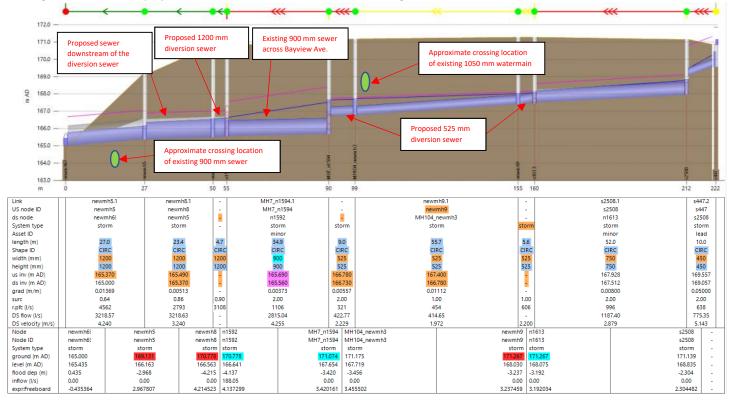
Proposed sewers profile with 100-yr design storm event simulation results - from s447 to overland system at newmh6! -

The vertical distance (including pipe size and thickness) is estimated to be $\underline{0.53 \text{ m}}$ at the crossing location where the existing 1050 mm City of Markham watermain is above the proposed 525 mm diversion sewer (east of Bayview Ave.). The vertical distance is estimated to be $\underline{0.33 \text{ m}}$ at the crossing location where the proposed 1200 mm storm sewer is above the existing 900 mm storm sewer.

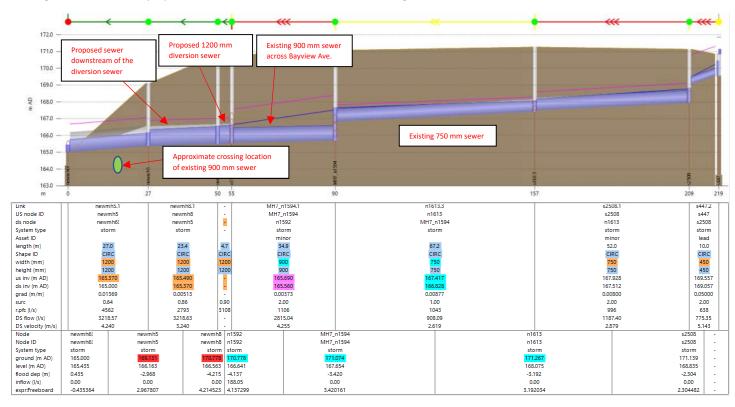
Proposed Sewers Profile with 100-yr design storm event simulation results from s448 to overland system at newmh6! (Depth of HGL is greater than 1.8 m at all minor system locations. No pipes surcharge in the 5-year design storm event)

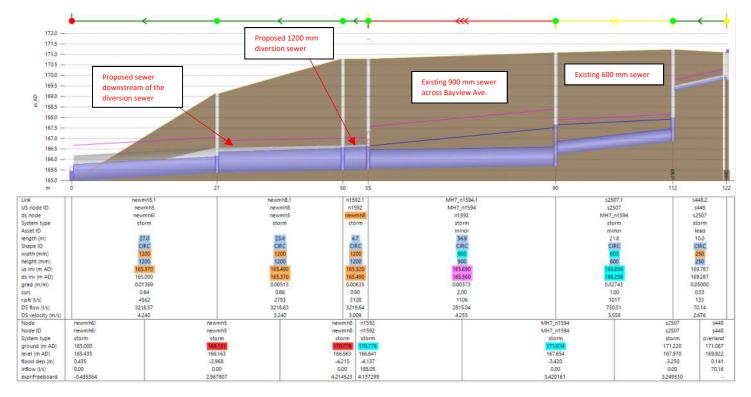
Proposed Sewers Profile with 100-yr design storm event simulation results from s468 to overland system at newmh6! (Depth of HGL is greater than 1.8 m at all minor system locations. No pipes surcharge in the 5-year design storm event)

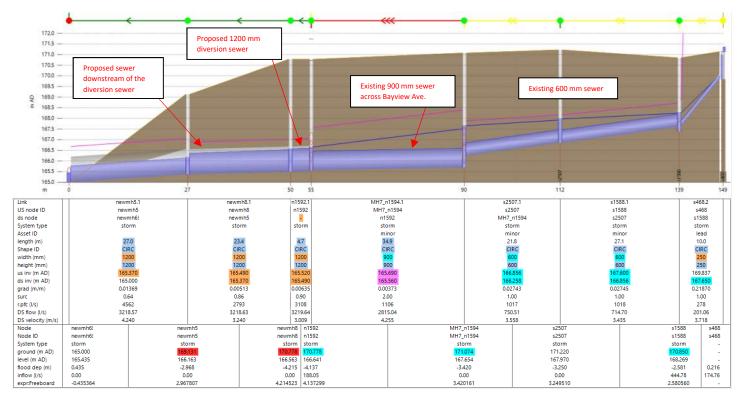
Existing overland system profile with 100-yr design storm event simulation results from Parking Lot east of Bayview Ave. to SWM Pond

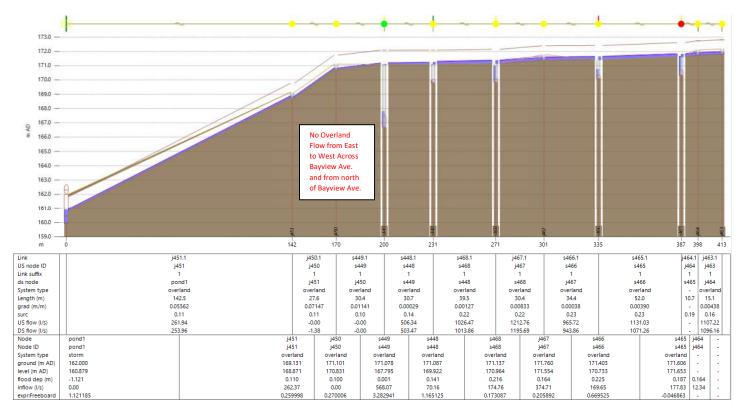
Existing overland system profile with 100-yr design storm event simulation results from s447 to SWM Pond

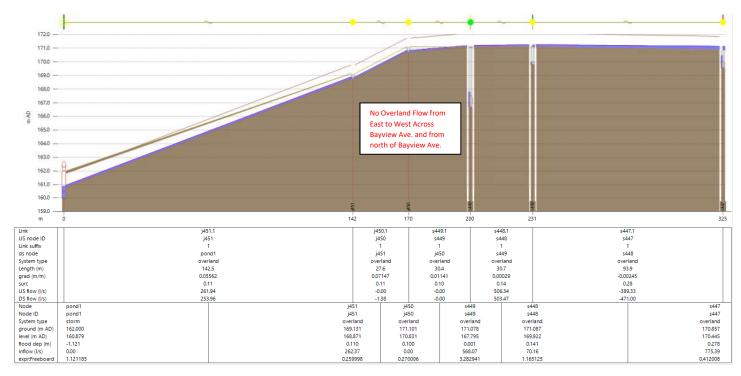
Existing overland system profile with 100-yr design storm event simulation results from s341 to n1592

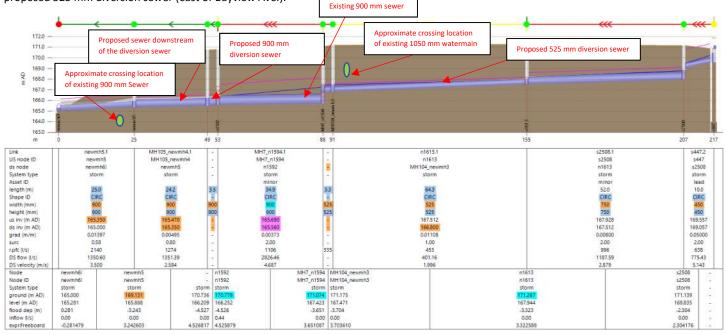
The vertical distance (including pipe size and thickness) is estimated to be **0.34 m** at the crossing location where the proposed 900 mm sewer is above the existing 900 mm sewer, and **0.50 m** at the crossing location where the existing 1050 mm City of Markham watermain is above the proposed 525 mm diversion sewer (east of Bayview Ave.).

Proposed Sewers Profile with 100-yr design storm event simulation results from s448 to overland system at newmh6! (Depth of HGL is greater than 1.8 m at all minor system locations. No pipes surcharge in the 5-year design storm event)

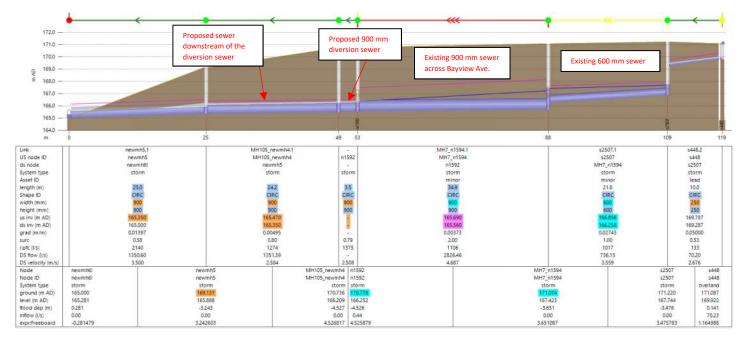
Proposed Sewers Profile with 100-yr design storm event simulation results from s468 to overland system at newmh6! (Depth of HGL is greater than 1.8 m at all minor system locations. No pipes surcharge in the 5-year design storm event)

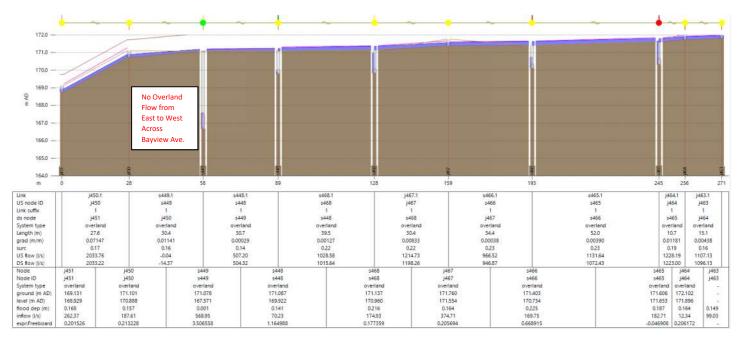
Existing overland system profile with 100-yr design storm event simulation results from Bayview Avenue North to SWM Pond

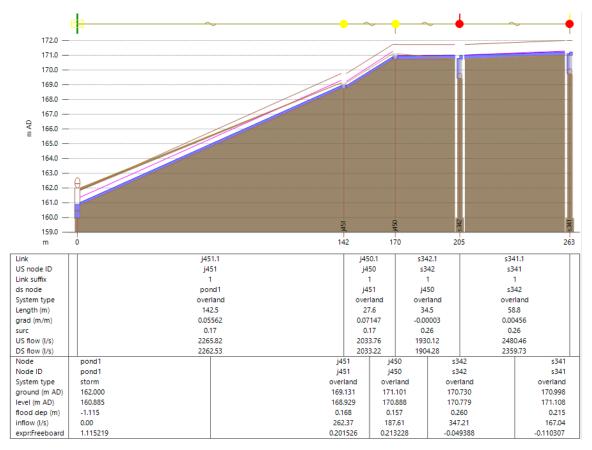
Glynnwood Scenario 2 under the 100-yr Design Storm Event Simulation Results

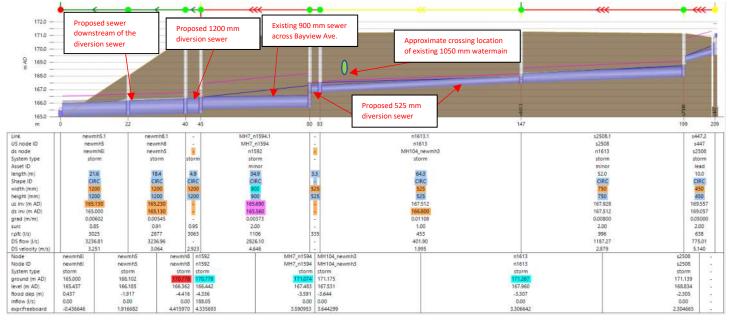
Proposed Sewers Profile with 100-yr design storm event simulation results from s448 to overland system at newmh6! (Depth of HGL is greater than 1.8 m at all minor system locations. No pipes surcharge in the 5-year design storm event)

Since the proposed sewers west of Bayview Avenue are north of the existing 900 mm sewer, the vertical sewer crossing was eliminated.

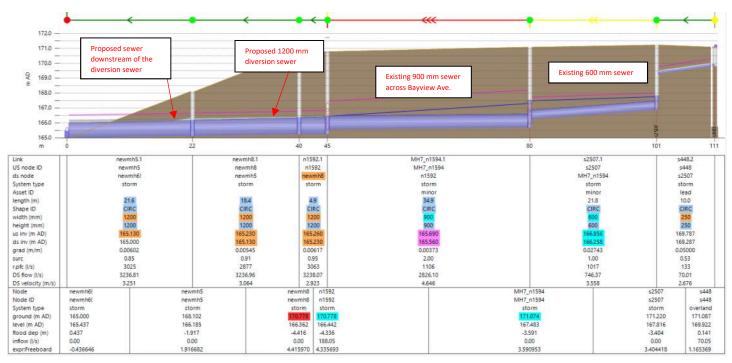
Proposed Sewers Profile with 100-yr design storm event simulation results from s468 to overland system at newmh6! (Depth of HGL is greater than 1.8 m at all minor system locations. No pipes surcharge in the 5-year design storm event)

Since the proposed sewers west of Bayview Avenue are north of the existing 900 mm sewer, the vertical sewer crossing was eliminated.

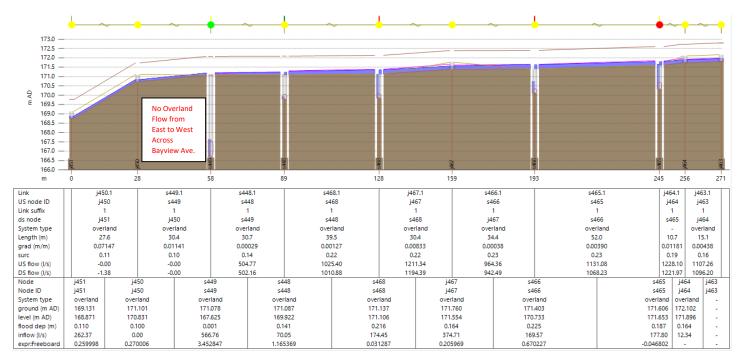
Existing overland system profile with 100-yr design storm event simulation results from s447 to SWM Pond

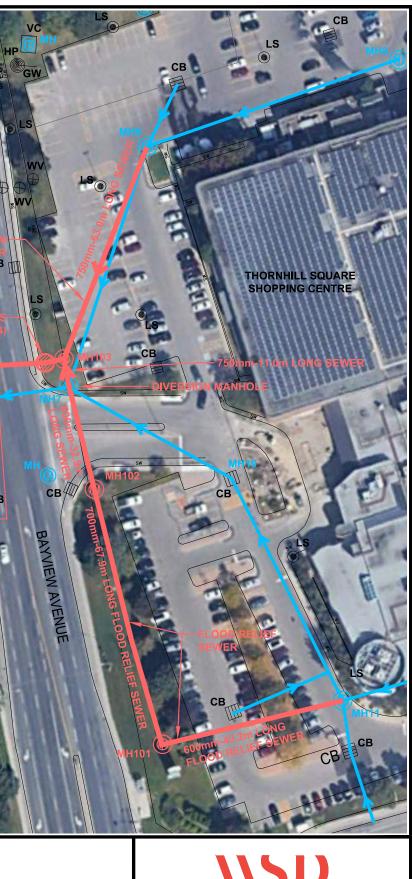
SHOULDICE HOSPITAL PLUNCE POOL	HP PROPOSED 78m RETAINING WALL PROPOSED 81m CHANNEL MEADWALL HP DIVERSION STORM	CB C
A DEEGROUND A DEE	SEVUER CB CB CB CB CB CB CB CB CB CB CB CB CB	CB 75 mm-11 0m LONG SEWER DIVERSION MANHOLE
	900mm-31.0m LONG BYPASS SEWER BANNEN AVENUE IIIIIIIIIIIIIIIIIIIIIIIIIIIIIIIIIII	CB FLOOD RELIGE SEV/ER CB
LEGEND EXISTING STORM SEWER PROPOSED STORM SEWER EXISTING MANHOLE PROPOSED MANHOLE OL/GRIT SEPARATOR (OGS)	CLIENT CITY OF MARKHAM TITLE GLYNWOOD TRIBUTARY CLASS EA PREFERRED ALTERNATIVE (FEBRUARY 2020)	Checked A.Z.Z. Date FEBRUARY 2020 Scale

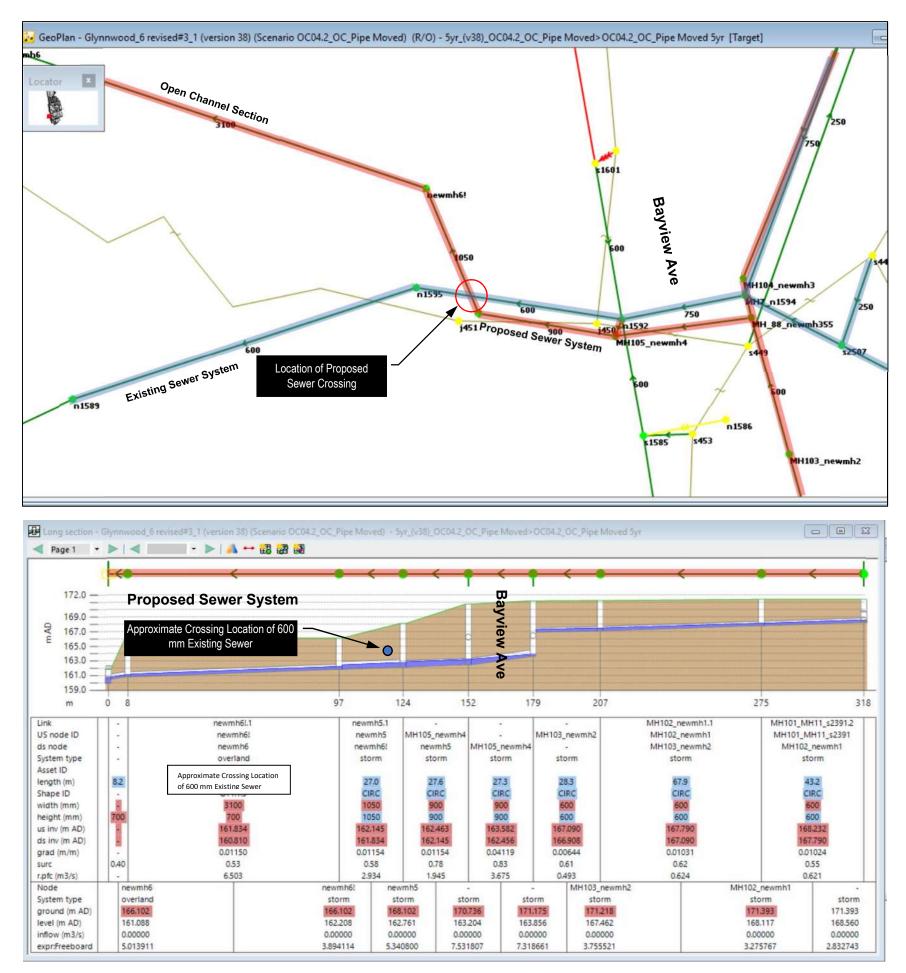
Illustration 1. InfoWorks Modelling Results - Preferred Alternative – Bypass Sewer and Open Channel (Feb 2020)

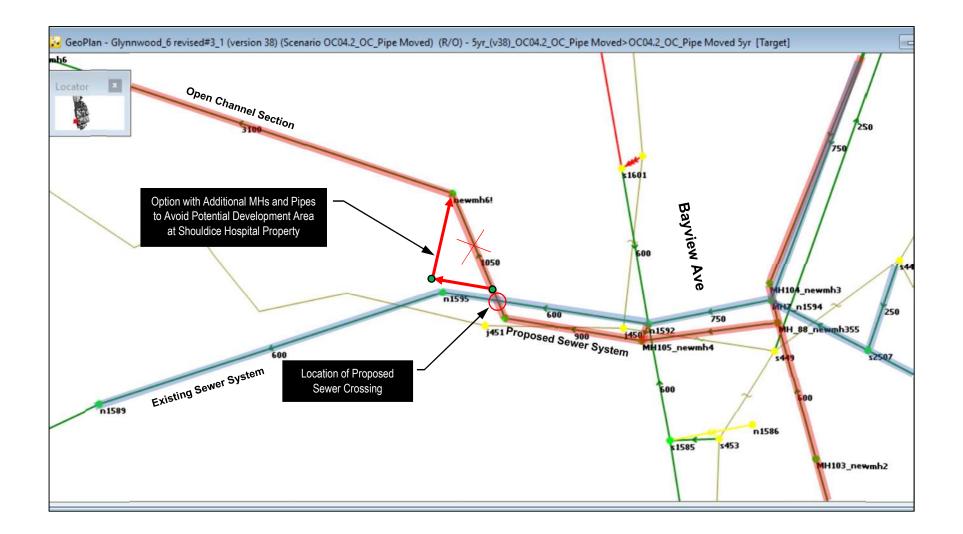
Illustration 2. InfoWorks Modelling Results - Additional Alternative – Proposed Bypass Sewer at South of Existing Sewer along Glynnwood Driveway (Feb 2020)

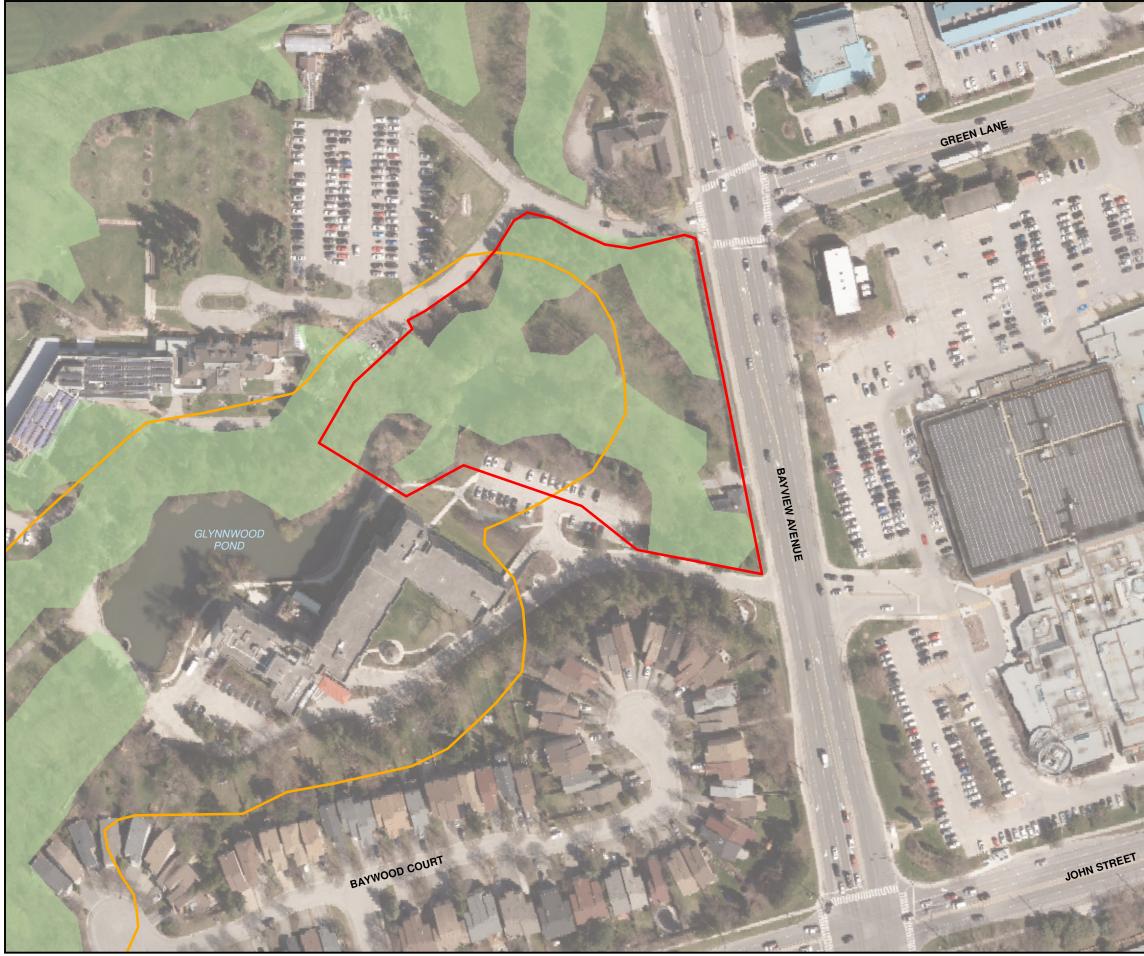
Document Path: D:\aProjects\121-15461-00\MXD\121-15461-00 Figure 2 NHF.mxd

3.6		11	SD.	
-		AURORA, ONTA	OCK DRIVE, UNIT 2 RIO CANADA L4G 0G9 905-727-0463 WWW.WSP.COM	
ar 1	LEGEND			N
		STUDY AREA	W	
		WOODLAND (MNR	.F)	∇
-	\bigcirc	TRCA REGULATIO	N LIMIT	S
1.50				
are the				
1-1	20 10 Data Source: I Imagery, York		s, Ontario Base Mapping, October :	2019.
1.00	CLIENT:			
1-1		CITY O	F MARKHAM	
1323-1"	PROJECT:			
ST.	SCO	GLYNNWOOD	MENTAL IMPACT ST) TRIBUTARY AREA ITAL ASSESSMENT	UDY -
L.M.			i	
PRIL	PROJECT NO 121-15461		DATE: OCTOBER 2020	
the franks	DESIGNED B			
	DRAWN BY:			
-	T.P. CHECKED BY	Y:		
	- FIGURE NO:		SCALE:	
Citra I	2		1:1,500	
	TITLE:			
Coloran -		NATURAL HE	RITAGE FEATURES	
-1	DISCIPLINE:		IRONMENT	
and the second second	ISSUE:			REV.:
- AL	-			-

Based on field observations the wooded area within the study area (CUW1) is part of a larger contiguous woodland associated with the Pomona Creek valley corridor (**Figure 1**), and as such meets YROP criteria to be considered a significant woodland (key natural heritage feature) (refer to **Section 2.3**). As the woodland abuts the parking lot of 7700 Bayview Avenue, a minimum vegetation protection zone cannot be provided in this area.

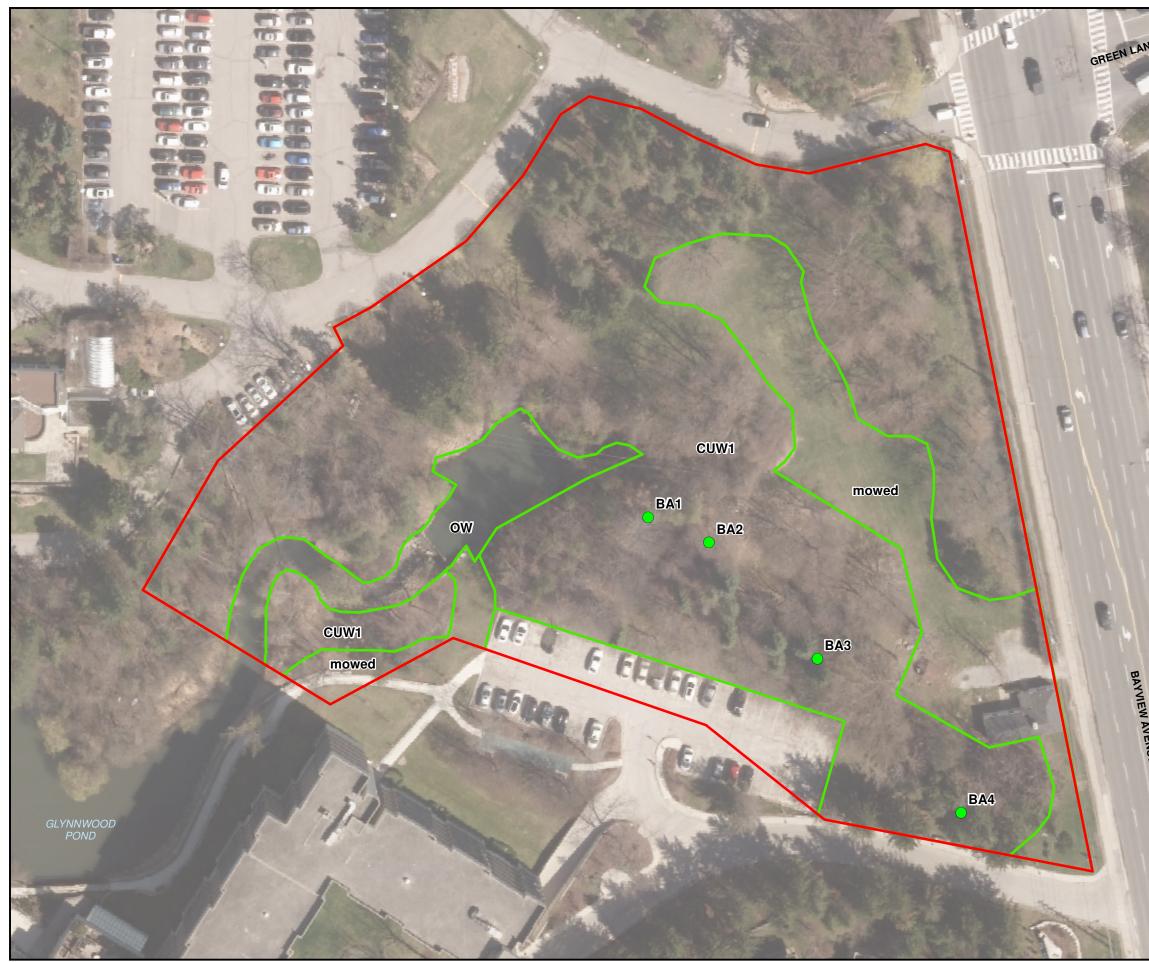
The study area is surrounded by urban land use (e.g. residential mid-rises, commercial property, parking lots, railway and arterial roads). Vegetation community types were observed to be highly impacted by historic anthropogenic activities and the introduction of exotic/invasive species. This has led to the establishment of a cultural woodland and manicured green spaces within and surrounding the study area. Planted landscape vegetation with species typical of cities was observed surrounding the residential buildings and within public spaces. Landscape plant species observed are typically used due to their tolerance to air pollution, salt and drought. The vegetation type comprising the treed area within the study area and surrounding the banks of the stormwater management pond is considered to have relatively higher ecological value; however, this area was also observed to consist largely of exotic / introduced species. ELC vegetation types are identified in **Figure 3** and described in the text that follows.

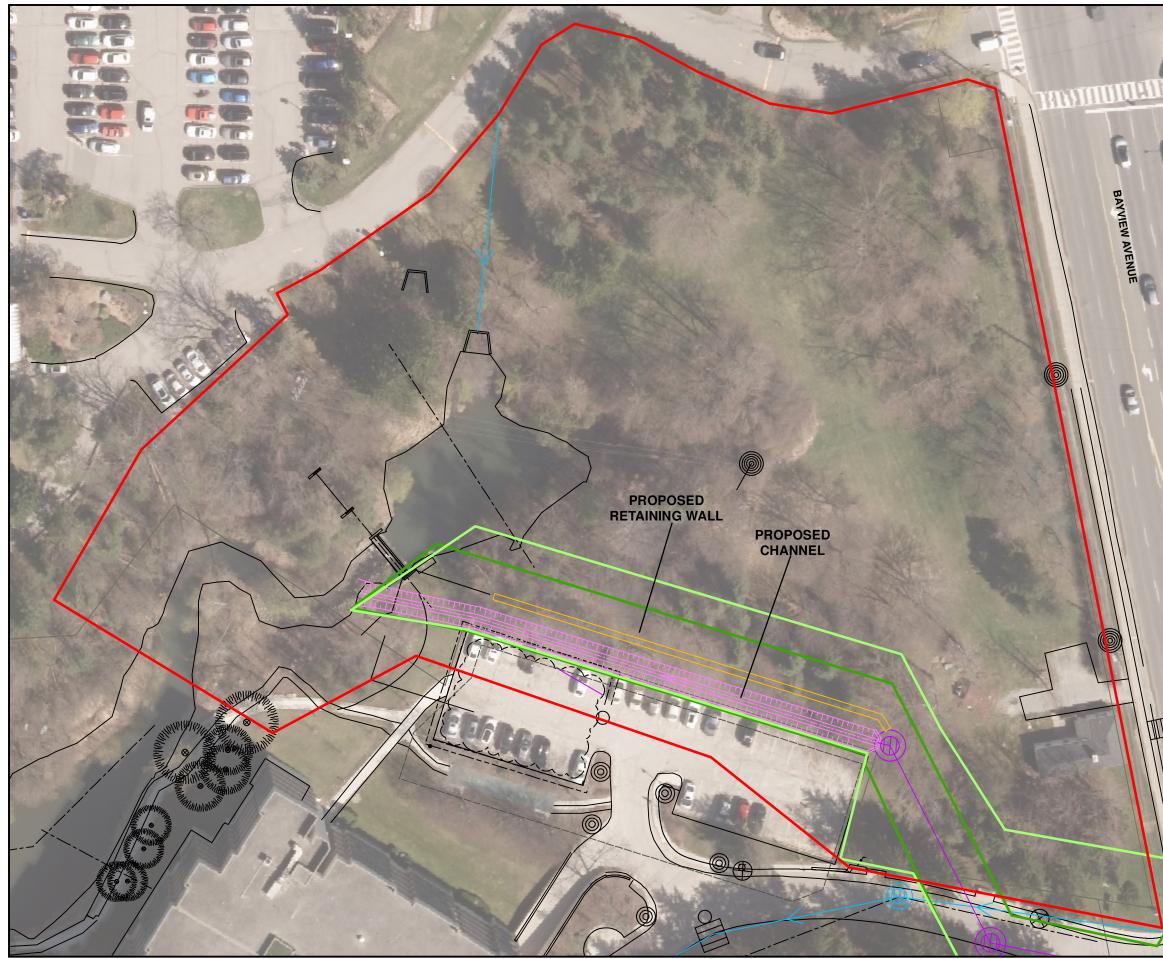
Document Path: D:\aProjects\121-15461-00\MXD\121-15461-00 Figure 4 Site Plan.mxd

11	51)	
H		AURORA, ONTARI	CK DRIVE, UNIT 2 O CANADA L4G 0G9 15-727-0463 WWW.WSP.COM	
			EASEMENT	N E
	6 3 0 Data Source: M Imagery, York R CLIENT:	Region, 2019	Ontario Base Mapping, October 20)19.
11	PROJECT:			
		GLYNNWOOD	ENTAL IMPACT STU TRIBUTARY AREA TAL ASSESSMENT	IDY -
14	PROJECT NO: 121-15461-		DATE: OCTOBER 2020	
111	DESIGNED BY -	<i>.</i> .		
1	DRAWN BY: T.P.			
11	CHECKED BY:	:		
	FIGURE NO: 4		SCALE: 1:600	
	TITLE:			
		SIT	E PLAN	
N N	DISCIPLINE:	ENVI	RONMENT	
10	ISSUE:			REV.:
	-			-

within the study area are shown on **Figure 4**. It is anticipated that much of the temporary easement will be disturbed to permit construction; the permanent easement will be secured to facilitate future maintenance activities.

The staging areas and construction works are expected to be located within the existing parking lot, roadways and landscaped portions of the CUW1 vegetation community within the limits of the temporary easement (**Figure 4**).

- To construct the retaining wall and open channel, tree removal from within the significant woodland is anticipated (**Figure 4**). Impacts to the woodland should be determined during detailed design when the footprint of disturbance has been established. Efforts should be made to retain trees located within the vicinity of the proposed development where possible; however, as removals are expected to be limited to the woodland edge, significant alterations to the overall form and function of the significant woodland are not anticipated. It is expected that an Arborist Report and Tree Protection Plan will be completed by a certified arborist to determine the extent of tree removal / injury as a result of the proposed works.

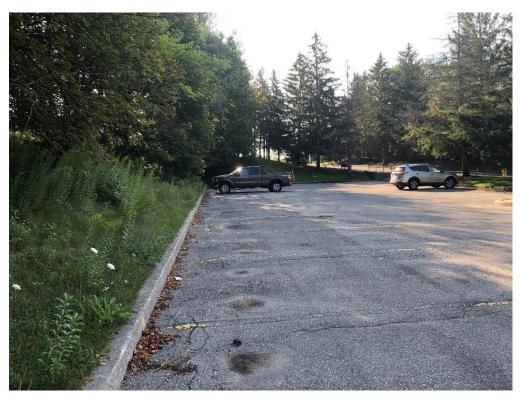
Photograph 1 – View of the bottom of Slope, Existing Parking Lot (Looking East)

- The top of slope and slope surface are generally covered by trees/vegetation/bushes while the bottom of slope is covered by asphalt pavement parking lot, as shown on Photographs 1 to 4 in Appendix C;

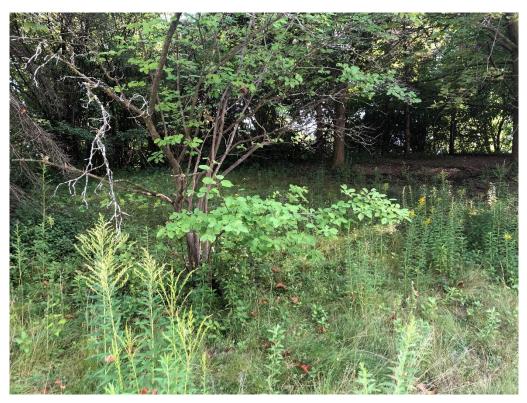
Photograph 2 – Vegetated/Treed Slope Surface (Standing at the Toe of Slope, Looking North)

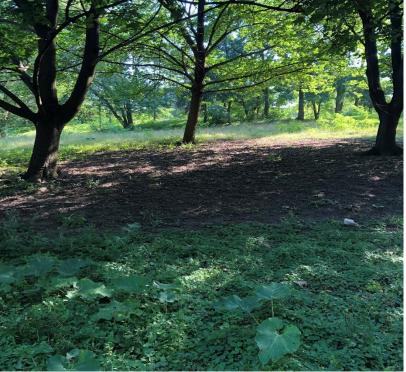
Photograph 3 – View of Vegetated/Treed top of Slope

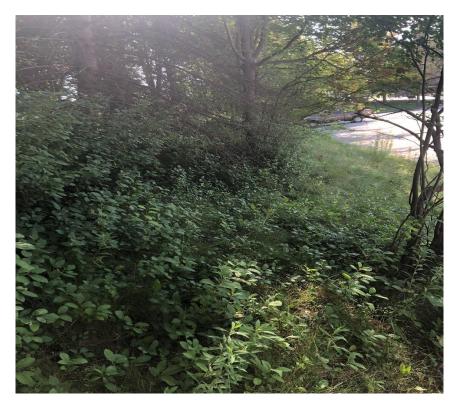
Photograph 4 – Vegetated/Treed Slope (Standing in the middle of Slope, Looking East)

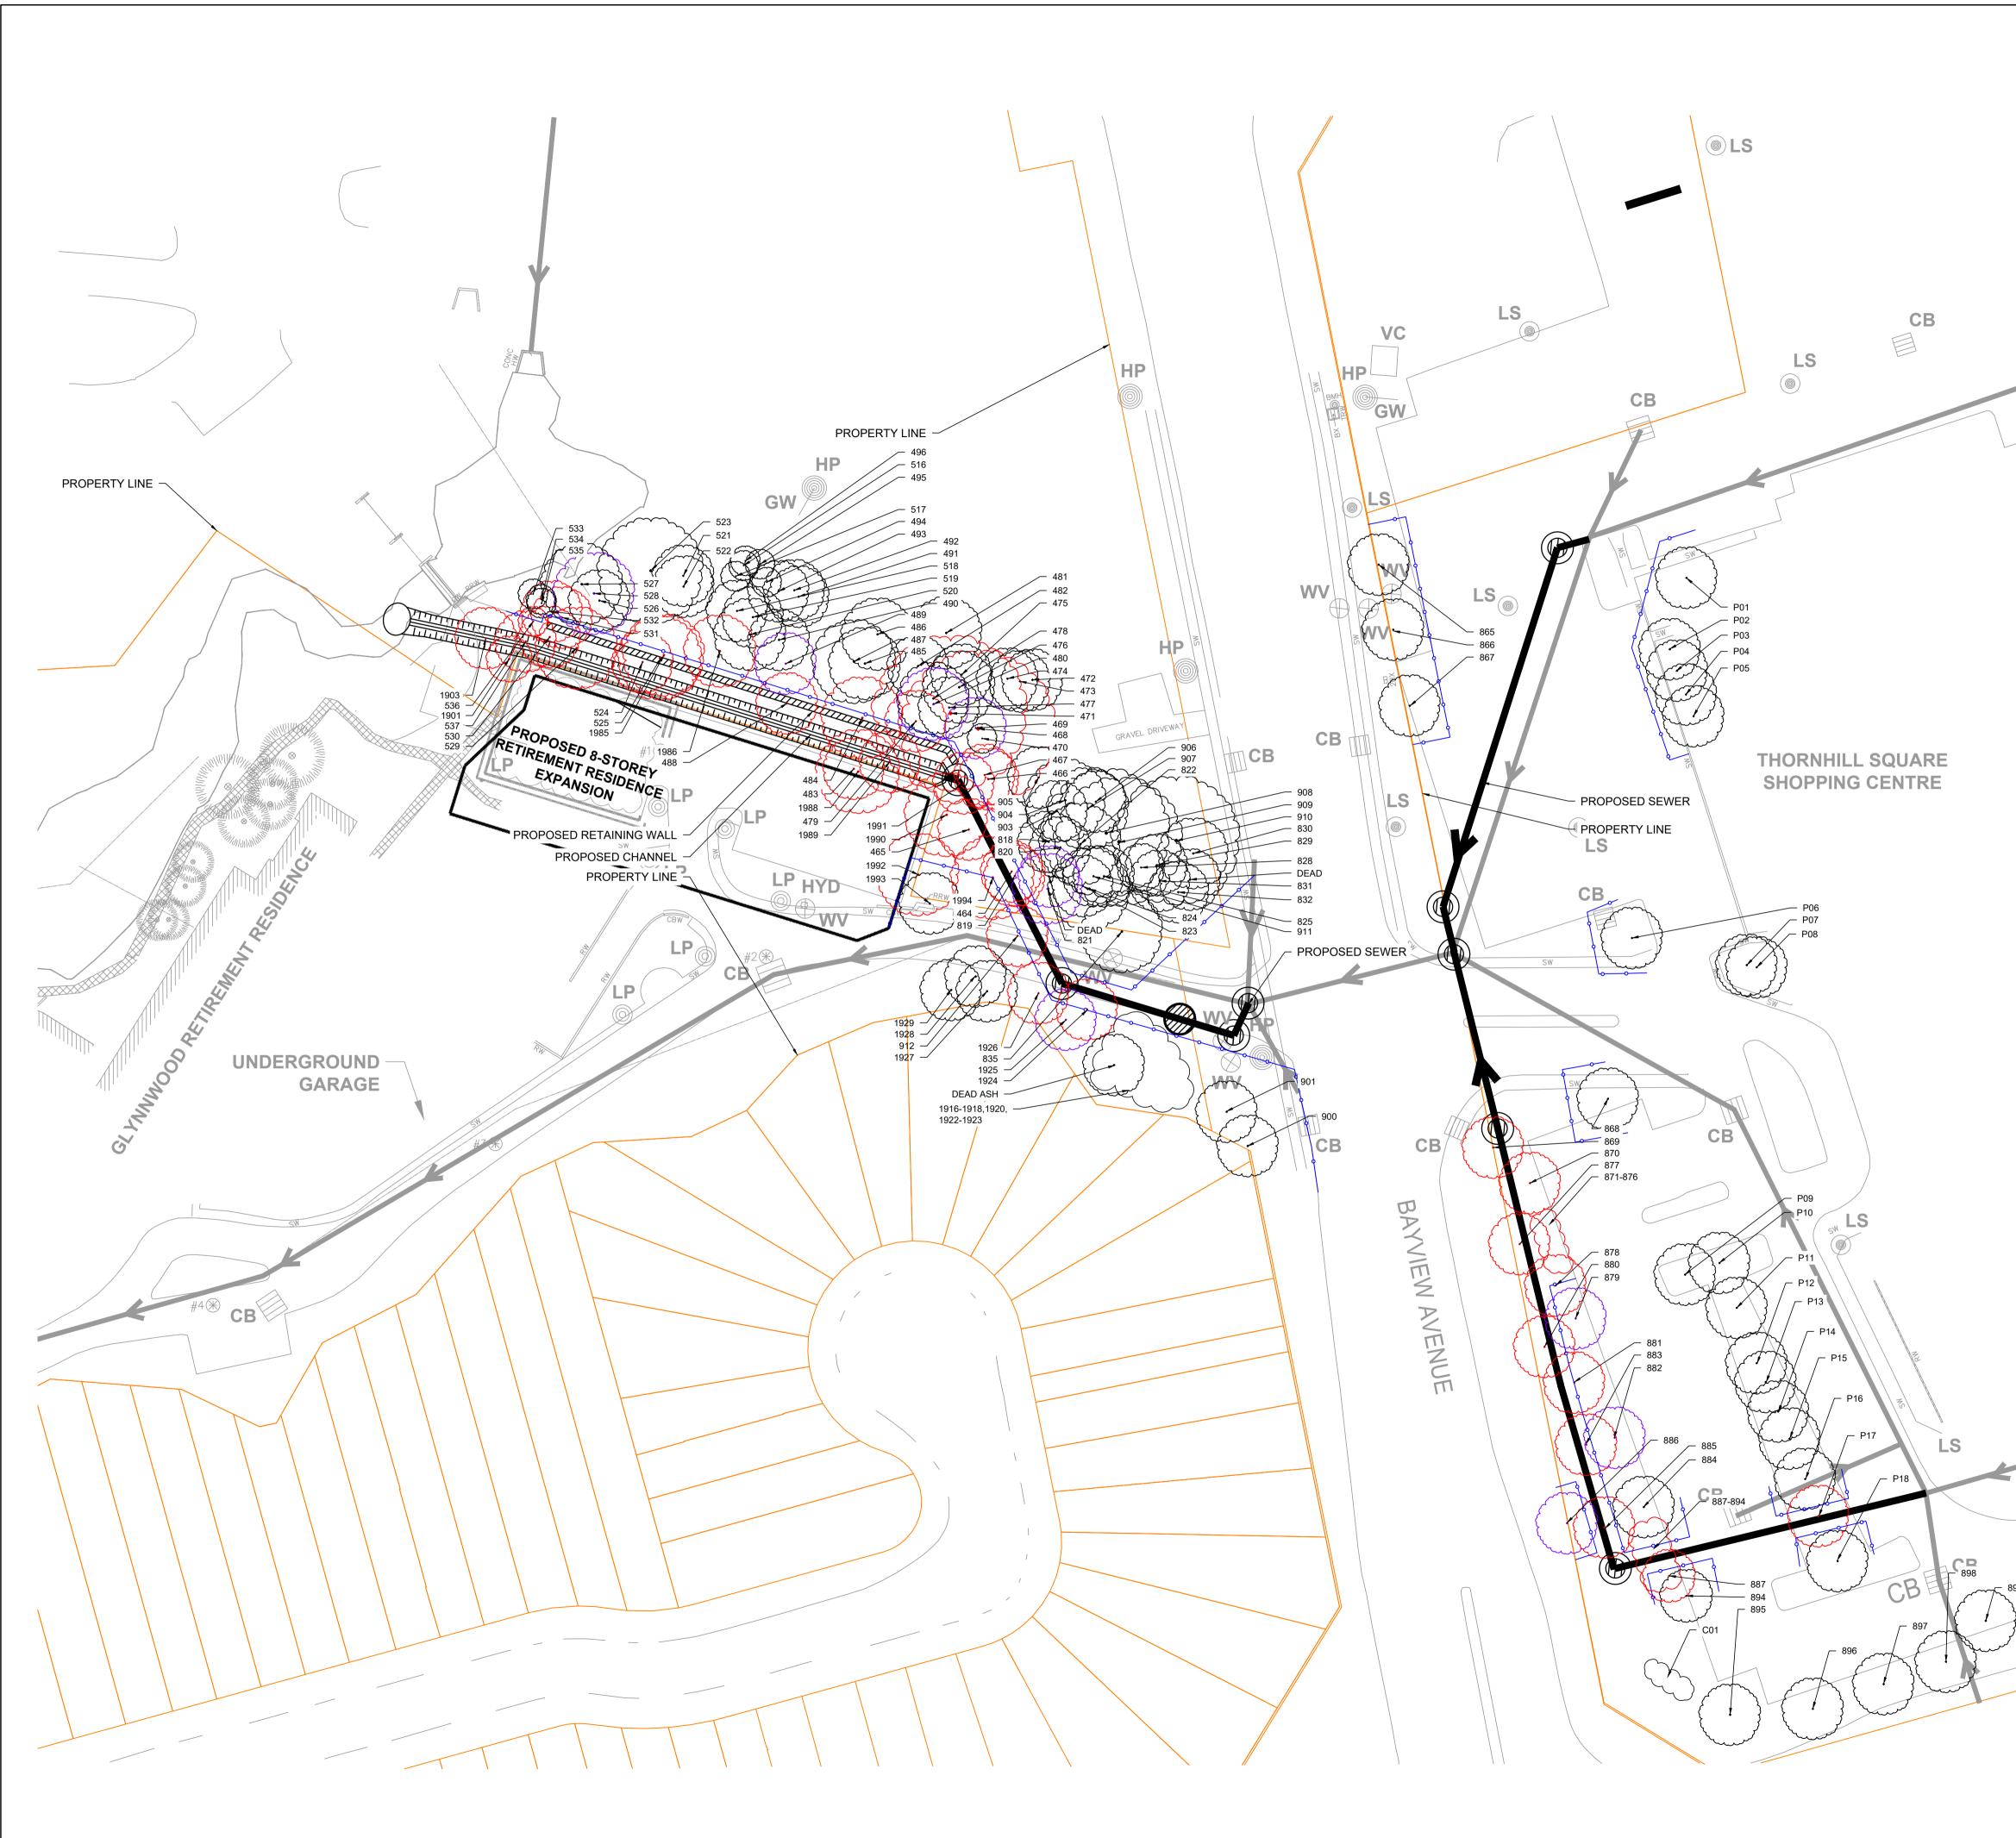
KE	Y MAP			
\mathbf{F}				
	GEND			
	\sim	EXISTING SUR	VEYED TREES T	0
		REMAIN & BE P		-
	\frown	EXISTING SUR PROPOSED FO		
(كريب	FROFUSED FO	K REMOVAL	
	\frown	& BE PROTECT	VEYED TREES T ED, TREE PROT	ECTION
		ZONE ENCROA	CHMENT / INJUI	RY
		EXISTING SUR	VEYED TREE GR	ROUPING
	\longrightarrow	EXISTING SUR	VEYED TREE GR	ROUPING
				FECTION
		FENCING AS PE	ER 1/TM-2	
_		PROPERTY LIN	E	
				1 1
1 NO	09-10-2021 DATE	EA SUBMIS REVISION/IS		JB BV BY APPD
				1
			582 Lancaster Kitchener, C	N N2K 1M3
				19-743-8777 ww.wsp.com
CL	IENT:	TY OF MA	RKHVW	
		MARKHAM		
PF	ROJECT TITLE	Ξ:		
G		DRETIREM		IDENCE
	TR	EE MANAGME	-NT PLAN	
SI	TE ADDRESS	: 7700 BAYVIE	WAVE	
		IORNHILL, ON		
	RAWING TITLE	≕ MANAGEN		AN
STA				-7 XI N
	SIGNED JB	DRAWN JB	CHEC	CKED BV
SC/ PR(^{ALE} 1:500 DJECT NUMBER	DAT	DWG. NL	JMBER
12	21-1546	1-00-20		Л-1

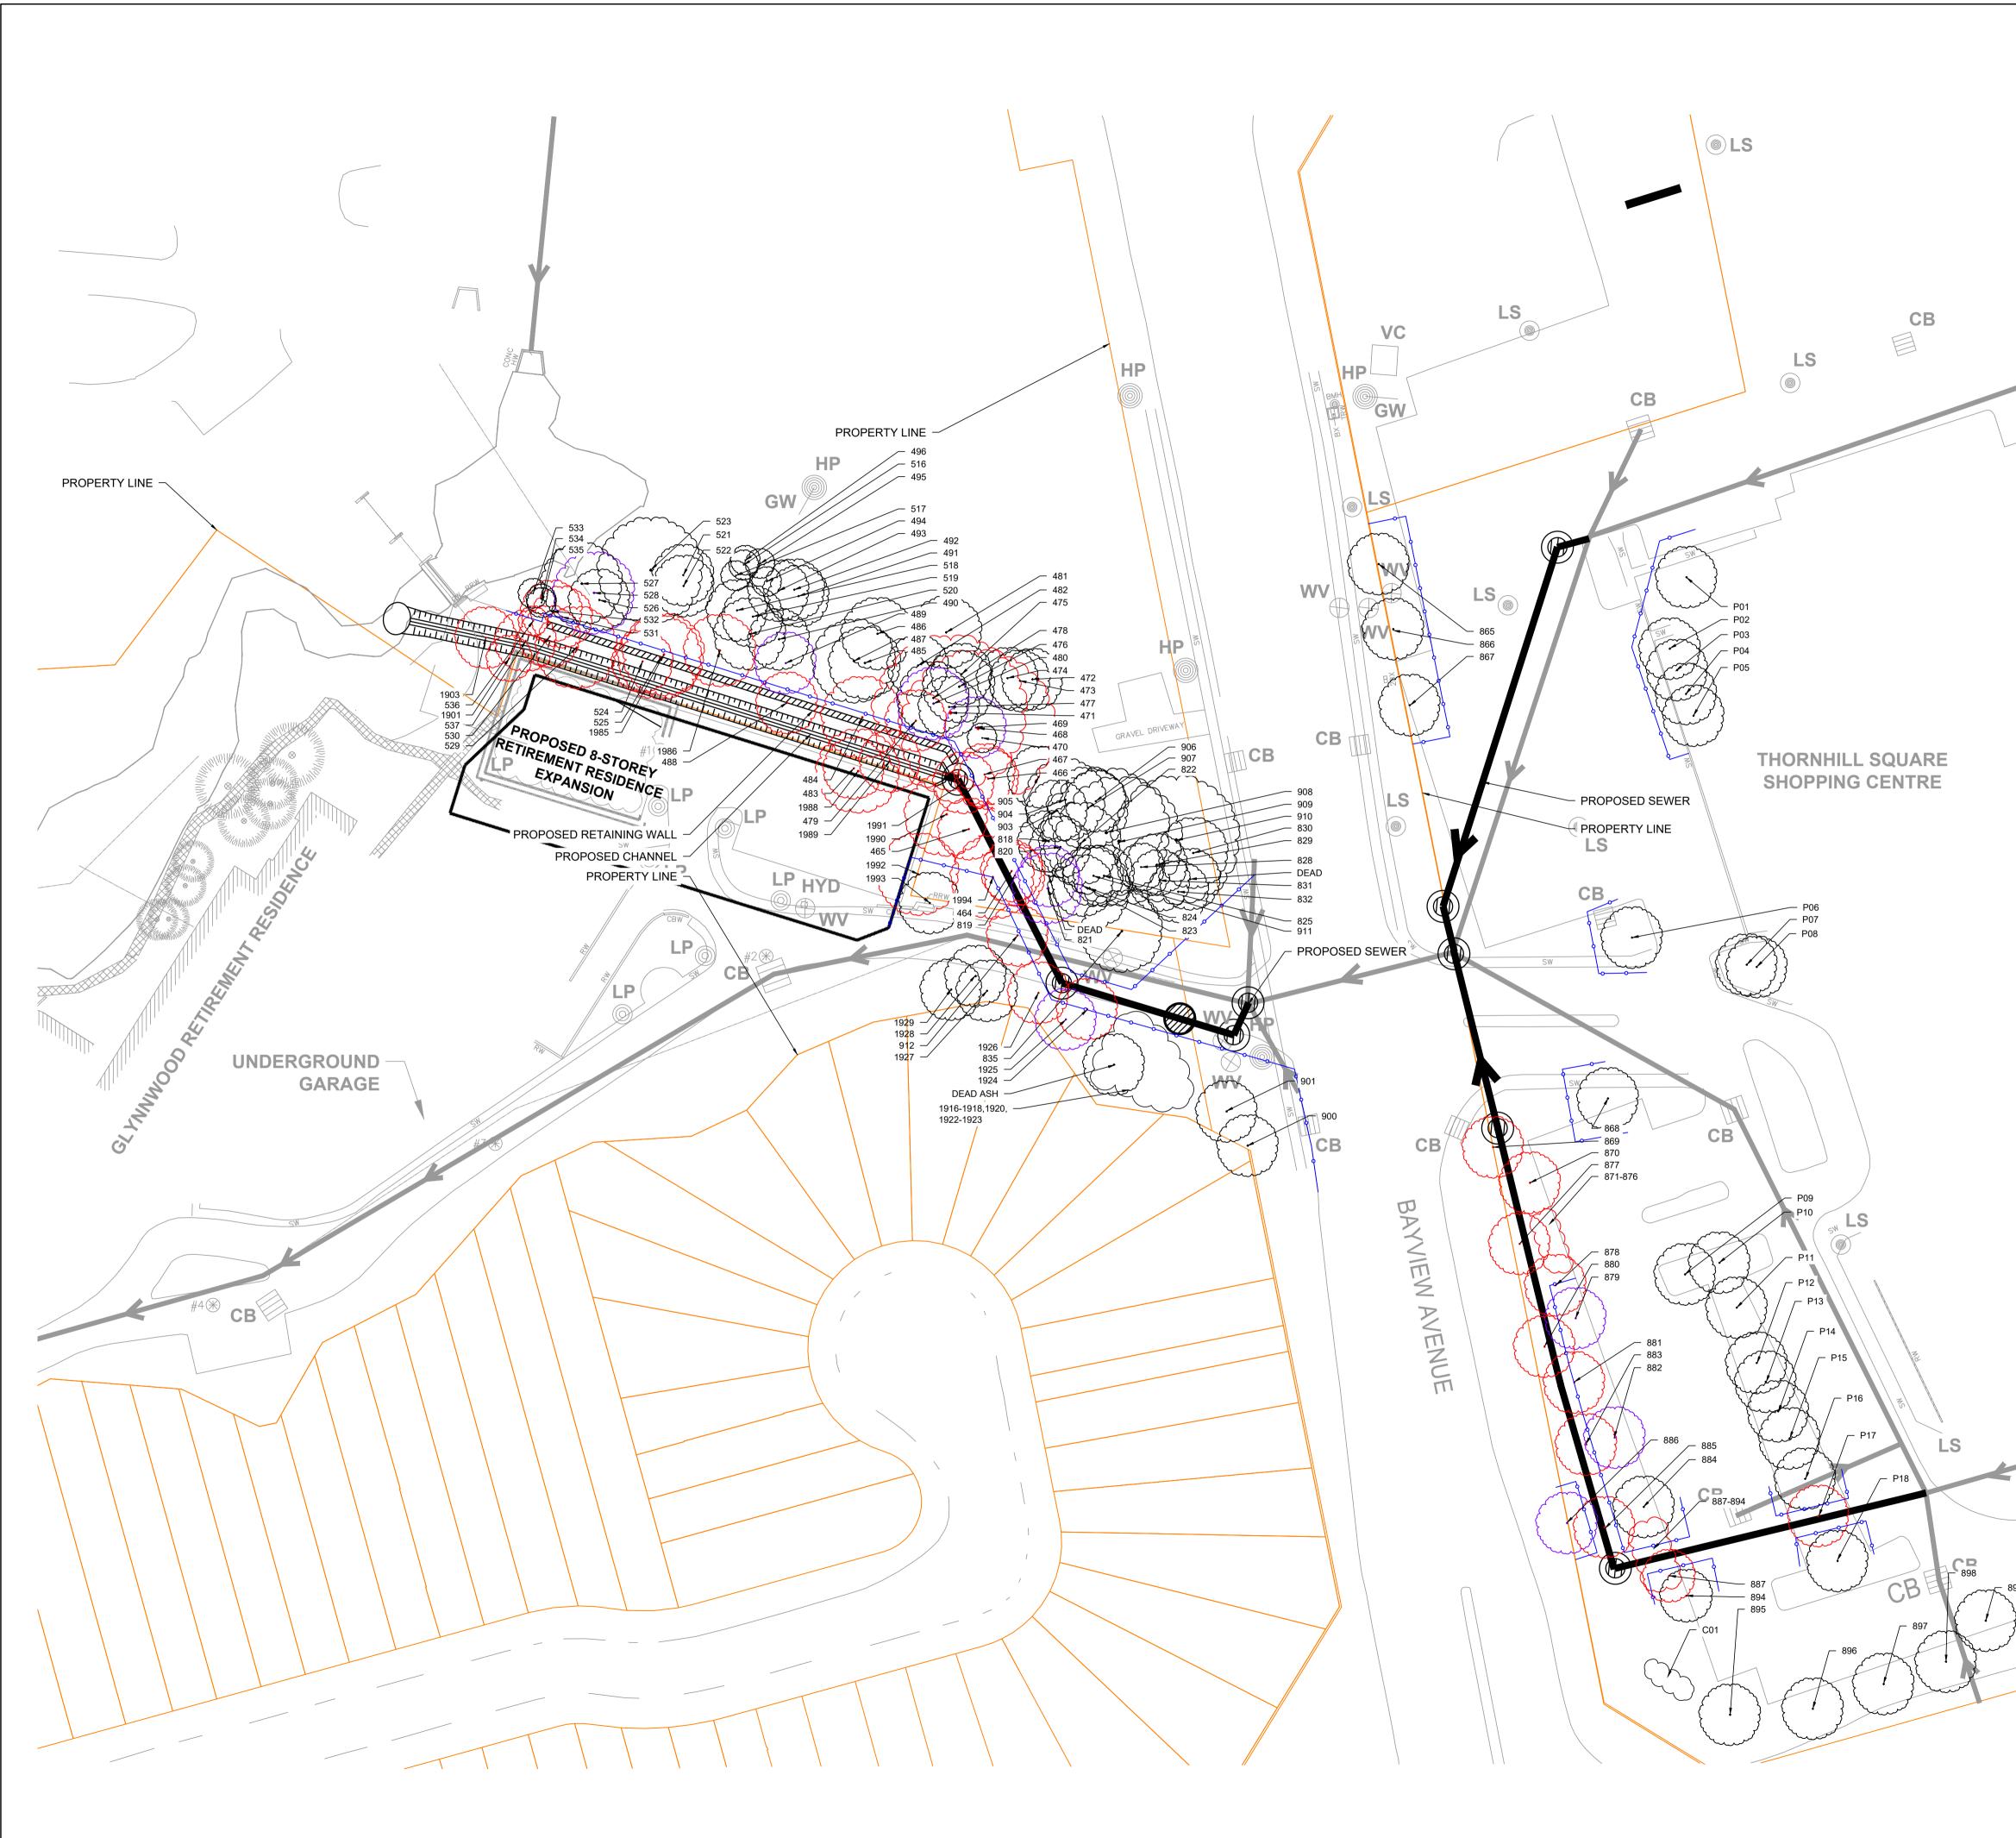
KEY MAP	
	EXISTING SURVEYED TREES TO REMAIN & BE PROTECTED
	EXISTING SURVEYED TREES PROPOSED FOR REMOVAL
	EXISTING SURVEYED TREES TO REMAIN & BE PROTECTED, TREE PROTECTION ZONE ENCROACHMENT / INJURY
	EXISTING SURVEYED TREE GROUPING
	EXISTING SURVEYED TREE GROUPING PROPOSED FOR REMOVAL
	SUPPLY & INSTALL TREE PROTECTION FENCING AS PER 1/TM-2
	PROPOSED SEWER
1 09-10-2021 NO DATE	EA SUBMISSION JB BV REVISION/ISSUED BY APPD
	582 Lancaster Street West Kitchener, ON N2K 1M3 t. 519-743-8777
	www.wsp.com
	CITY OF MARKHAM MARKHAM, ON
PROJECT TIT	
	OD RETIREMENT RESIDENCE
г г	REE MANAGMENT PLAN
SITE ADDRES	SS: 7700 BAYVIEW AVE
	THORNHILL, ON L3T 5W1
	E MANAGEMENT PLAN
STAMP	STAMP
DESIGNED JB	DRAWN IB CHECKED BV
SCALE 1:500	DATE AUGUST 2021
	61-00-20 TM-1
