**MARKHAM EROSION  
RESTORATION IMPLEMENTATION  
PLAN**

***FINAL REPORT***

Aquafor Beech Limited  
8177 Torbram Rd.  
Brampton, ON

June 30, 2007, (updated January, 2011)  
Reference: 64550

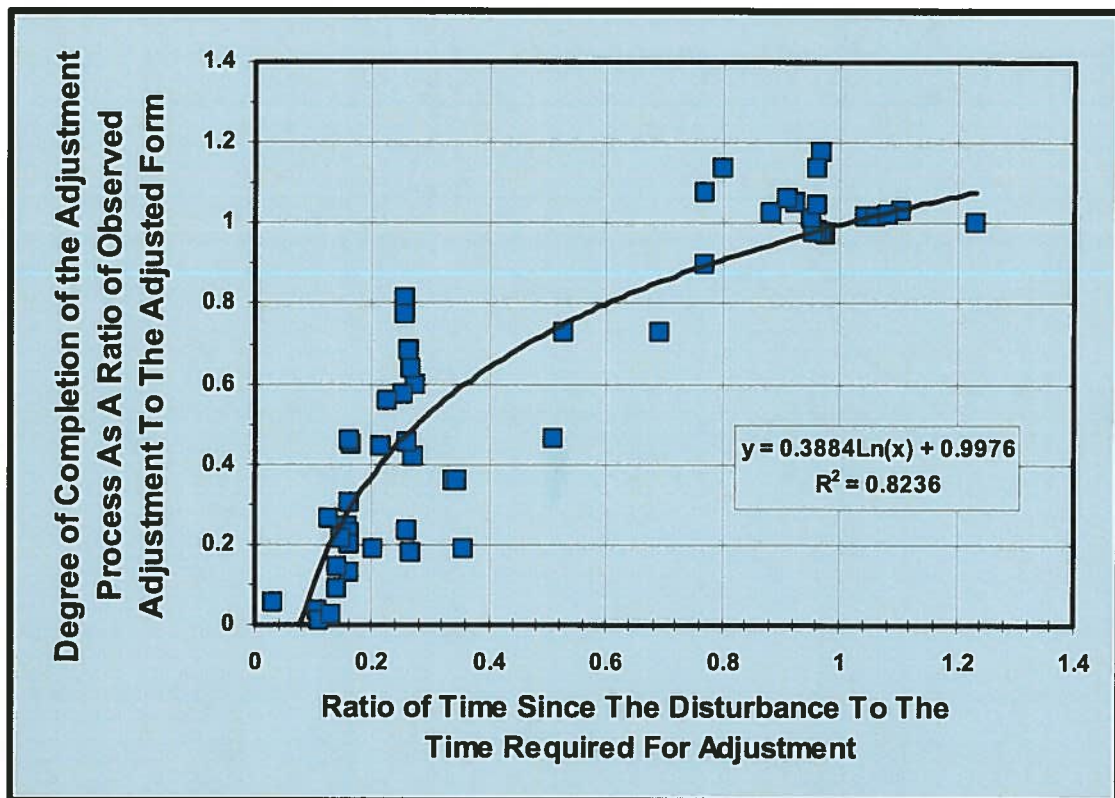
Figure 5.2 Channel enlargement vs. time.

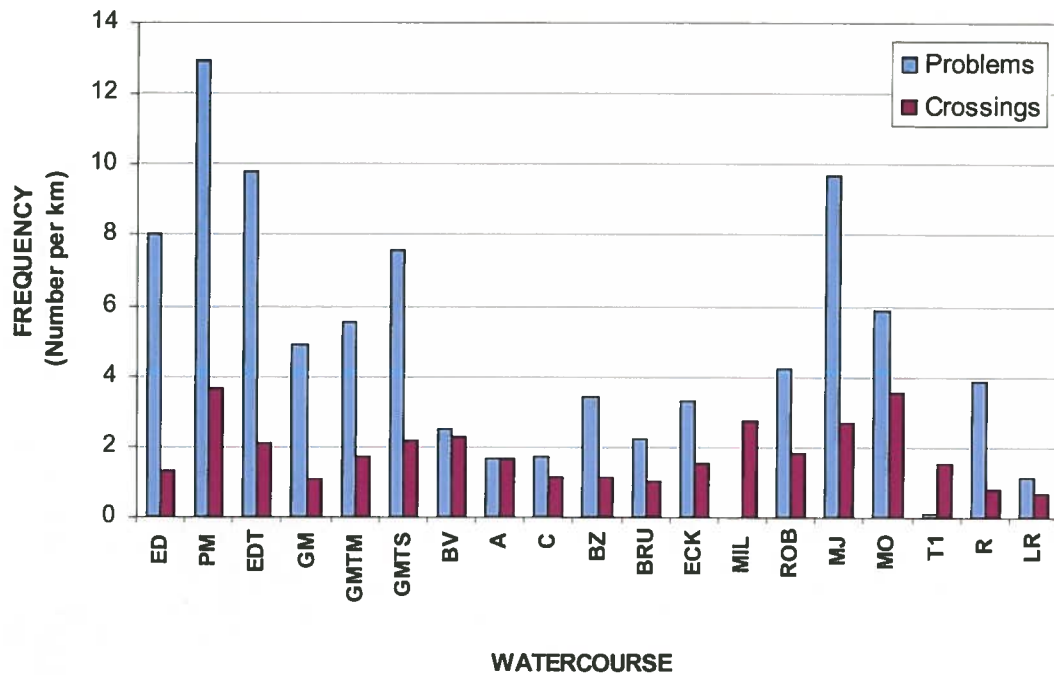
**Figure 7.3:** The frequency of erosion problems by watercourse within the Town of Markham. (see **Table 7.1** for watercourse abbreviations)

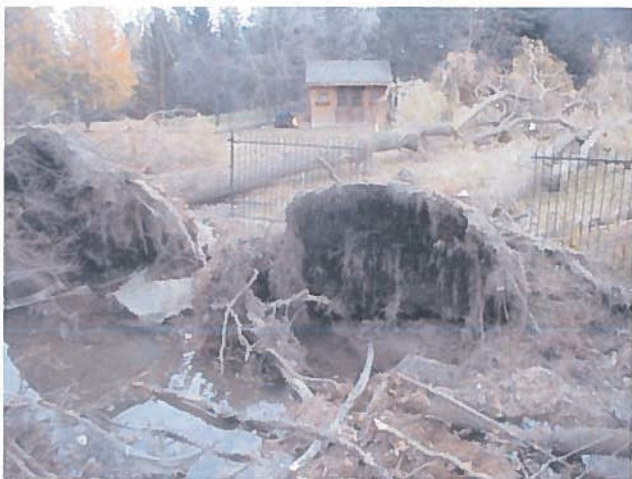
Fallen trees - East Don Tributary

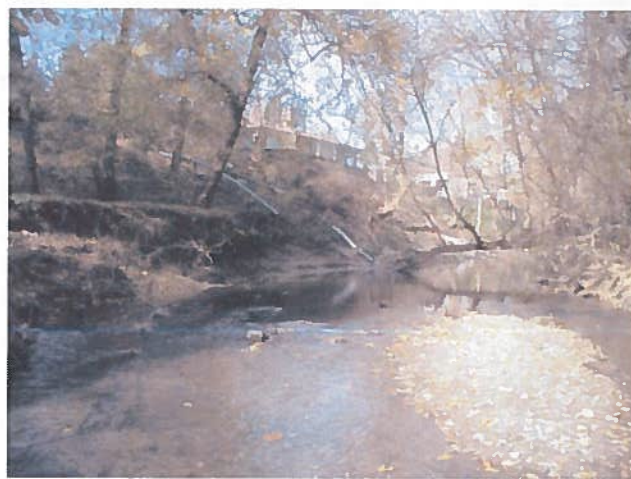
Erosion in private yards - East Don River

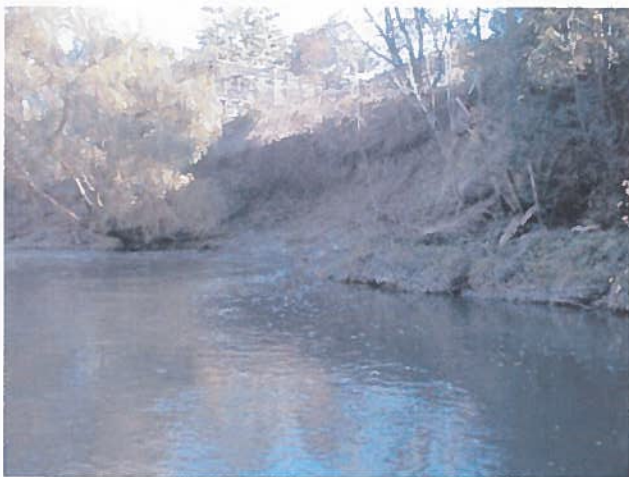
Erosion in private yards - Rouge River

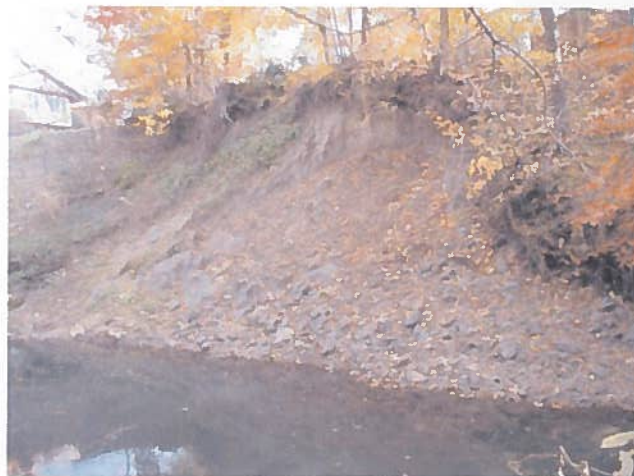
Valley wall erosion - East Don River

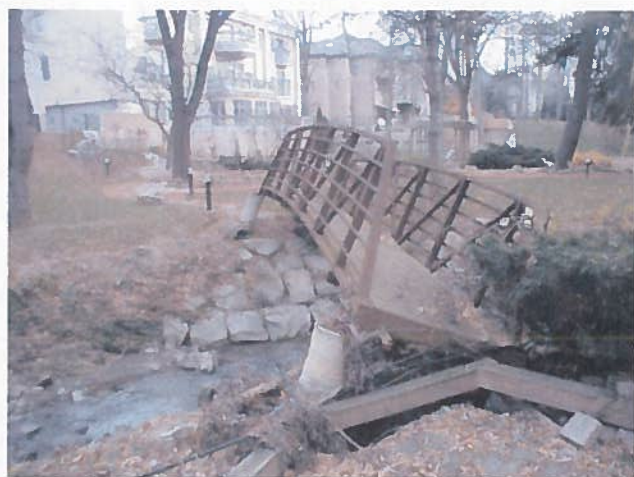
Bridge failure - East Don River Tributary

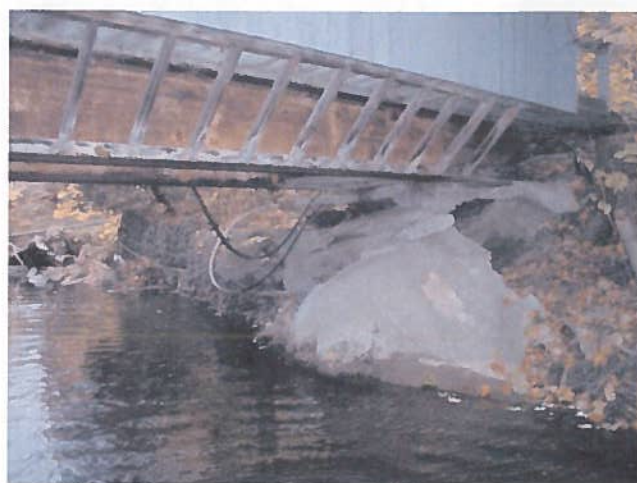
Private bridges/crossings - Berczy Creek

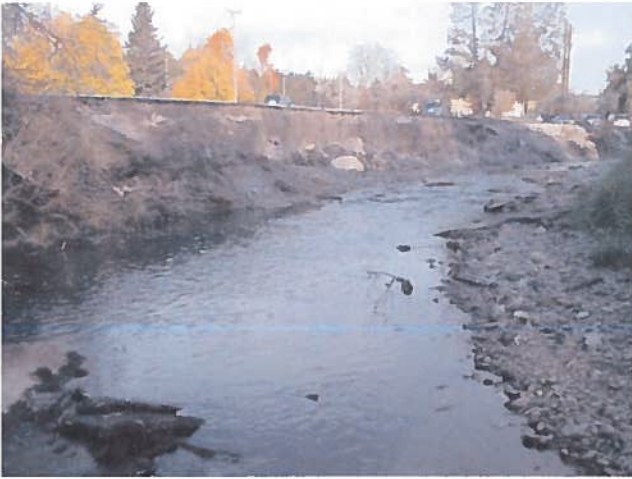
Parking lot - German Mills Creek

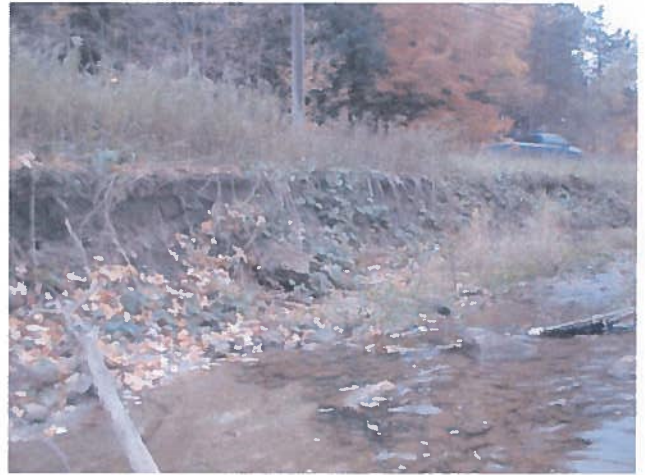
Roads - Warden Ave - Berczy Ck

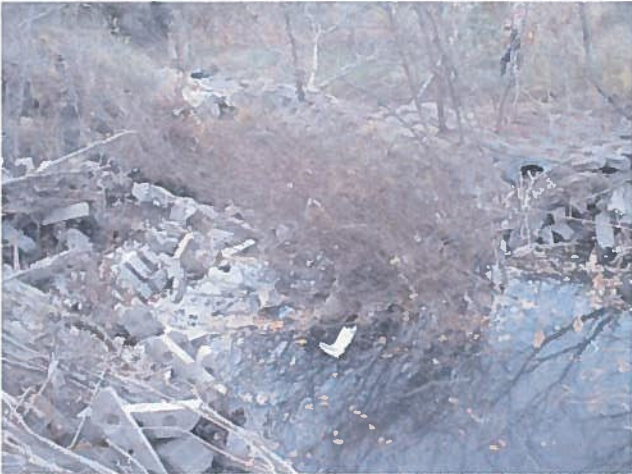
Upheaval of existing bed protection - German Mills Creek Tributary

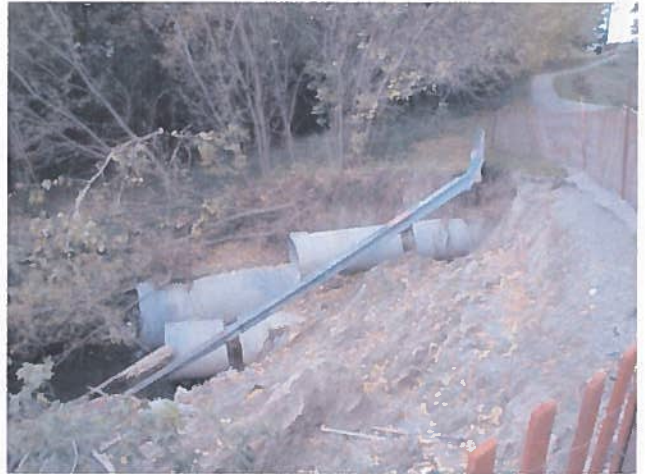
Walkway crossing - Pomona Mills Creek

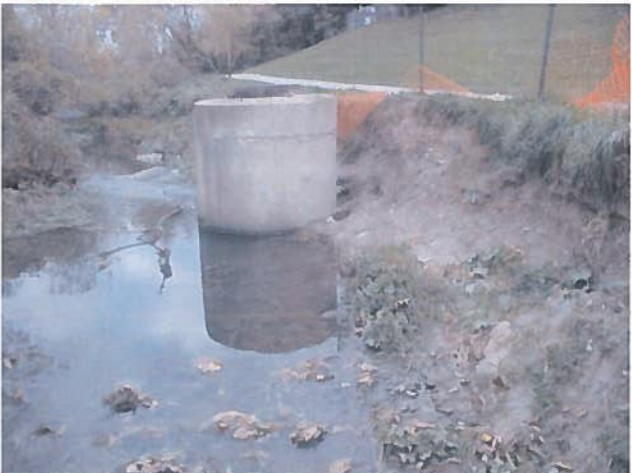
Exposed Manhole - Mt. Joy Creek

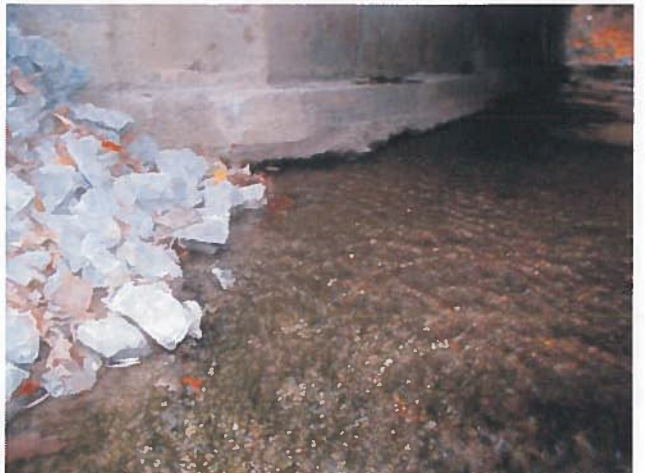
Bridge pier undercutting - East Don River Tributary

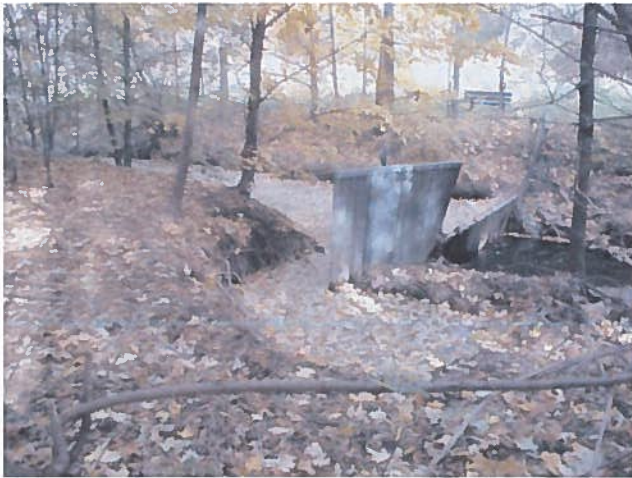
Weir - Pomona Mills Creek

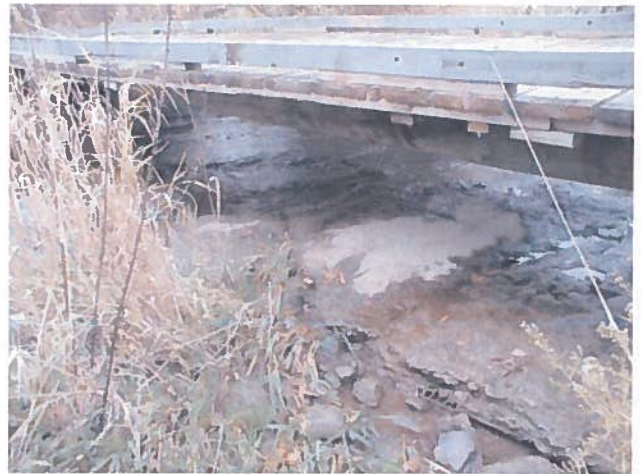
Shallow water - Bruce Creek

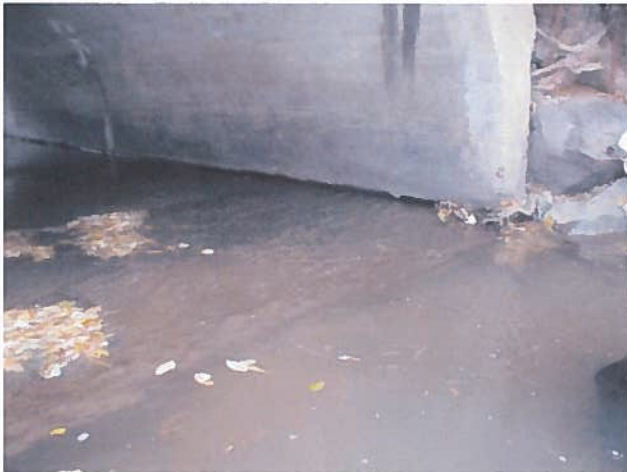
Shallow water - Pomona Mills Creek

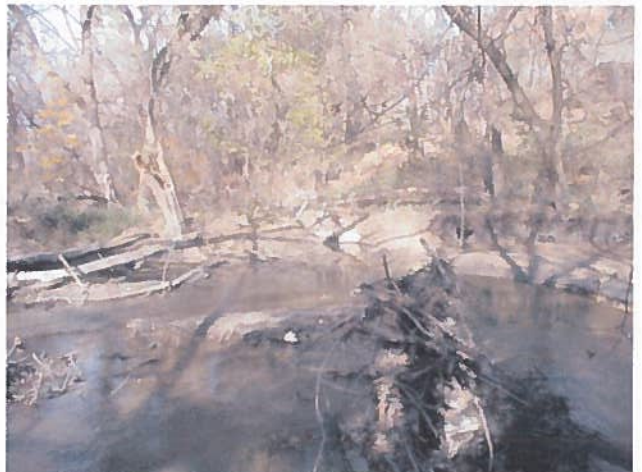
Fine sediment in channel - East Don River

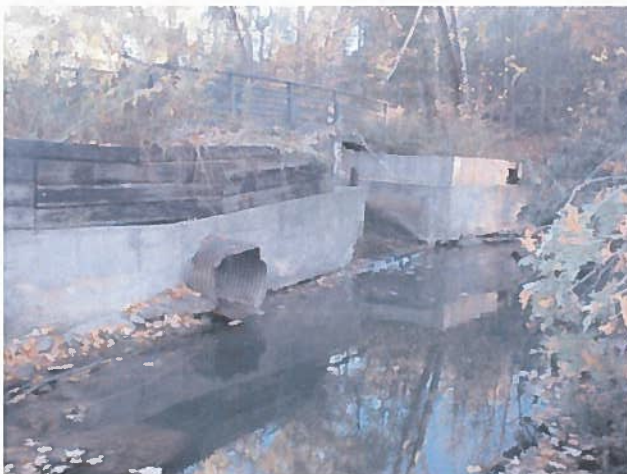
Weirs/barriers - Berczy Creek

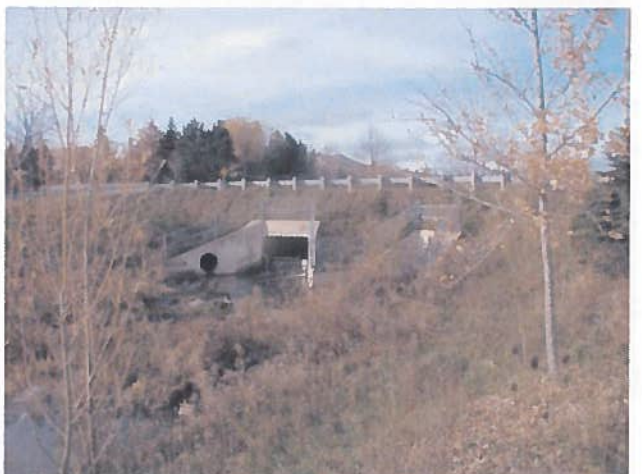
Culvert barrier - Applewood Creek

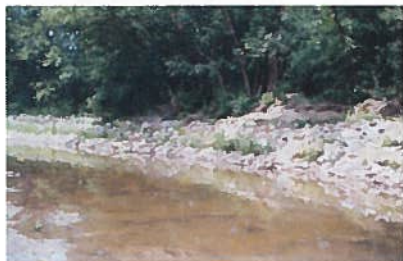
### Joint Plantings, Vegetated Rock Revetment, Vegetated Riprap

Live stakes tamped into joints or openings between rock previously been installed on a slope or while rock is being placed on the slope face.
