THURBER ENGINEERING LTD.

**CONTAMINATION OVERVIEW STUDY
HIGHWAY 404 NORTH COLLECTOR ROADS
ENVIRONMENTAL ASSESSMENT STUDY
MARKHAM, REGION OF YORK**

Date: November 27, 2019
File: 18189-30

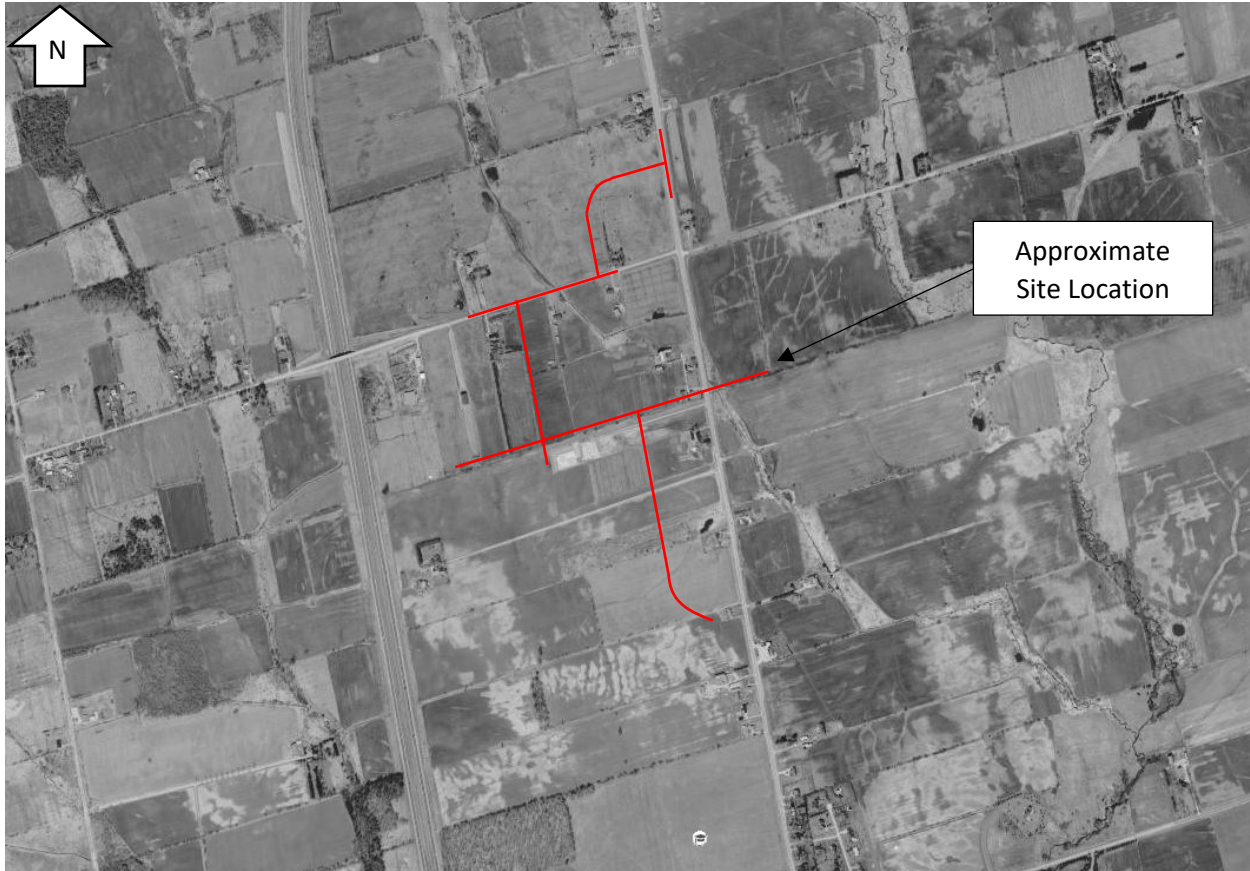
1988 Aerial Photograph

1988	No significant changes were observed since 1978.	Highway 404 was constructed approximately 250 m west of the Site. Ground disturbance was observed on the property with municipal address 2705 19 th Avenue. The property with municipal address 2743 19 th Avenue appeared to be used for sporting fields.

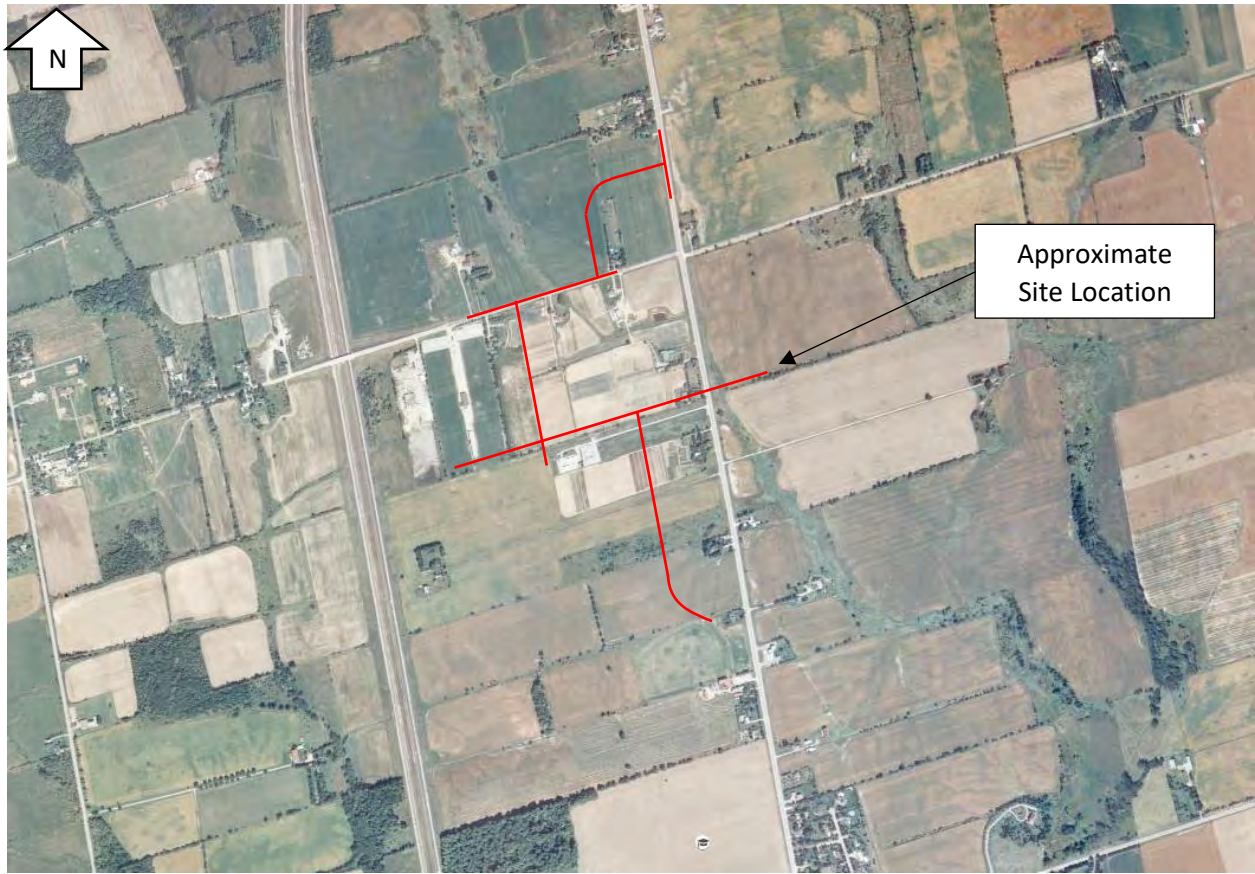
1995 Aerial Photograph

Aerial Photograph Observations		
Year	Site	Surrounding Properties
1995	No significant changes were observed since 1978.	Further development of 2705 19 th Avenue was observed with possible commercial and/or industrial operations. Parking lots and a rectangular building were respectively constructed at the north and south ends of 2743 19 th Avenue. Sporting fields existed on the property.
2002	No significant changes were observed since 1978.	Increased commercial and/or industrial operations were observed at 2705 19 th Avenue (i.e. vehicle, equipment, and materials storage). Equipment storage at 2780 19 th Avenue was observed.
2009	A residential/farm driveway which crossed the Site in an approximate east-west direction about 650 m south of 19 th Avenue was observed to have been expanded and appeared to be used as an access driveway to 180 Honda Boulevard.	The developed property at 2705 19 th Avenue appeared expanded (approximately doubled in size). Equipment, materials, and vehicle storage was observed across the property. Possible truck and trailer, vehicle, equipment, and/or materials storage was observed at 2936 19 th Avenue, 2931 19 th Avenue, and 2787 19 th Avenue. The right-of-way for Honda Boulevard appeared to be under construction. A large building was observed to be under construction at 180 Honda Boulevard where an agricultural field and rural dwelling previously existed. Significant groundworks were observed at 101 Honda Boulevard and properties adjacent to 101 Honda Boulevard. Hydro poles were observed adjacent to the access driveway for 180 Honda Boulevard. The present-day address of the driveway is 11258 Woodbine Avenue.

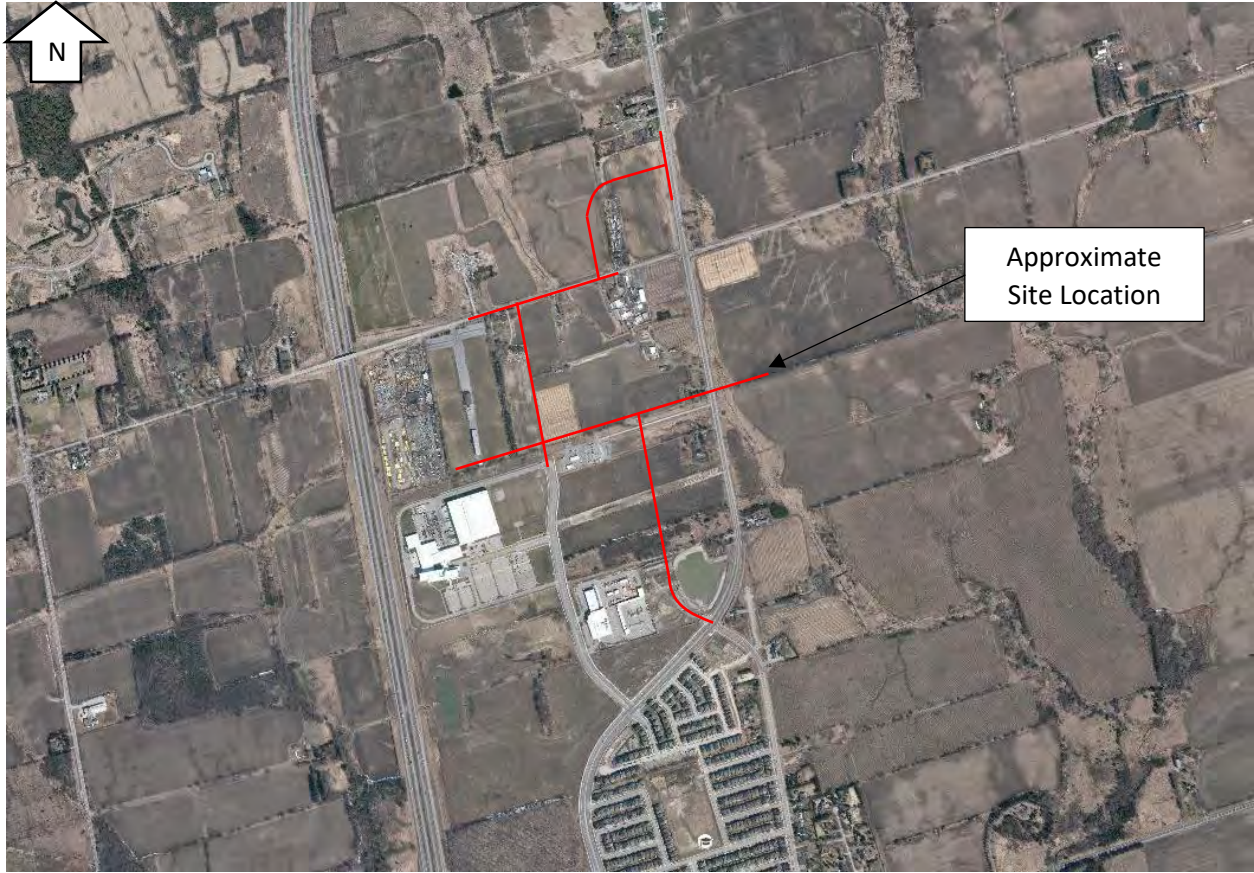
2014 Aerial Photograph

2014	Ground disturbance was observed on the Site within the property easterly adjacent to 101 Honda Boulevard. The east-west driveway from Woodbine Avenue to 180 Honda Boulevard (present-day address 11258 Woodbine Avenue) which crossed the Site appeared to be abandoned. A channel of water approximately 110 m in length crossed the Site in an east-west direction at the north end of the property easterly adjacent to 101 Honda Boulevard.	Construction of the Honda Boulevard right-of-way appeared to have been completed and the roadway paved which provided access to 180 Honda Boulevard. The construction of two large buildings and associated paved parking lots and property roadways at 180 Honda Boulevard appeared to have been completed. The property of 101 Honda Boulevard was developed with a large building and associated structures and paved parking lots. Stormwater from 101 Honda Boulevard appeared to be conveyed to a stormwater pond (approximately 150 m in diameter) which was observed to exist on an easterly adjacent property. Ground disturbance was also observed on the property. The east-west driveway that extended from Woodbine Avenue to 180 Honda Boulevard (present-day address 11258 Woodbine Avenue) no longer appeared to be in use and soil stockpiles were observed at the east end of the former driveway. Woodbine Avenue was reconfigured to extend in a northeast to southwest direction, perpendicular to the south limit of the Site. A residential subdivision was constructed to the south of the new Woodbine Avenue alignment (south end of the Study Area).

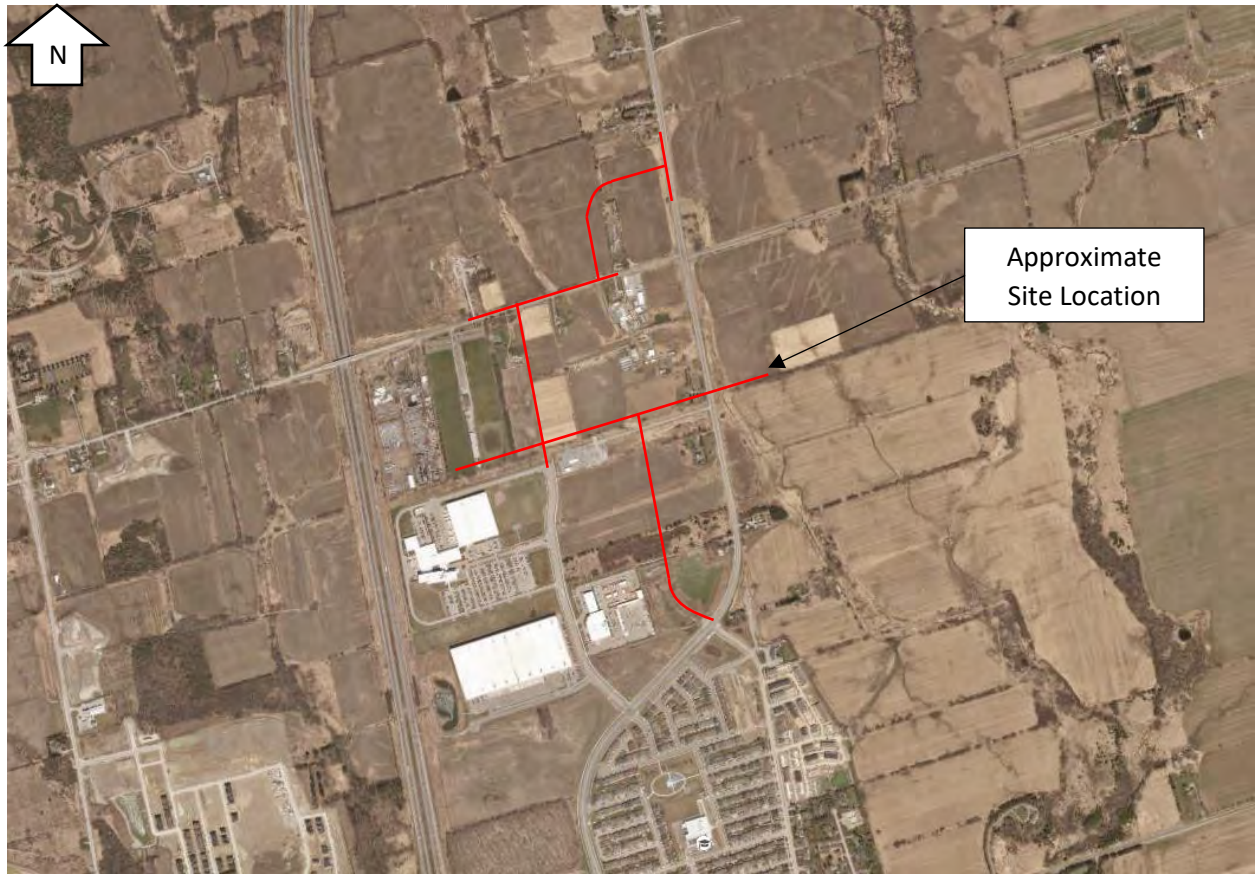
2019 Aerial Photograph

2019	No significant changes were observed since 2014.	Soil stockpiles existed at the west end of the former driveway at 11258 Woodbine Avenue.

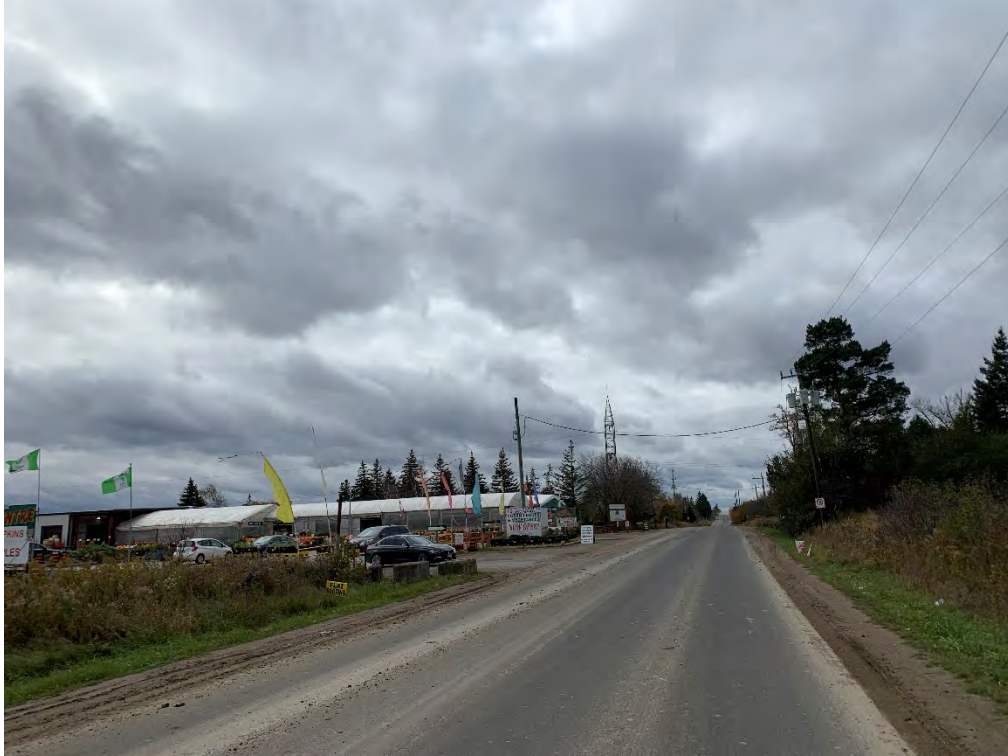
Photo 1: View of 19th Avenue towards the west from approximately 2931 19th Avenue (19th Avenue Farmer's Market).

Generally, utilities were not observed on the Site Alignments with the exception of overhead utility wires which existed on the north side of 19th Avenue (Photos 1 and 2), along the east and west sides of Woodbine Avenue (Photos 3 and 4), and along the north side of the former driveway at 11258 Woodbine Avenue (Photo 7). Additionally, overhead hydro laterals were observed to cross 19th Avenue at select locations (Photos 1 and 2), high-voltage hydro cables crossed 19th Avenue approximately 280 m west of Woodbine Avenue, and natural gas transmission lines likely traversed the Site Alignment within an easement between Woodbine Avenue and the TransCanada meter station (Photo 7).

Generally, land use to the north of 19th Avenue consisted of agricultural land with rural residential dwellings. However, the storage of vehicles, equipment, and wooden utility poles were observed on the property at 2780 19th Avenue (Photo 13). Additionally, a transport truck, trailer, and storage of wooden pallets were observed at 2936 19th Avenue, which appeared to be associated with the 19th Avenue Farmer's Market (commercial use) located southerly adjacent at 2931 19th Avenue. Food stands and farming equipment (i.e. tractors) were observed at the 2931 19th Avenue property (Photo 1).

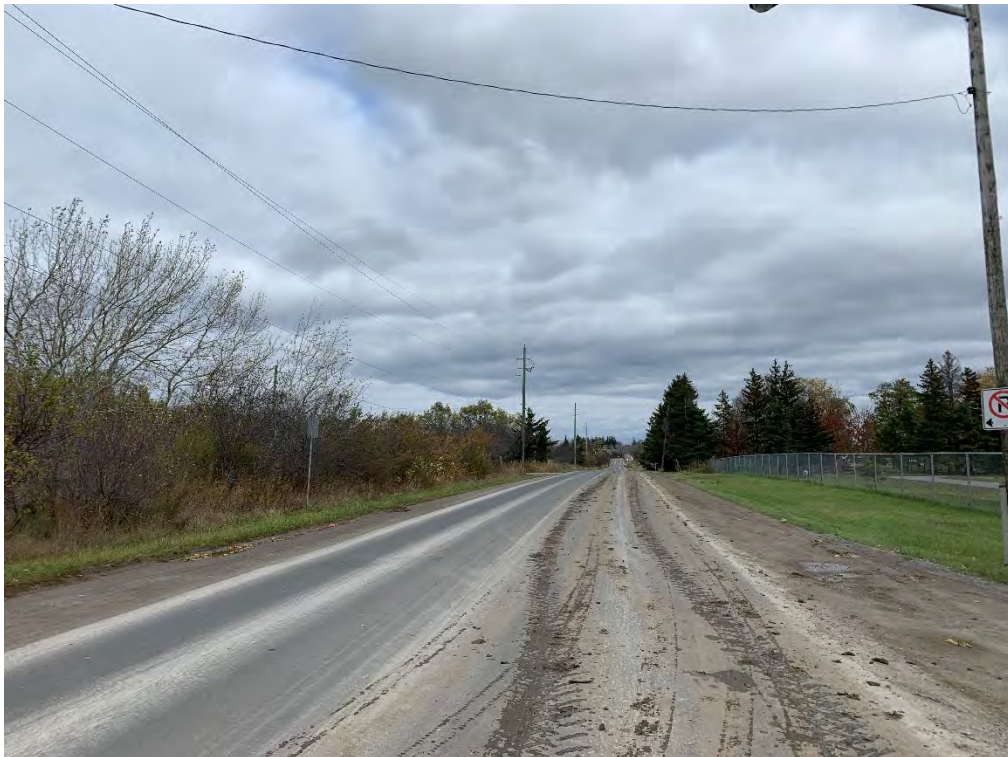
Photo 2: View of 19th Avenue towards the east from approximately 2743 19th Avenue.

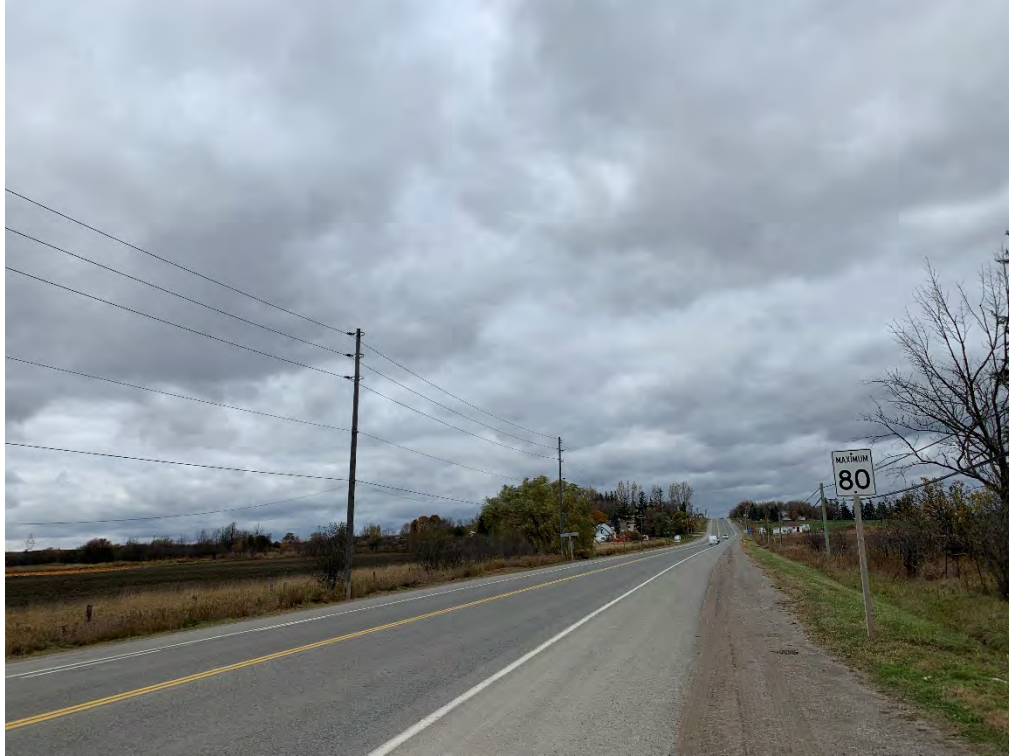
Photo 3: View of Woodbine Avenue towards the north from approximately 250 m north of 19th Avenue.

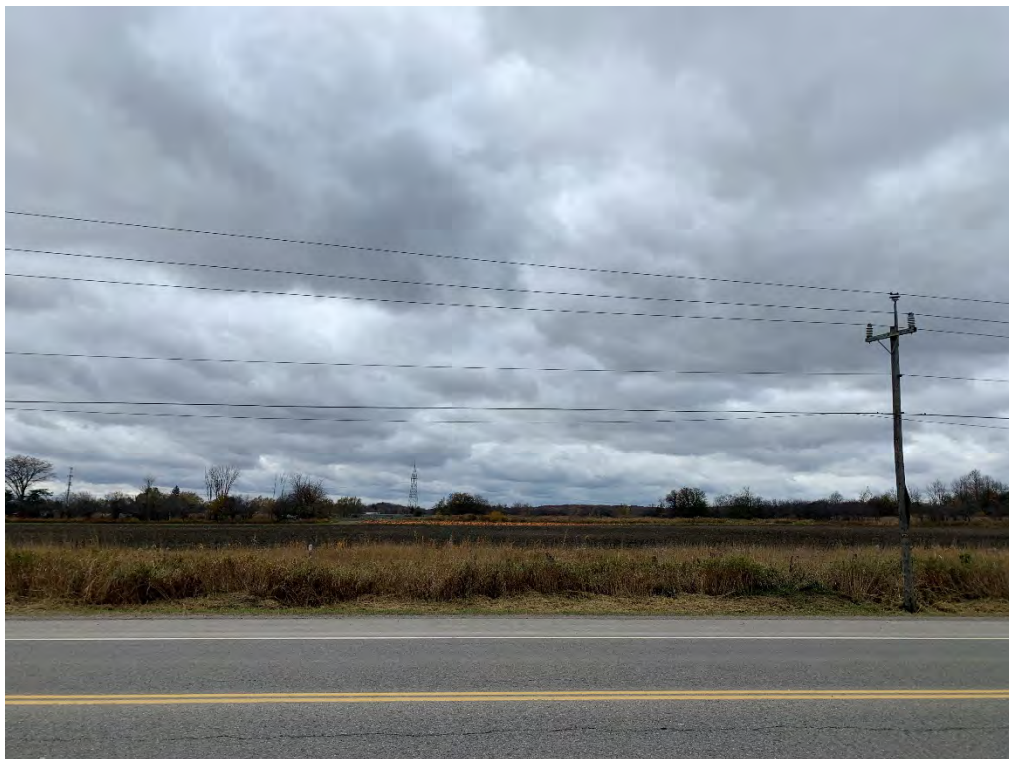
Photo 4: View towards the west of the Site alignment which connects to Woodbine Avenue approximately 250 m north of 19th Avenue.

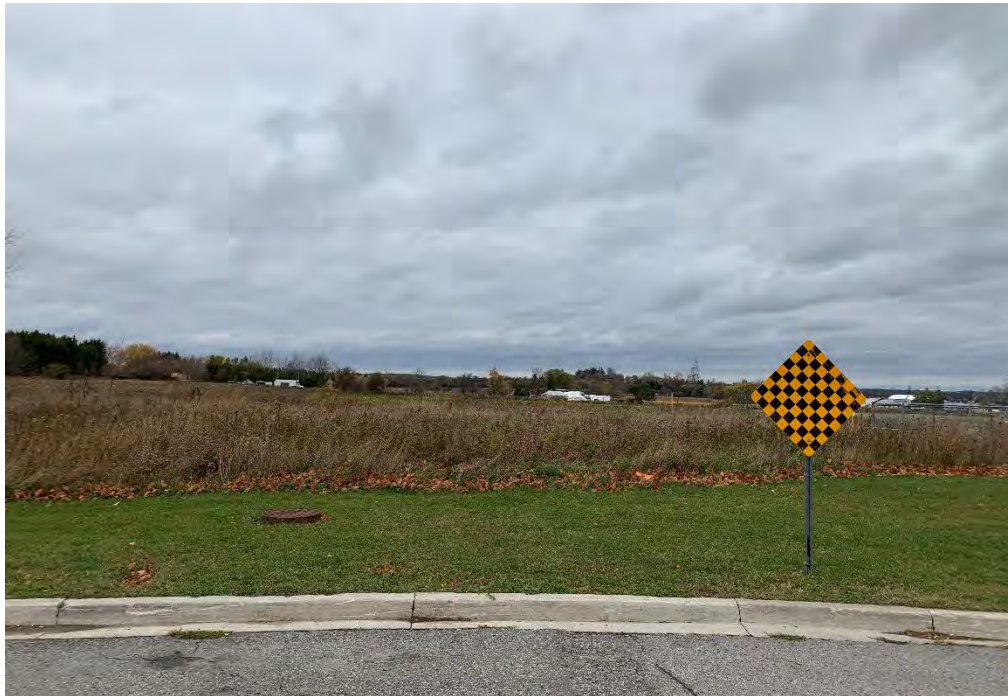
Photo 5: View towards the north of the north-south Site alignment which connects to the north end of Honda Boulevard.

The Site alignment to the north of 19th Avenue and connecting to Woodbine Avenue (approximately 500 m in length) (Photo 4), and the Site alignment extending in a north-south direction between 19th Avenue and Honda Boulevard (approximately 475 m in length) (Photo 5) consisted of agricultural lands.

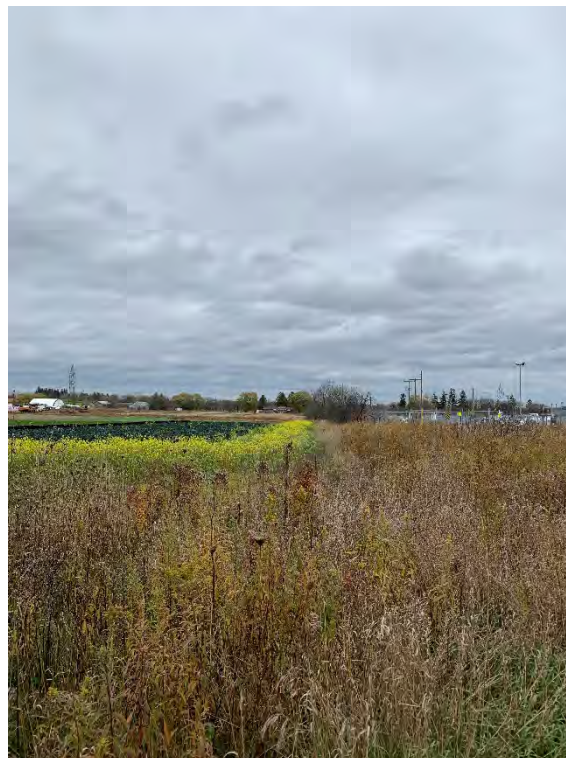
Photo 6: View towards the east of the east-west Site alignment (approximately 400 m south of 19th Avenue) from the north end of Honda Boulevard

Approximately 400 m south of 19th Avenue, a Site Alignment extended in an east-west direction (approximately 1 km in length) from the west side of the parkland property with municipal address 2743 19th Avenue, traversing between agricultural fields aligned with scattered mature trees and the Woodbine Avenue right-of-way to approximately 200 m east of Woodbine Avenue (Photos 6 through 8). A natural gas pipeline easement and meter station (industrial use) was observed southerly adjacent to this Site Alignment (Photo 7).

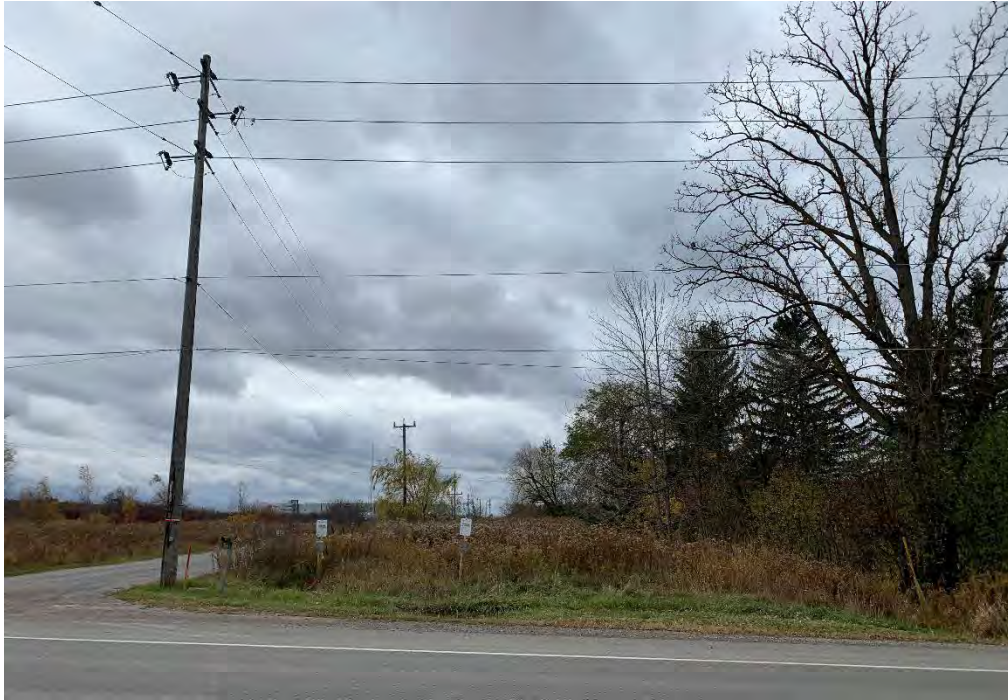
Photo 7: View towards the west of the east-west Site alignment (approximately 400 m south of 19th Avenue) from Woodbine Avenue. Signage indicating a natural gas pipeline easement to the south of this east-west Site alignment was observed.

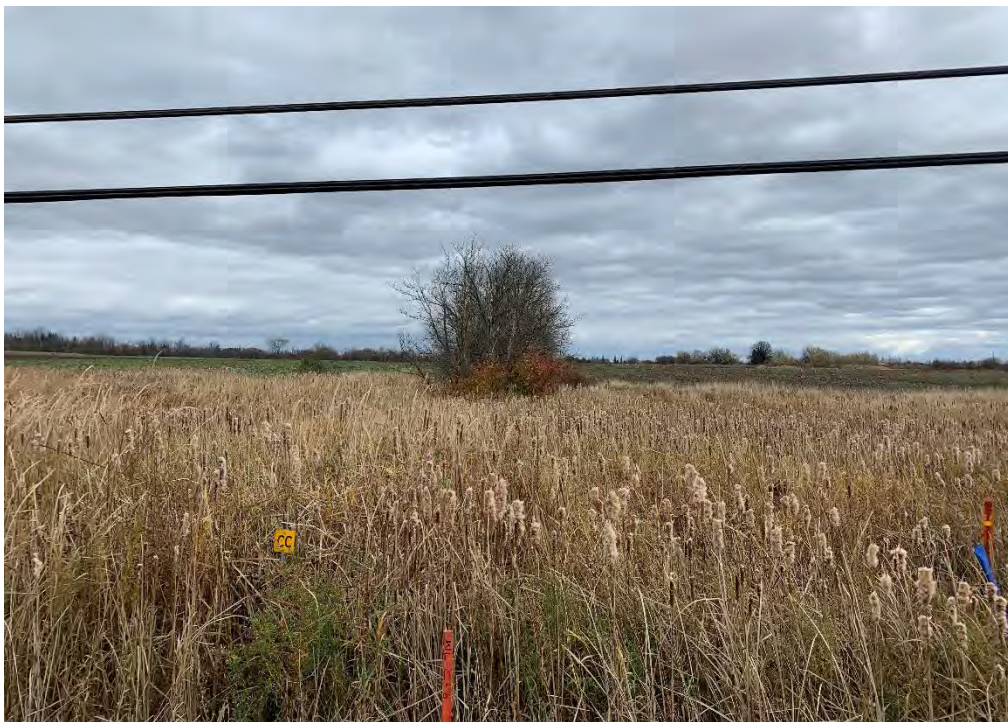
Photo 8: View towards the east of the east-west Site alignment (approximately 400 m south of 19th Avenue) from Woodbine Avenue.

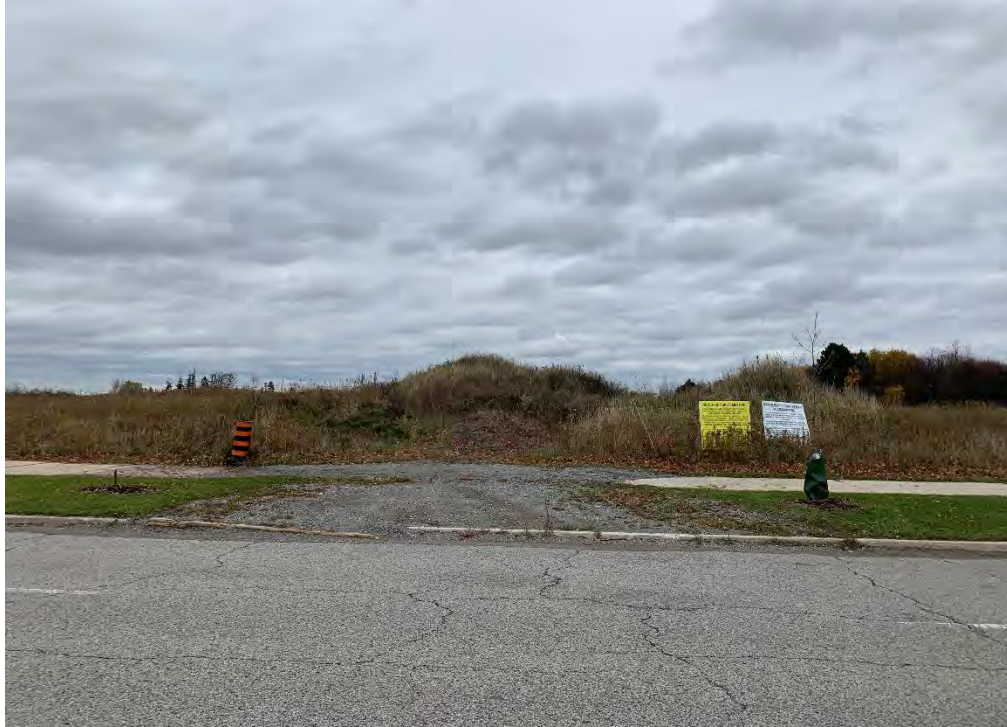
Photo 9: View from Honda Boulevard to the east at a former driveway for 11258 Woodbine Avenue (approximately 650 m south of 19th Avenue). The southern north-south Site alignment is proposed to intersect this property.

A linear parcel of land (11258 Woodbine Avenue) was observed to extend in an east-west direction between the east side of Honda Boulevard (across from 180 Honda Boulevard) to the west side of Woodbine Avenue (Photo 9). The land was observed in aerial photographs to have been used as a former driveway for a rural residential dwelling that previously existed at the location of 180 Honda Boulevard, and later appeared to be used as a temporary access driveway for the Honda Canada facility until Honda Boulevard was constructed between 2009 and 2014. At the time of the Site visit, the land no longer appeared to be used as a driveway and large soil stockpiles were observed across the property. Signs at the east and west limits of the property noted the receipt of a zoning amendment application which would permit a two-storey office building, if approved.

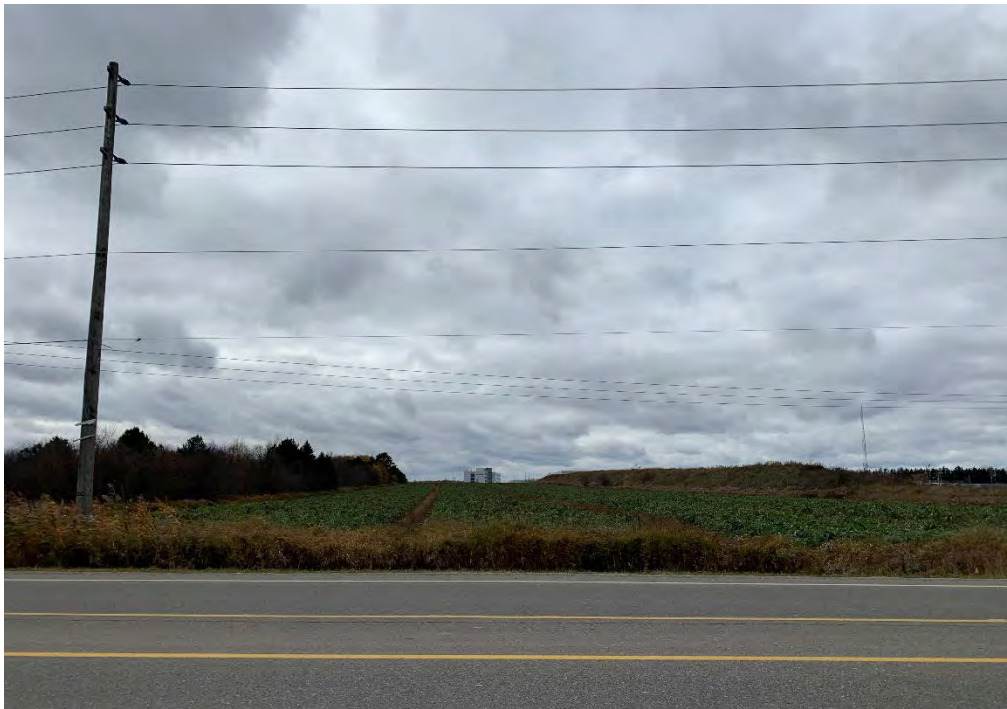
Photo 10: View from Woodbine Avenue to the west towards agricultural fields approximately 700 m south of 19th Avenue, which the southern north-south alignment of the Site is proposed to intersect.

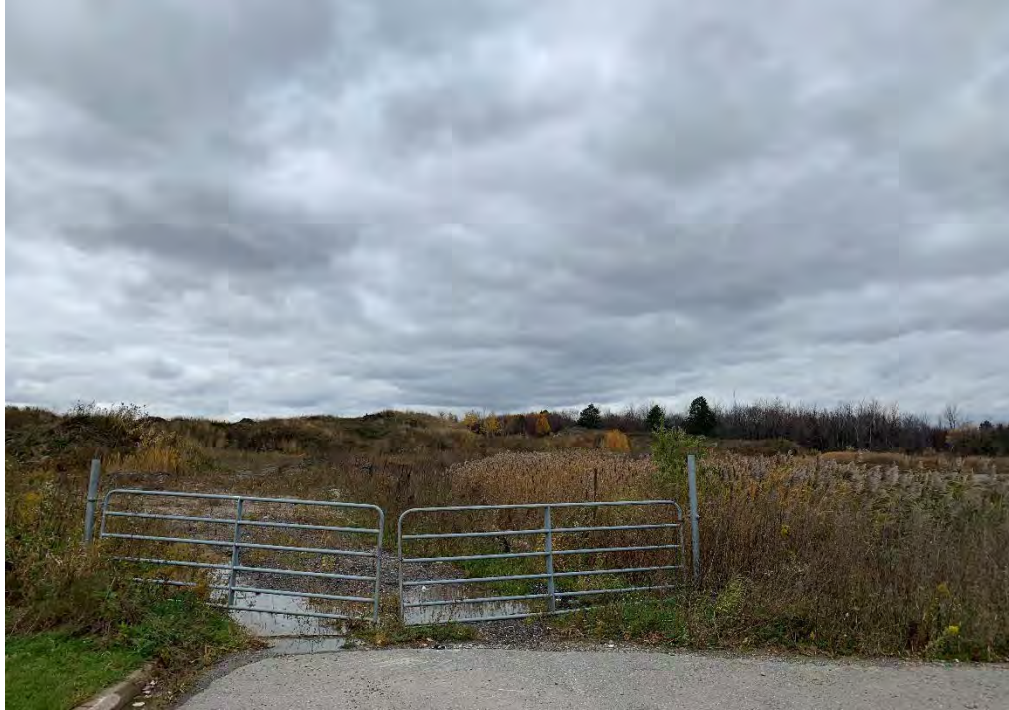
Photo 11: View towards the north of the south end of the Site. Stockpiled soils were observed at the location of the Site alignment.

The approximate southern 250 m of the Site intersected land which appeared to be associated with 101 Honda Boulevard (commercial/industrial use). On the property, stockpiled soils were observed on and to the west of the Site alignment (Photo 11) and a stormwater management pond was observed east of the alignment (Photo 12).

Fill materials were not encountered at the five boreholes advanced along the Site Alignments during the geotechnical investigation carried out by Thurber on July 11 and 12, 2019. However, stockpiled soils were observed on and adjacent to the approximate southern 250 m of the Site, and along the former driveway at 11258 Woodbine Avenue which crossed a Site Alignment in an east-west direction. Additionally, fill materials likely exist beneath the asphalt pavement structures (i.e. roadways) along portions of the Site on 19th Avenue and Woodbine Avenue.

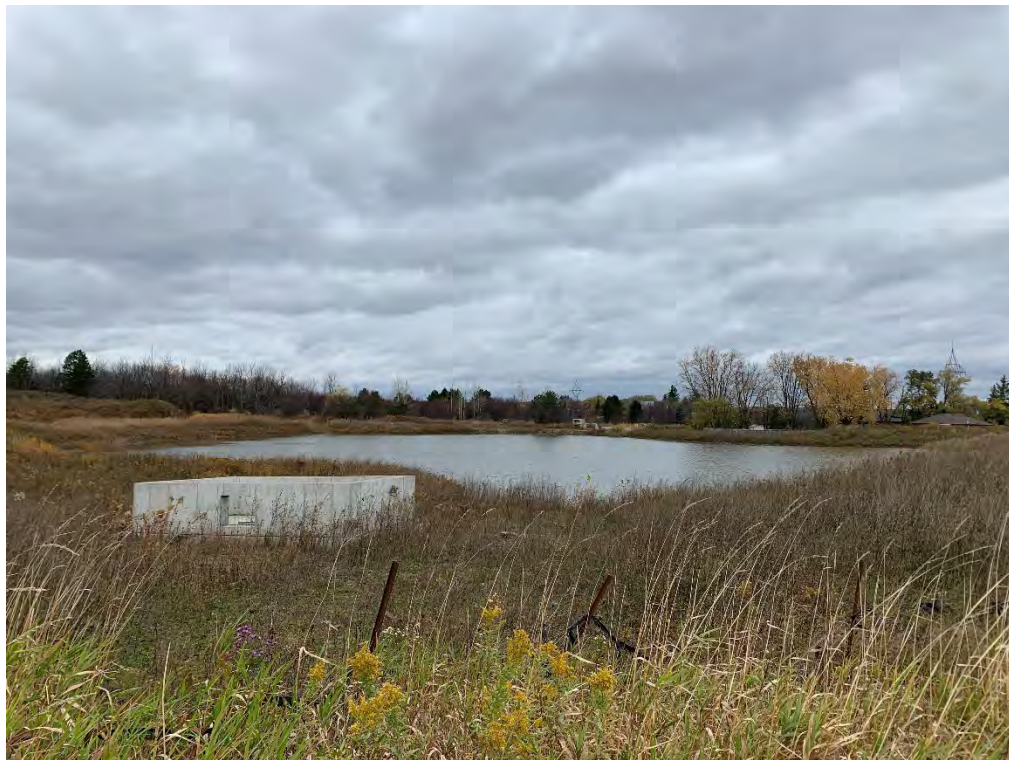
Photo 12: A stormwater management pond observed on the property adjacent to 101 Honda Boulevard and located easterly adjacent to a Site alignment.

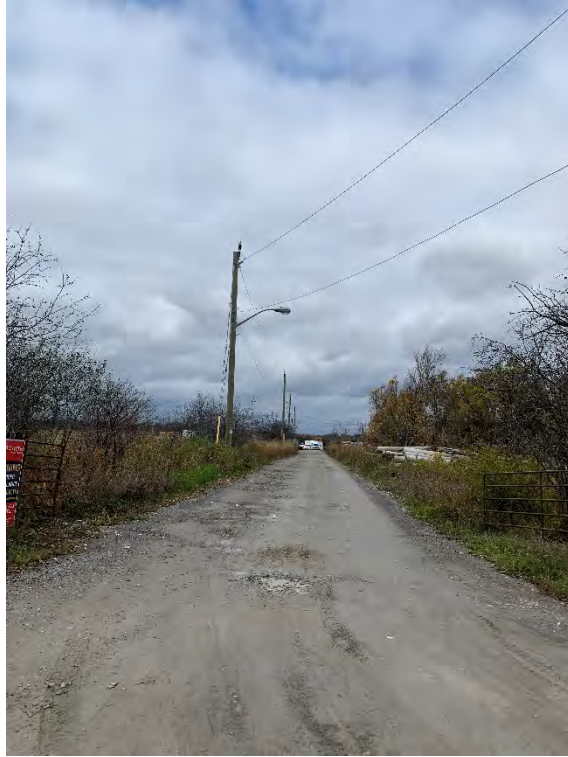
Photo 13: View of 2780 19th Avenue towards the north. The storage of vehicles, equipment, and wooden utility poles were observed on the property.

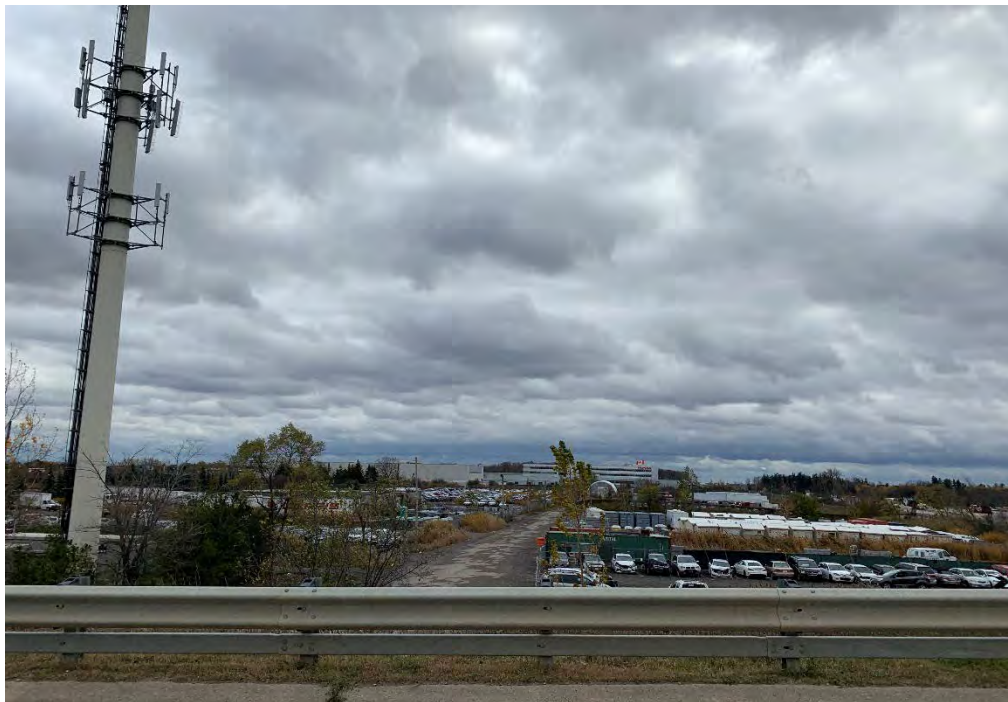
Photo 14: View of 2705 19th Avenue towards the south. Vehicle storage, sheds (possibly new for wholesale), shipping containers, possible materials storage (i.e. stone), truck parking, and multiple waste bins were observed on the property.

Parkland (Fletcher's Fields sporting fields) existed at 2743 19th Avenue, and a commercial/industrial property was observed at 2705 19th Avenue (Photo 14). Multiple companies were advertised on signs outside of the commercial/industrial property including Monument Depot Inc. (gravestone supplier), YTL, TMP Fence, TMP Fence Depot, ARAN, and TCC. Vehicle storage, sheds (possibly new for wholesale), shipping containers, possible materials storage (i.e. stone), truck parking, and multiple waste bins were observed on the property.

Various storage containers were observed at 2705 19th Avenue. The containers were located on private property and therefore the contents could not be ascertained.

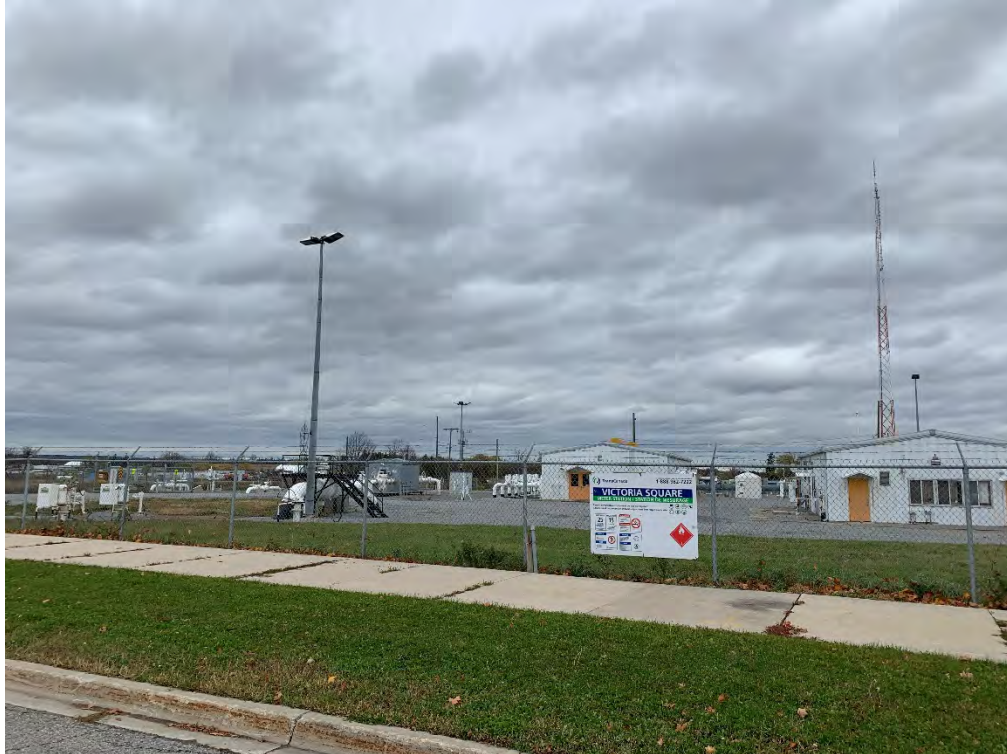
Photo 15: View towards the east of the TransCanada Victoria Square (natural gas) meter station 11346 Woodbine Avenue.

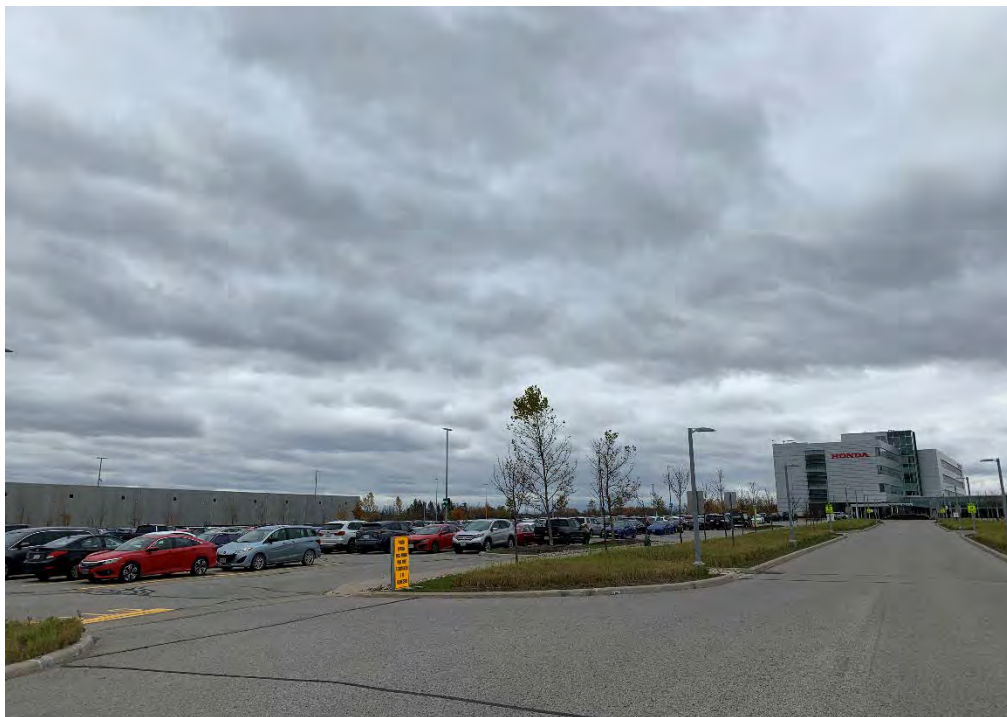
Photo 16: View towards the west of the Honda Canada facility at 180 Honda Boulevard. An office building was observed on the property. A second building was observed which may involve vehicle parts assembly and/or manufacturing.

A Honda Canada facility existed at 180 Honda Boulevard (Photo 16). An office building was observed, with a possible vehicle parts assembly and/or manufacturing plant on the property. Sporting fields existed at the northeast corner of the property.

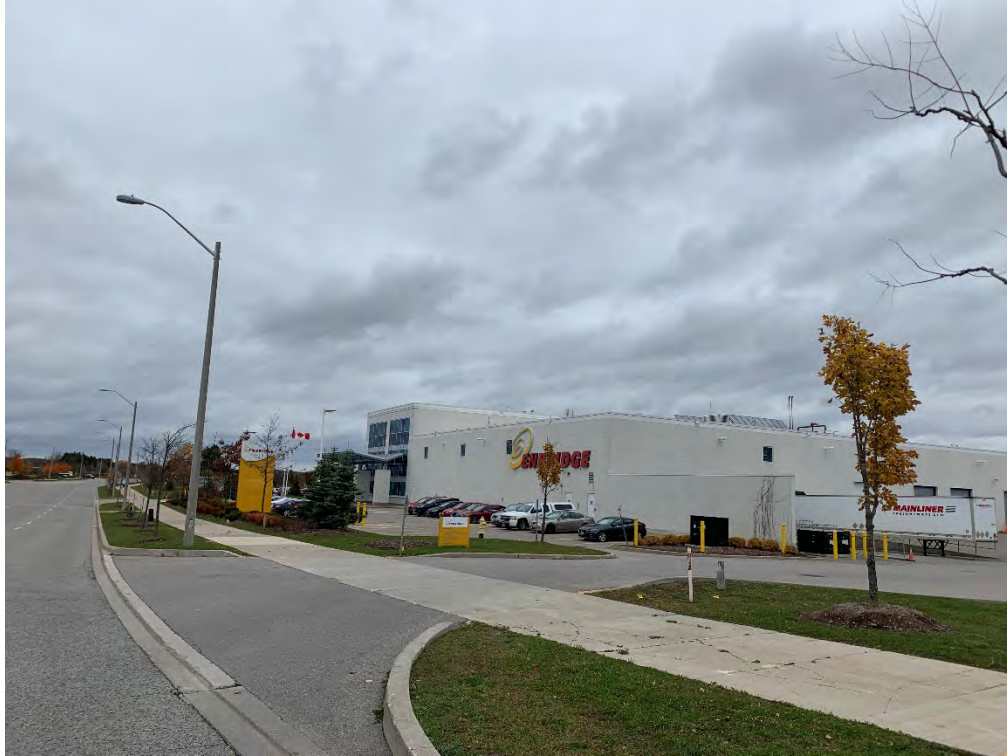
Photo 17: View towards the northeast of the Enbridge facility at 101 Honda Boulevard. Two ASTs were observed at the southeast corner of the property.

An Enbridge facility existed at 101 Honda Boulevard (Photo 17). Two ASTs were observed at the southeast corner of the property. Records of an “active” private fuel outlet with fuel tanks were identified at 101 Honda Boulevard through a TSSA search.

Access covers for underground storage tanks were observed at the RaceTrac gas station at 11087 Woodbine Avenue, and two above ground storage tanks were observed at 101 Honda Boulevard. The contents of the tanks at 101 Honda Boulevard are currently unknown.

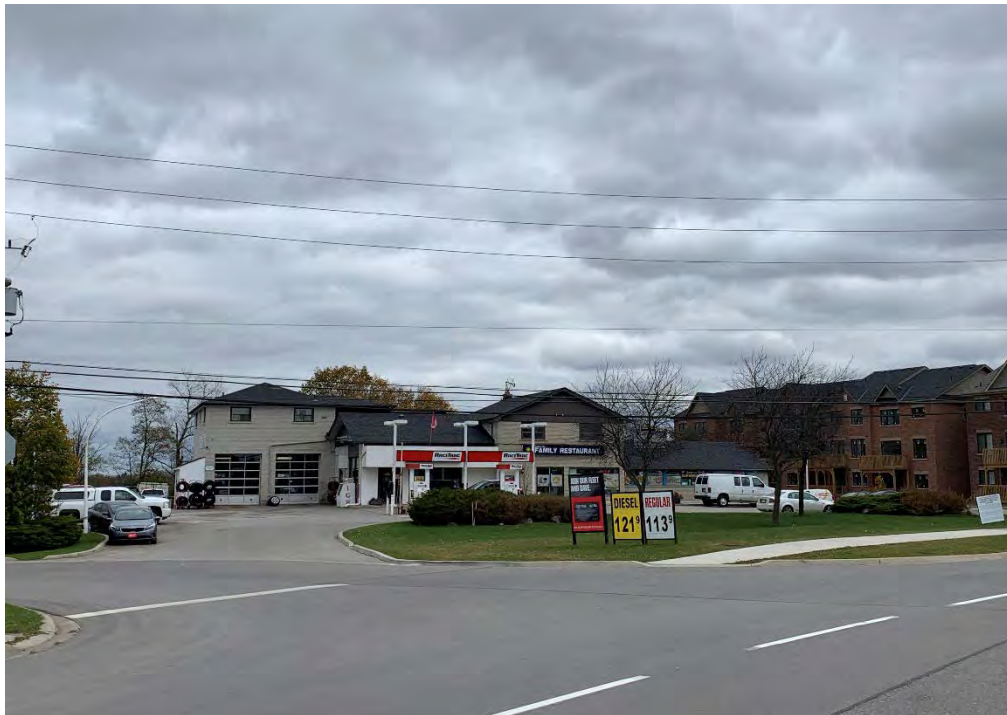
Photo 18: View towards the east of the RaceTrac gas station and Victoria Square Service Centre at 11087 Woodbine Avenue. Covers for USTs were observed near the gas station pumps.

A gas station and auto garage (RaceTrac gas station and Victoria Square Service Centre) were observed at 11087 Woodbine Avenue (Photo 18). Covers for USTs were observed near the gas station pumps. With the exception of the gas station and service centre, property use to the south of Woodbine Avenue (south end of the Study Area) was residentially developed.

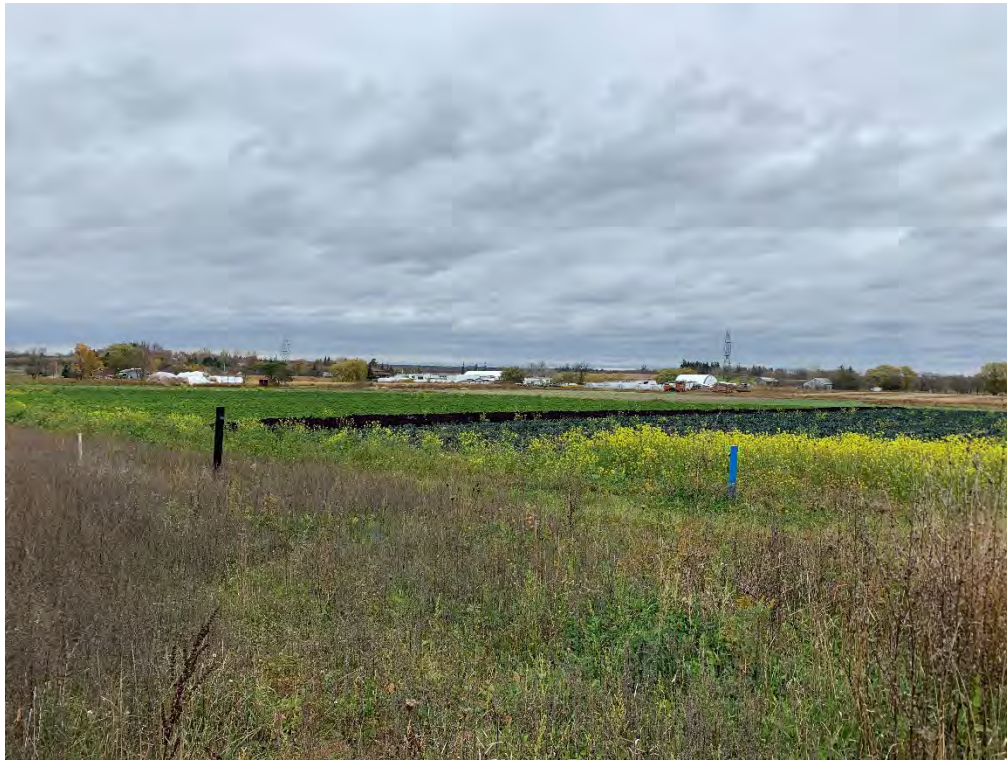
Photo 19: Two monitoring wells located at the southwest corner of the agricultural field located westerly adjacent to 2825 19th Avenue. The monitoring well with black protective casing was installed by Thurber on July 11, 2019.

Various stick-up monitoring/private wells with protective casings were observed within the Study Area at the time of the Site visit at the following locations:
